9x1 - Interior Door Panel Warps Along the Top Surface

Models	Model Year	Model Type	VIN Range	Vehicle-Specific Equipment
911	2012 - 2019	991	N/A	N/A
Boxster/ Cayman	2013 - 2016	981	N/A	N/A

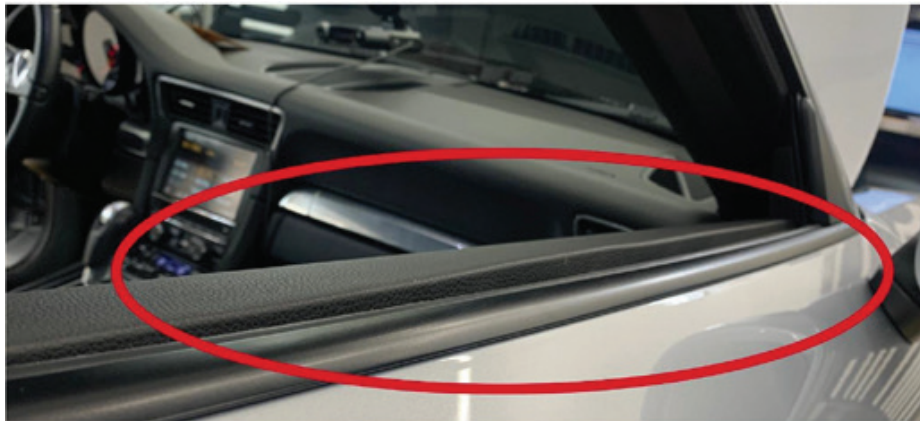
Figure 1

The customer complains that the interior door panel is deformed along the top surface. This condition is possible on both the driver and the passenger door panels.

Over time, it is possible that the glue that secures the door panel trim will deteriorate. This deterioration is accelerated with prolonged or frequent exposure to heat.

1. Please document the affected door panel(s) with pictures, and attach the pictures to the PCSS job.
2. Replace the affected door panel(s) with the most recent available parts. Updated parts to address this issue have been in production since June 10, 2016.
