## **SERVICE BULLETIN**

**ALLISON 3000 SERIES TRANSMISSION PLUG  
INSPECTION**

**RELIABILITY INSPECTION BULLETIN**

**GROUP: 0-GENERAL  
SB NO : T0520  
DATE: 6/14/2023  
REF HMM SCB-001-23**

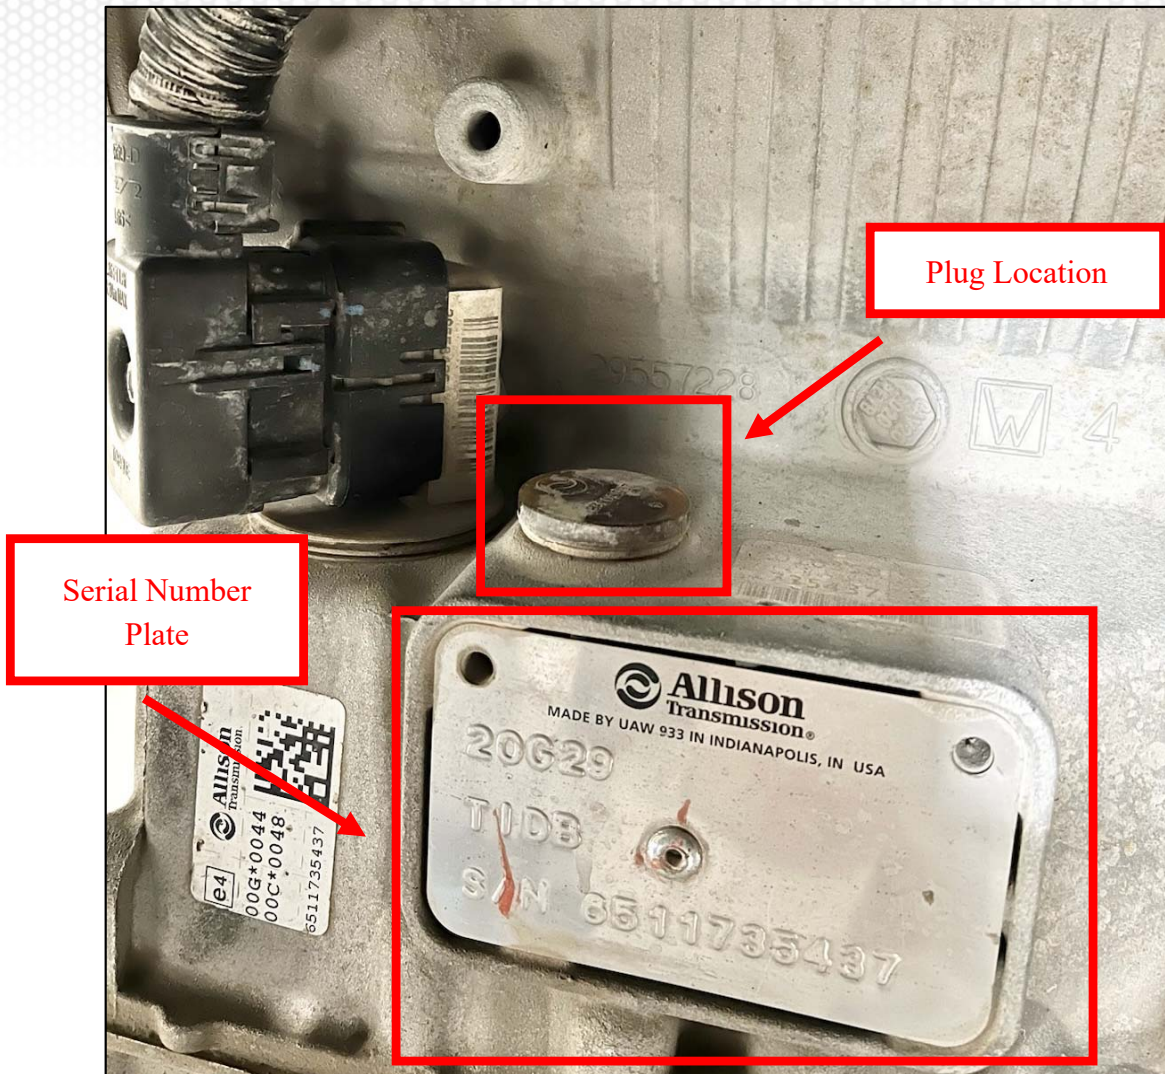
1. On the passenger rear side of the transmission, capture a picture of the entire transmission serial number plate including the plug like the image below.

2. If the transmission has a permanent plug installed as in the above image, no further action is needed.

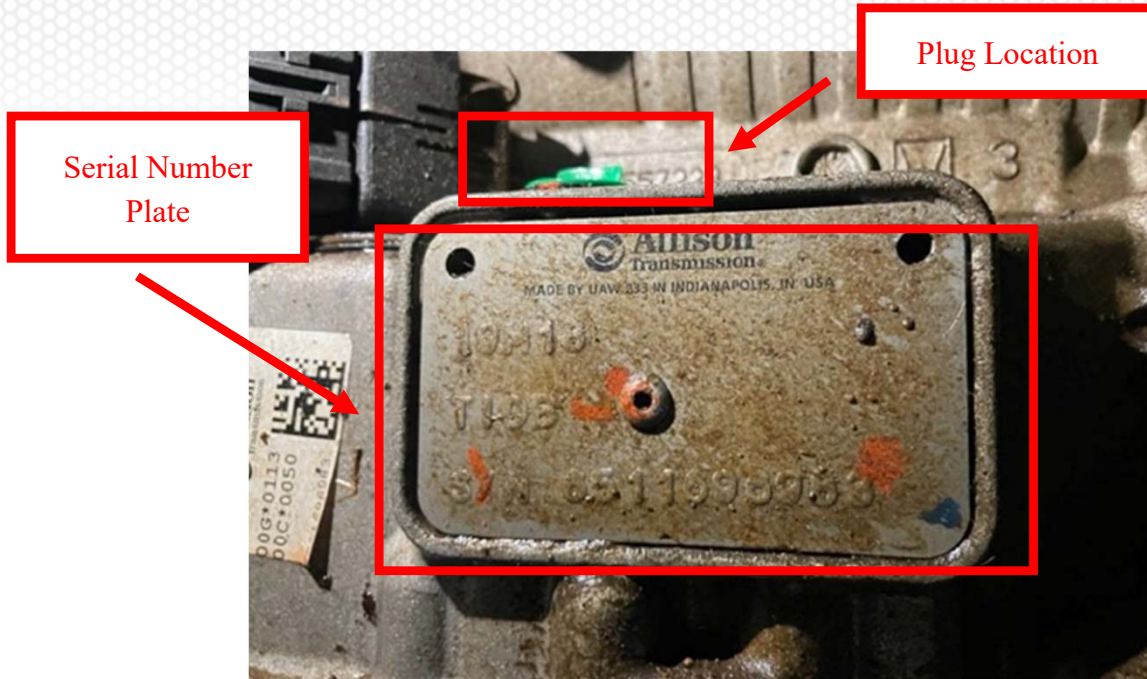
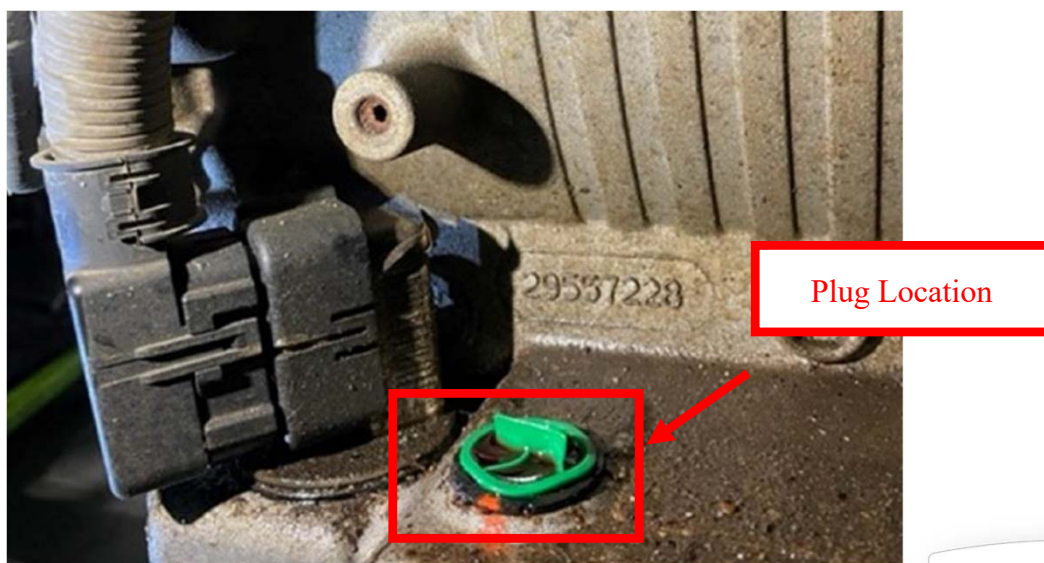
3. If the image taken in step 1 has a green plastic plug installed in the transmission like the images below, create a TechAssist case and attach the picture(s).

TechAssist will provide further direction.
