Technical product information

Topic	Window lift switch is loose within the switch carrier and/or a rattle noise can be heard from the switch
Market area	Australia E04 Bentley rest Asia and Australia (6E04),China 796 VW Import Comp. Ltd (Vico), Beijing (6796),Germany E02 Bentley rest Europe (6E02),Japan E03 Bentley Japan (6E03),Korea, (South) E08 Bentley South Korea (6E08),United Arab Emirates E06 Bentley Middle East and Africa (6E06),United Kingdom E01 Bentley UK (6E01),United States E05 Bentley USA and rest America (6E05)
Brand	Bentley
Transaction No.	2070519/1
Level	EH
Status	Approval
Release date

Window lift switch is loose within the switch carrier and/or a rattle noise can be heard from the switch

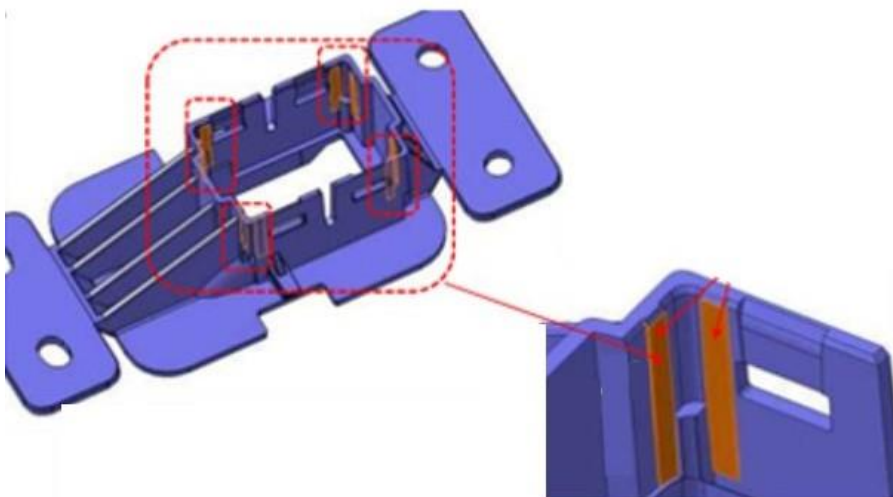
Window lift switch is loose within the door aperture

The window lift switch rattles when the door is closed

3) Referring to Figure 1 - Apply anti creak tape to the inside face of the switch carrier
