Technical product information

| Topic | DTC P263500 with symptom code -10061 - Noise from within the fuel tank |

Bentayga W12 and Bentayga W12 Speed

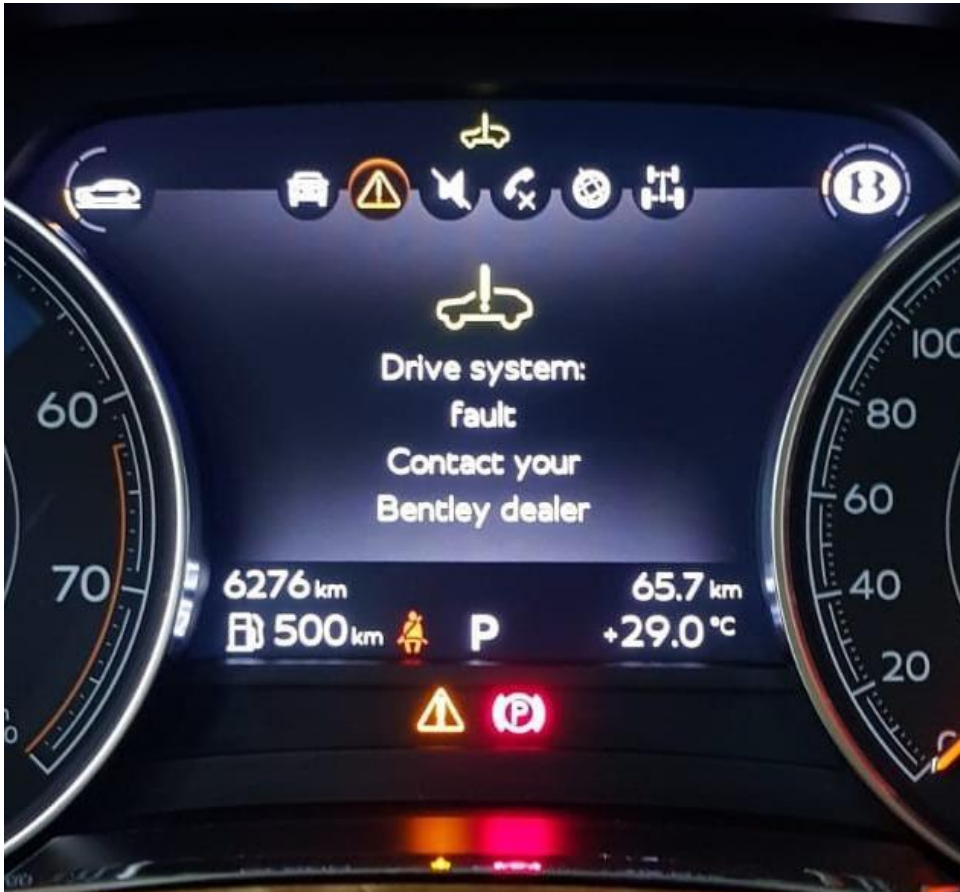
Figure 1

- Drive system fault warning within the DIP (Figure 1)

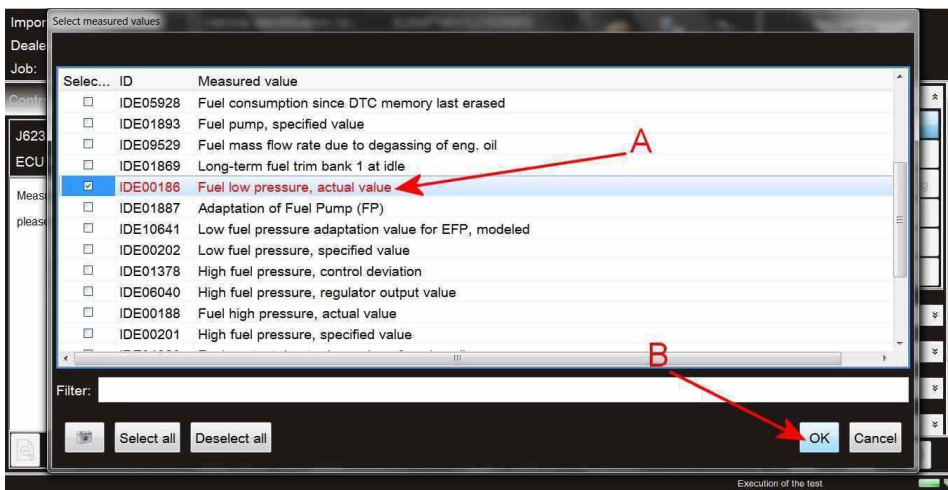
- The engine must be running and at operating temperature, Do Not switch off the engine until advised **CAUTION: Ensure that suitable exhaust extraction is used whilst the engine is running within the workshop**
- Using ODIS Carry out a full GFF of all control modules
- Clear all applicable DTC's
- Select Engine control module 1
- Select Guided functions - Read measured values
- Referring to Figure 2 (Point A) - Navigate to Measured value IDE00186 Fuel low pressure, actual value

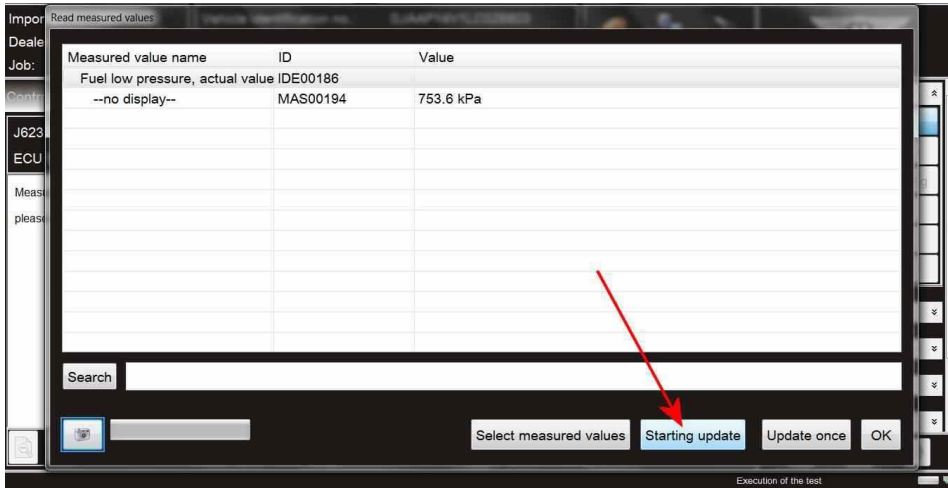
2) Referring to Figure 3 - Select Starting update

- Switch off the engine and leave the ignition on
- Monitor the pressure decay of the low pressure fuel system for 10 minutes

- Should the pressure drop below 300 kPa after 10 minutes and the fuel tank fuel pump is noisy (as per the video on the Bentley hub) the operative should replace the fuel pump as instructed within Rep.Gr 20 - Fuel pump, fuel level sensors, and jet pump (RH) - To remove and fit
