Technical product information

Topic	New Continental GT and GTC - Window drop glass
Market area	Australia E04 Bentley rest Asia and Australia (6E04),China 796 VW Import Comp. Ltd (Vico), Beijing (6796),Germany E02 Bentley rest Europe (6E02),Japan E03 Bentley Japan (6E03),Korea, (South) E08 Bentley South Korea (6E08),United Arab Emirates E06 Bentley Middle East and Africa (6E06),United Kingdom E01 Bentley UK (6E01),United States E05 Bentley USA and rest America (6E05)
Brand	Bentley
Transaction No.	2070497/1
Level	EH
Status	Approval
Release date

New Continental GT and GTC

Retailer glass reset procedure for GT/GTC

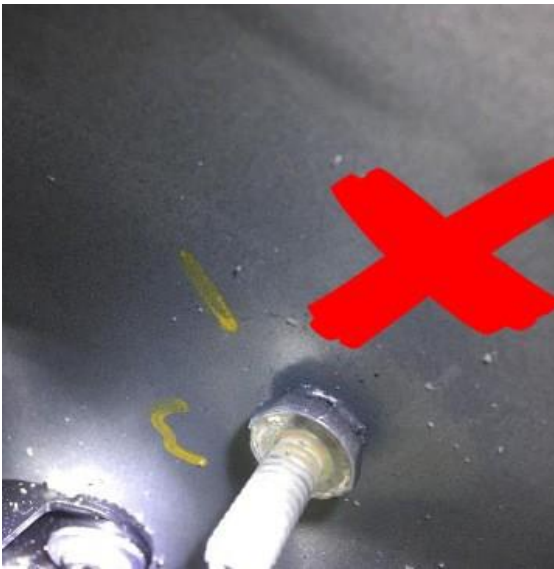
- Earth point 736 RHR and Earth point 738 LHR
- Check for cleanliness and security of both earth points Figure 5 shows an example of a contaminated earth point (dirt/paint/debris)

- Remove any dirt/paint/debris from the earth points using suitable abrasives/wire brush ensuring no damage is caused to the earth stud threads as shown in Figure 6

- Secure the earth point fixings to (9Nm)

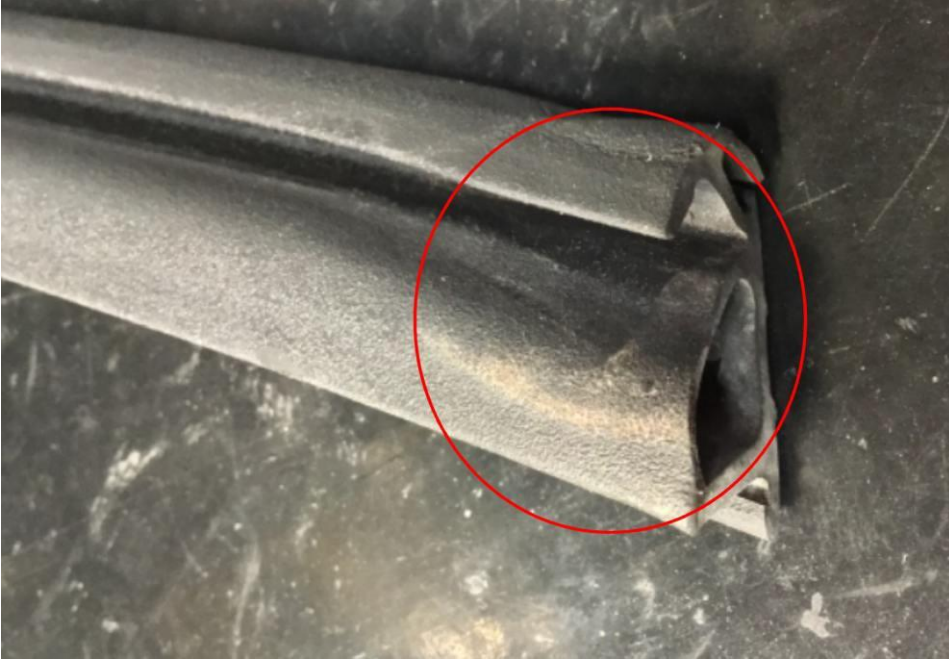
Figure 7

- Damage
- Splits
- Tears
- Misalignment
- Incorrectly fitted/located
- Drop glass seal deformation (see Figures 7 and 8 as examples)

NOTE: Any issues found with the window seals must be rectified before conducting the remaining steps

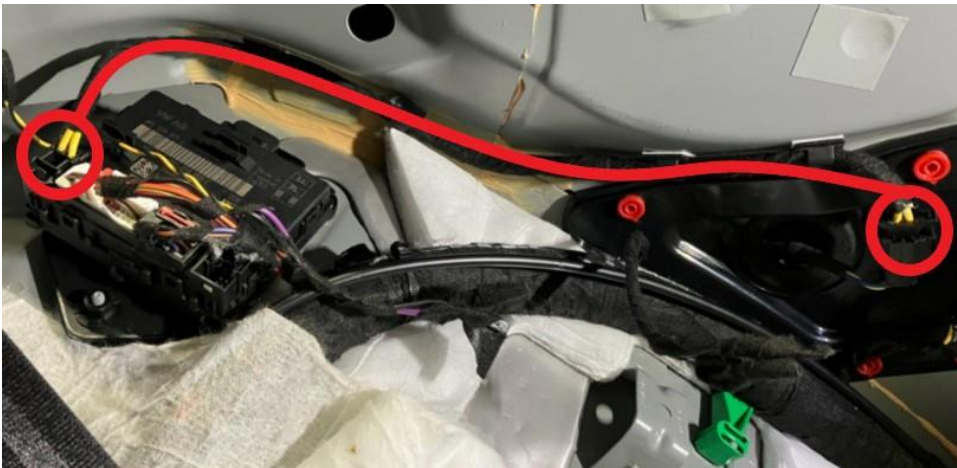
B148729: Window regulator motor Range/Performance

- Disconnect the original terminals from T6aq Pins 3 and 6 to T2jp Pins 1 and 2 respectively
- Once disconnected the terminals should be insulated with harness tape and suitably secured
- Referring to Figure 9 - Using 000 979 225 E repair wires and x2 000 979 fit the new wires into T6aq Pins 3 and 6 to T2jp Pins 1 and 2 respectively
- Ensure the newly fitted wires are suitably insulated and secured away from the harness as shown in Figure 9

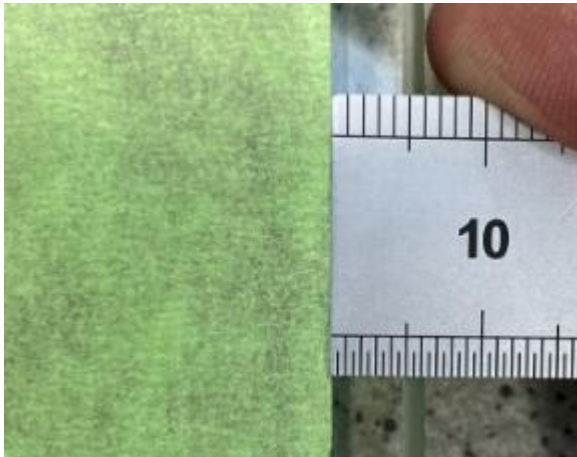
Example of incorrect fitment:
10mm intrusion into division bar seal not achieved. Only 6mm seen, front and rear side glasses will be too far rearwards, potentially clash condition between rear of rear glass and cant rail/roof seals

When reinstalling front drop glass ensure tape is applied at 10mm from front edge and align this with the previously set quarter glass division bar.

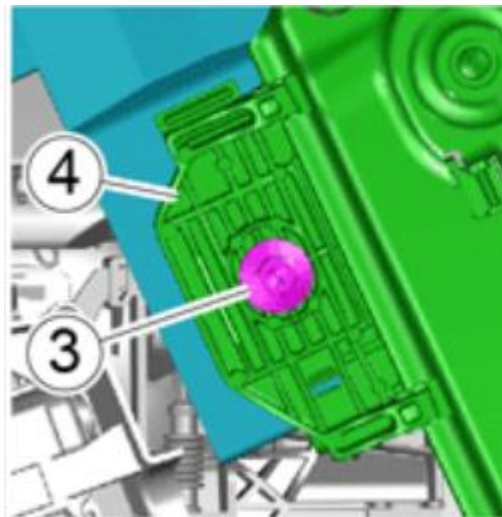
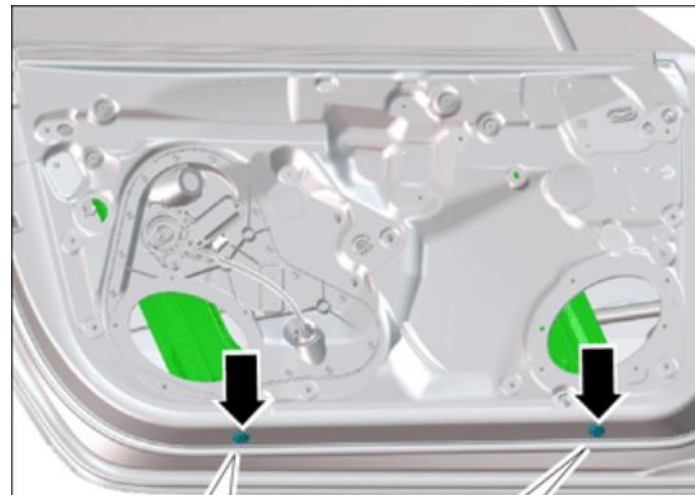
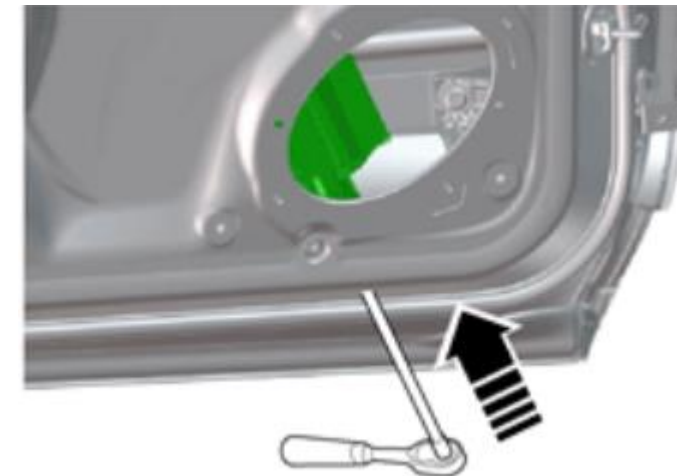
Example: Front drop glass Z axis not adjusted correctly. Bottom of tape was level with waist rail seal, after slackening pinch bolt (3 in bottom left image) front drop glass lowered 14mm to where pen marked line is.

Z-axis adjusters (bottom middle and right images) had not been used, pinch bolt had been slacked and glass lifted out of the regulator to achieve specification. This has a knock on effect of altering the 10mm division bar intrusion seen in previous slide as glass is loose and can be accidentally moved in X-axis.

This also creates a risk that the window will bottom out on the cant rail seals rather than the regulator bump stops meaning that the glass can raise further as the seals soften over time and affect end stop learning.

Z-Axis height should only be adjusted by the 4mm Allen key adjusters as per ELSAPRO

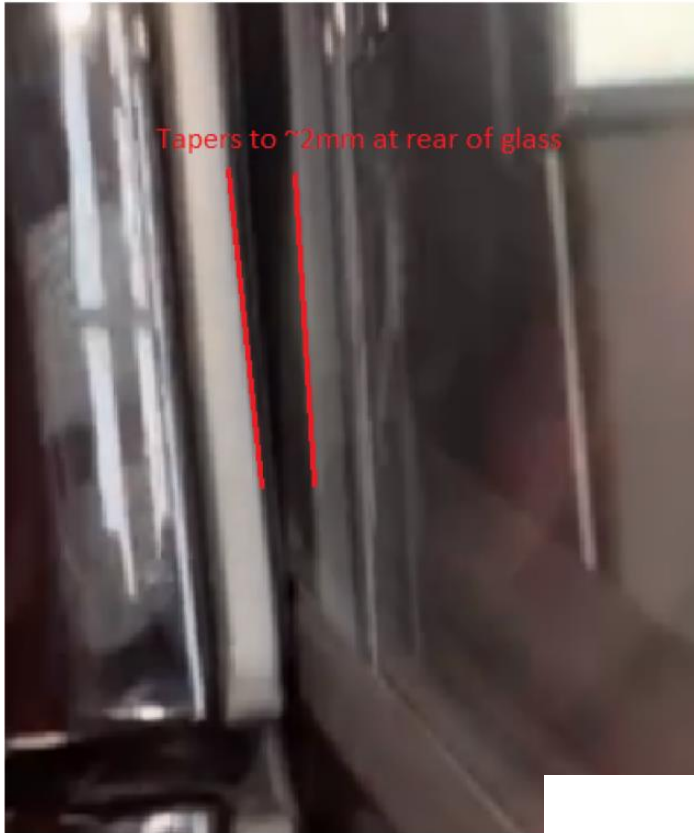
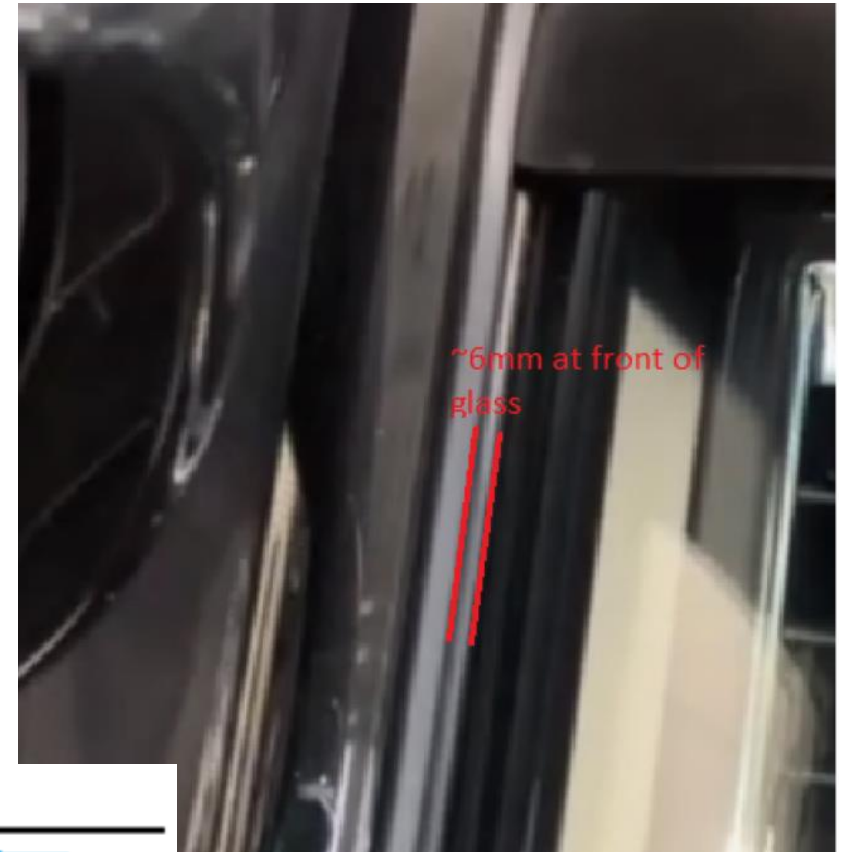
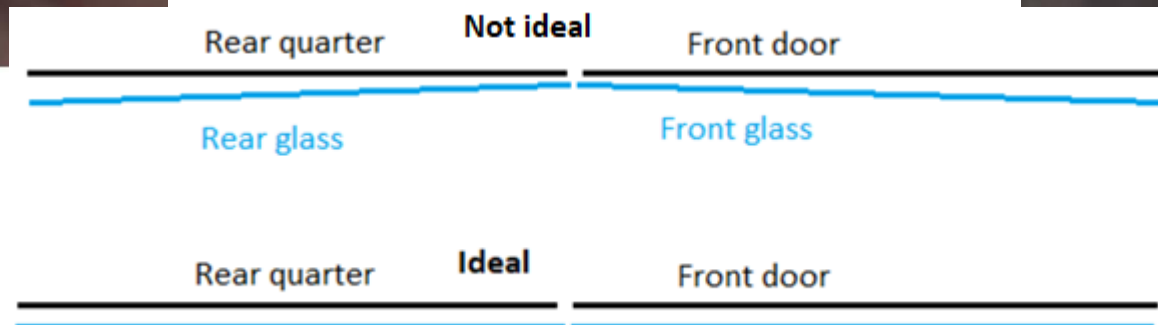
Images show a poor setting.
Circa 6mm at front edge (near wing mirror)
closing up to 2mm at the rear edge.

2mm at rear edge would have been set to achieve specified flush/2mm underflush profile condition between front and rear glasses, the rear quarter glass mirrors this taper condition. This potentially increases the risk of false anti trap as rear window/seal does not engage with front window at the correct angle. Suggested to set to specification on problem vehicles as per next slide. If both windows are set between 4-6mm then the flush/2mm underflush profile can be easily achieved.

Set waist rail gapping to between 4-6mm as mentioned in Glass setting guide videos on E-Academy and also check for parallelism along front and rear windows to door/quarter. 50mm from edge of Waistrail seal, roughly underneath the Bentley wings.

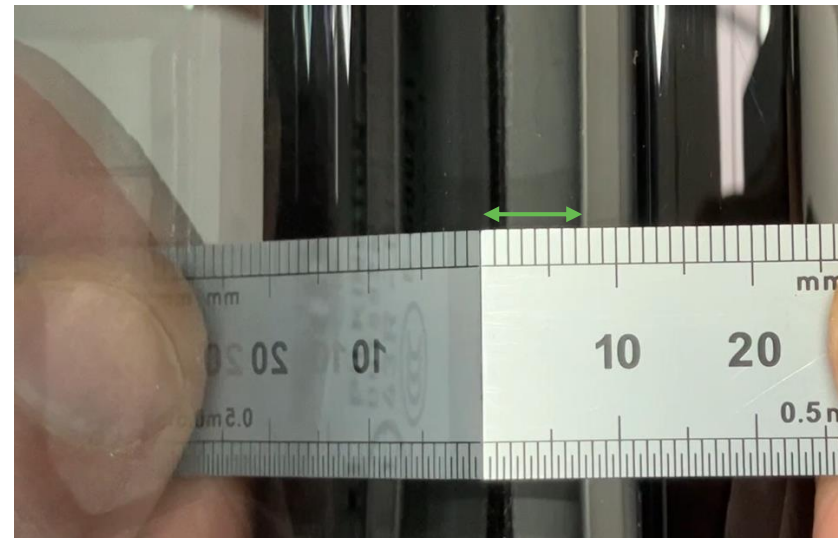
RHF window, front window closed, rear window closed. Note gap, over 0.25mm outboard movement, this is incorrect

If more tension is required to resolve a wind noise or water ingress then aim for no more than 0.25mm of outboard movement.

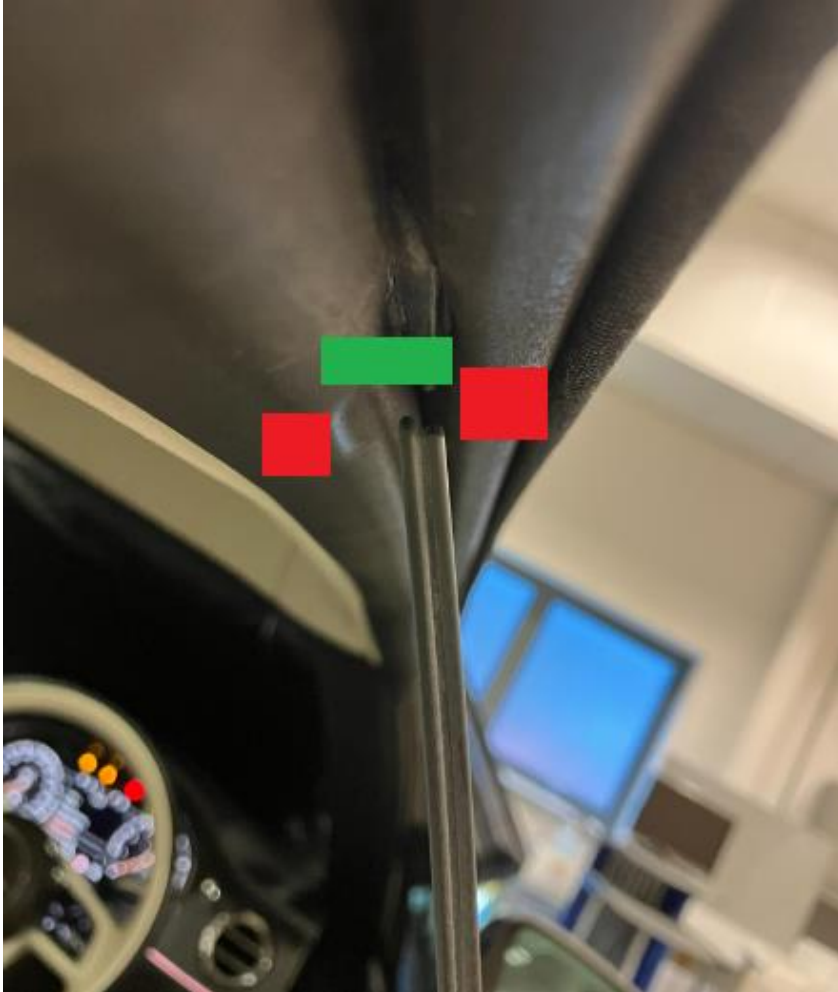
Window entry into cant rail/convertible roof seal

Windows should enter cant rail seal smoothly, making contact with inboard edge first and then be pushed outboard (green square).

Too far inboard increases the risk of the cant rail seal pinching, too far outboard will clash with cant rail brightware (red squares) For front door, poor door profile is a major contributing factor here and should be checked/adjusted if window found to be entering seal incorrectly
