Technical product information

New Continental GT/GTC and New Flying Spur

Clicking noise from the front wheels when conducting a static lock to lock steering manoeuvre

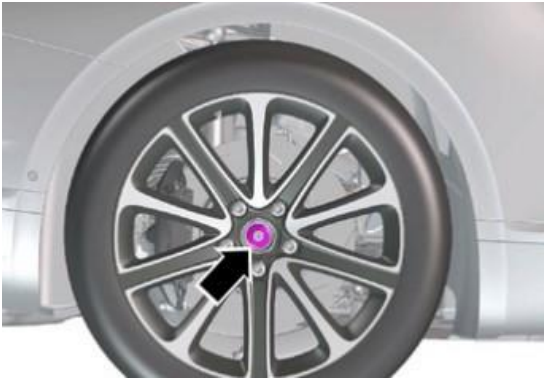
Figure 1

Clicking noise from the front wheels whilst performing a static lock to lock steering manoeuvre

5) De-torque the left and right front hub retaining nuts 360 degrees (Figure 1)

- Torque tighten the front hub retaining nut to 200Nm +100 degrees
