Field campaign

Topic	Engine oil pan (sump) requires removal - Visual checks required once the oil pan is removed (SC23/18)
Market area	Australia E04 Bentley rest Asia and Australia (6E04),China 796 VW Import Comp. Ltd (Vico), Beijing (6796),Germany E02 Bentley rest Europe (6E02),Japan E03 Bentley Japan (6E03),Korea, (South) E08 Bentley South Korea (6E08),United Arab Emirates E06 Bentley Middle East and Africa (6E06),United Kingdom E01 Bentley UK (6E01),United States E05 Bentley USA and rest America (6E05)
Brand	Bentley
Transaction No.	2070699/1
Campaign number	EC83
Note	
Type	
US code

New Continental GT/GTC and New Flying Spur

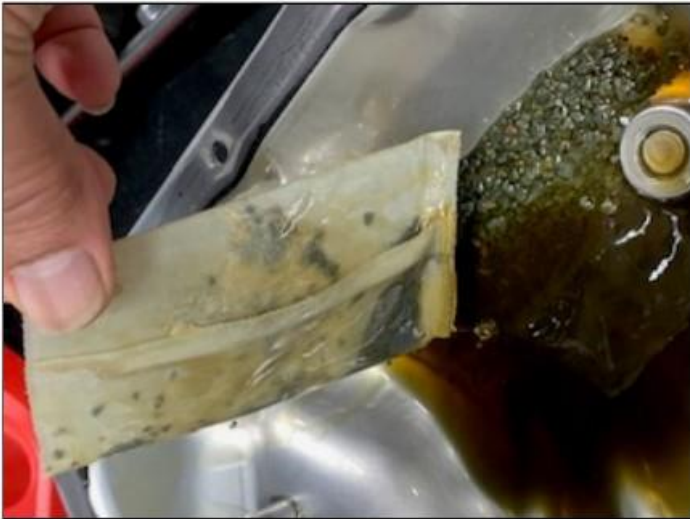
Figure 1

Scenario 1 - Desiccant bag is evident within the oil pan - Desiccant bag is split - Debris evident in the oil pan (Figure 1)

In the event a desiccant bag is evident within the oil pan and the bag is split **THE OPERATIVE MUST RAISE AND ESCALATE A TECHNICAL DISS QUERY ENSURING THE CURRENT ODIS LOG AND CLEAR PHOTOGRAPHS OF THE BAG, DEBRIS AND OIL FILTER ARE ATTACHED**

- **AWAIT FEEDBACK BEFORE CONDUCTING ANY FURTHER WORK**

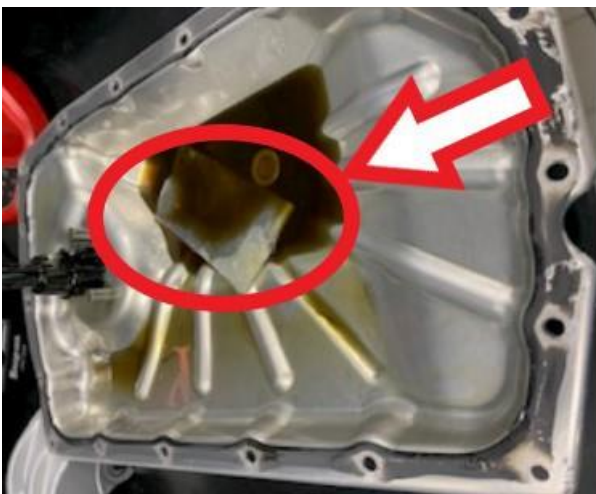
Figure 2

Scenario 2 - Desiccant bag in the oil pan although the bag is not split (Figure 2) No oil pressure DTC's are evident

In the event a desiccant bag is evident within the oil pan - Bag is NOT split conduct the following:

- Remove the bag from the oil pan (Retain the desiccant bag await further instruction)
- Check the oil filter for debris - Take photographs of the oil pan and oil filter (Retain the oil filter await further instruction)
- Raise a Technical DISS query ensuring the current ODIS log and photographs of the oil pan and oil filter are attached - Permission is not required via DISS to continue in this scenario, please continue as follows:
- New oil filter must be fitted
- New oil must be installed
- New oil pan drain plug must be fitted
- Oil pan sealing compound must be used and sourced (Refer to ETKA)
- Once complete the vehicle can be delivered to the customer
