VELA POP TOP STRUCTURAL ENHANCEMENT PROCEDURE

TSB Number:	304-002-2023		
Product:	Vela Pop Top		
Date: Original	May 25, 2023	Labor Rate:	2.0 hrs structural enhancement procedure 0.3 hr inspection only 1.0 hr per each crack repair
Revised	June 21, 2023

NOTE: This document supersedes a version dated May 25, 2023. The document has been revised to update part numbers for Vela Pop Top Side Cover Piece kits in all colors.

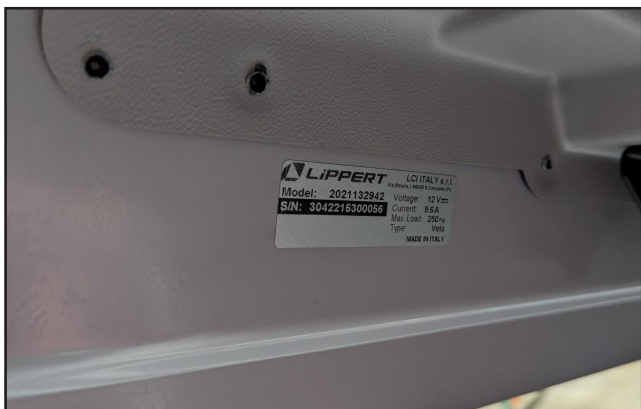
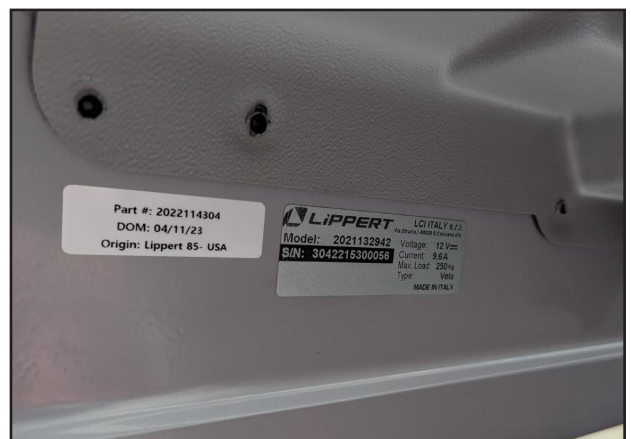
V1.0 DOES need the enhancement procedure performed.

V1.0 has no label OR one (1) label.

NO action is needed for V1.5.

V1.5 has two (2) labels OR one (1) label with any of the 17 serial numbers listed above.

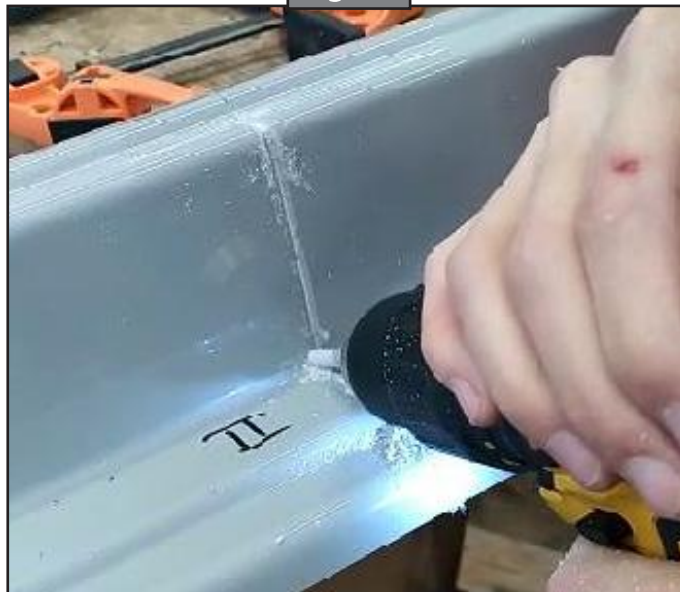
Fig. 14

1. Clean the area with alcohol wipes.
2. Using an electric drill with a small cutting bit or a dremel tool with a masonry bit, create a channel along the entire length of the area to be repaired (Fig. 14).

NOTE: Do not cut all the way through the pop top frame.
