Service Bulletin

Bulletin No.: 22-NA-232

Subject: Diagnostic Tip for 10 Speed Oil Pump Drive Gear

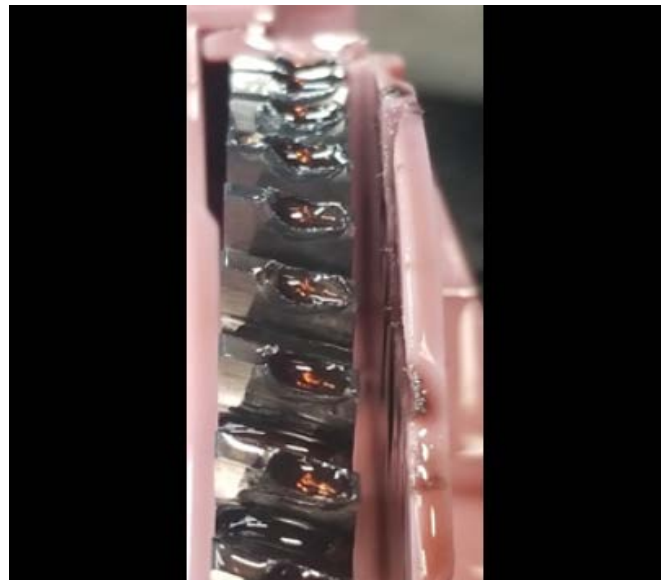
6196003

Note the damage to the oil pump idler gear.

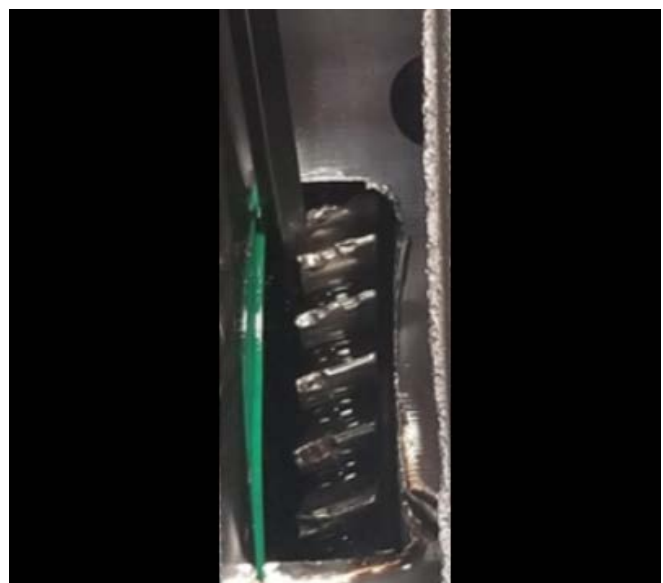
6196006

Note the side-to-side movement in the oil pump idler gear.

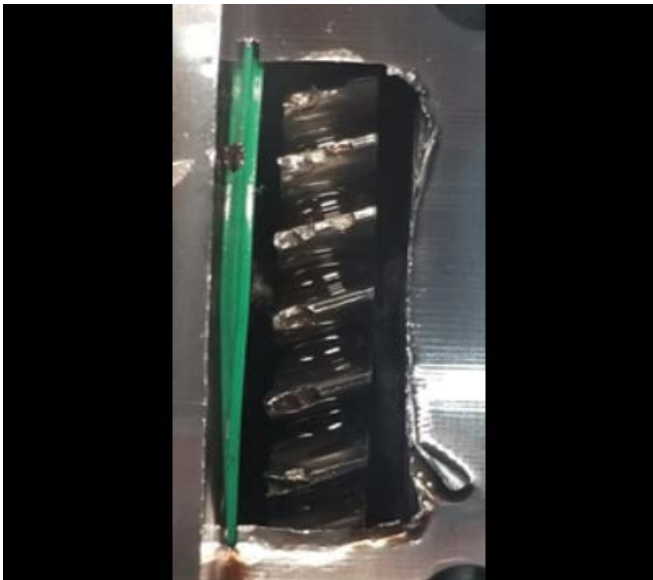
6196005

Note the damage to the oil pump driven gear.
