Service Bulletin

Bulletin No.: 23-NA-108

Subject: Replace Video Processing Module (VPM) When Programming Fails

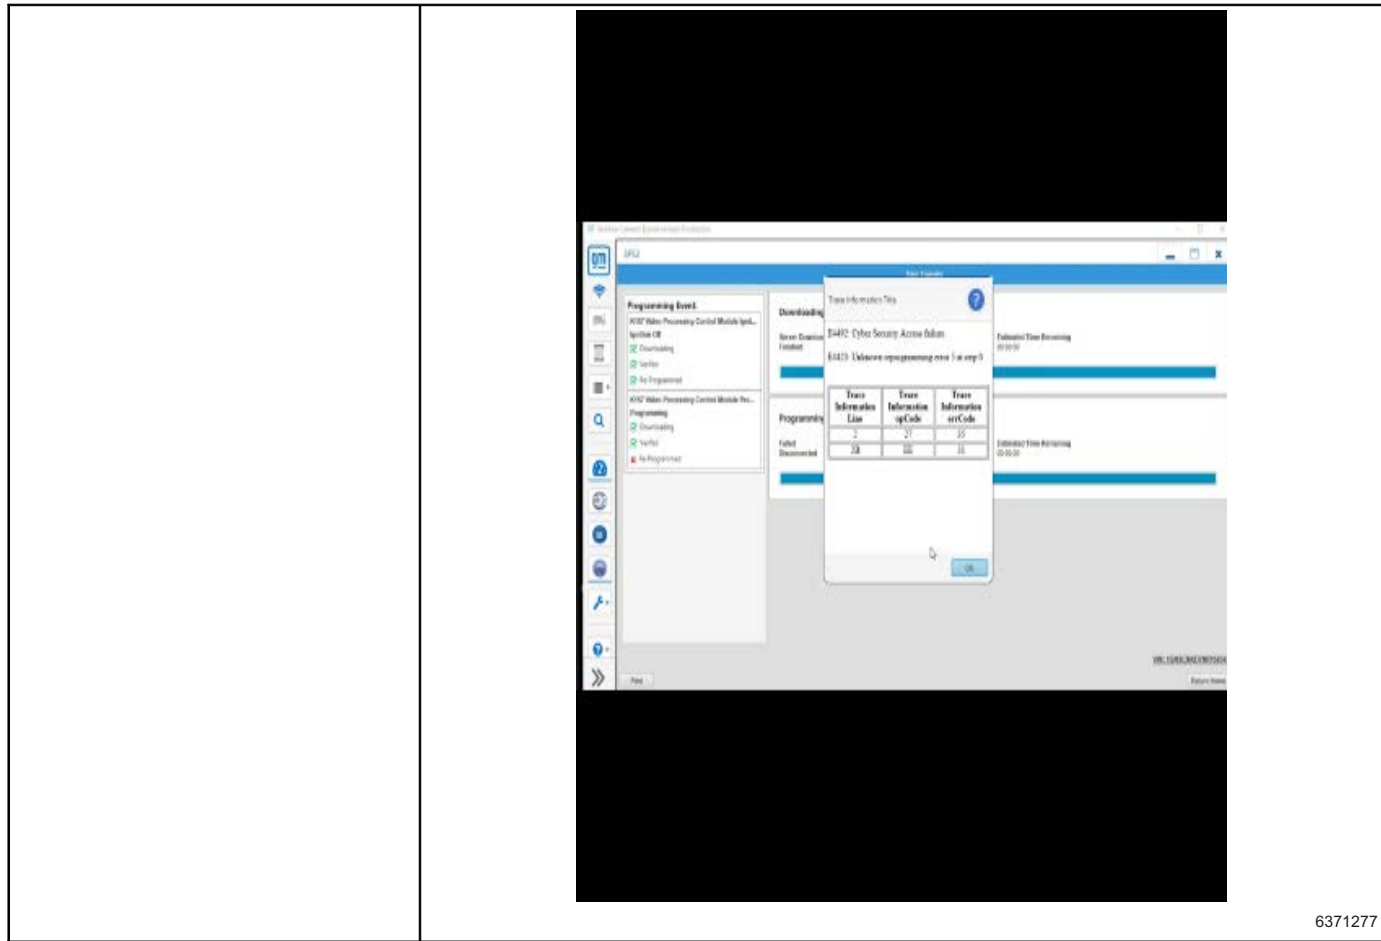
6371277

Involved Region or Country	North America, Brazil, Chile, Colombia, Europe, Uzbekistan, Middle East, Israel, Cadillac Korea (South Korea), GM Korea Company, China
Condition	Technicians may find that when attempting to program the K157 Video Processing Control Module, the following SPS2 errors may occur: <ul style="list-style-type: none"> • E4492 Cyber Security Access Failure • E4423 Unknown reprogramming error 5 at step 0

Cause	The cause of the condition may be that some K157 Video Processing Control Modules have an internal fault that causes SPS programming to fail.
Correction	Replace the K157 Video Processing Control Module.
