VOLUNTARY SERVICE CAMPAIGN

Classification: AT23-003	Reference: NTB23-056	Date: June 21, 2023
-----------------------------	-------------------------	------------------------

VOLUNTARY SERVICE CAMPAIGN 2022-2023 FRONTIER AND 2023 TITAN/TITAN XD; AUTOMATIC PARK FUNCTION

CAMPAIGN ID #: PC982
APPLIED VEHICLES: 2022-2023 Frontier (D41)
2023 Titan/Titan XD (A61)

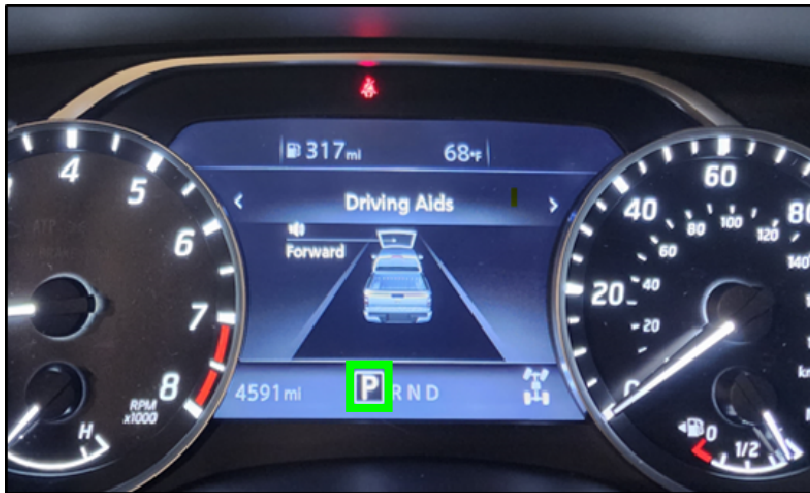
Figure 1

1. Start the engine.
2. With the transmission in the PARK position, inspect the **P** in the gear indicator on the combination meter.
 - If the **P** indicator is flashing, continue to step 3 to configure the Automatic Park function.
 - If the **P** indicator is not flashing, no further action is required. Skip to the **CLAIMS INFORMATION** on the last page.

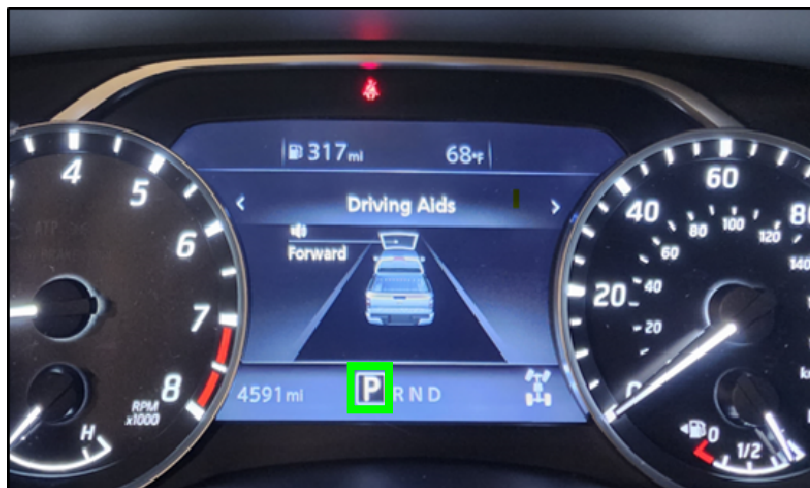
Figure 7

18. With the transmission in the PARK position, inspect and verify that the **P** in the gear indicator on the combination meter is no longer flashing.
