# Service Bulletin

Bulletin No.: 21-NA-005

**Subject: Service Safety Restraint Message Displayed on the Driver Information Center (DIC), Airbag Malfunction Warning and Airbag Malfunction Indicator Lamp (MIL) Illuminated - DTC B0001-1B and/or B0002-1B Set or B0012-OD and/or B0013-OD Set**

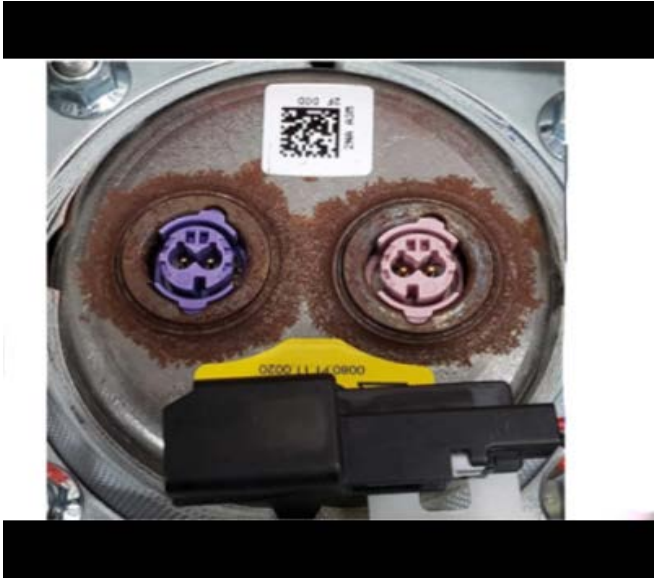
</div> <p style="text-align: right;">5704083</p> <p>Cause of condition may be rust particles, or other contaminants trapped within connection terminal interface causing excessive resistance seen in the airbag loops.</p>

<p><b>Correction</b></p>	<p>In order to correct the condition, the following steps in the Service Procedure below must be followed to ensure proper root cause.</p>

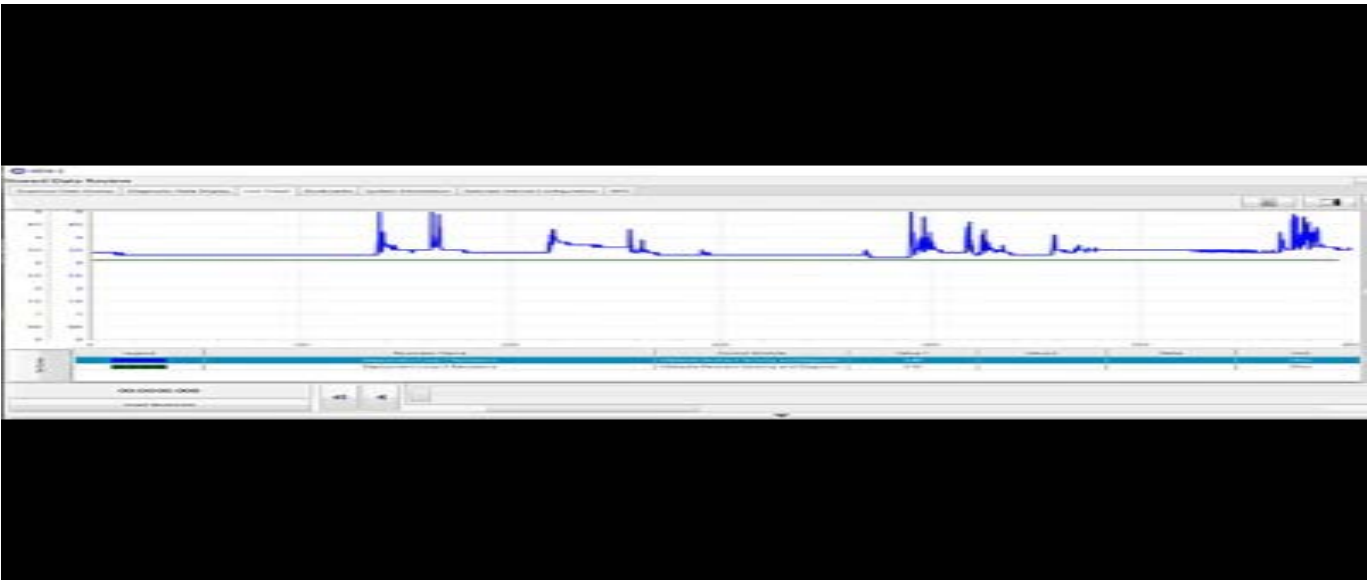
5972189

1. Use a MDI tool and plug it into the (ADL) to show a profile of the resistances.

2. Move the airbag cover both up and down, as well as left to right, to confirm if resistance spikes are observed:
  - If resistance spikes are seen. Replace the steering wheel airbag and steering wheel harness. Refer to *Steering Wheel Airbag Replacement* in SI.

- If resistance spikes are not seen (resistance is stable).
    - Move to Step 3.
3. Rotate steering wheel from lock to lock position to confirm if resistance spikes are observed:

- **A)** — First time around, if resistance spikes occur, Pull airbag out and ensure all connections are fully seated and CPA is engaged. (i.e. Airbag connectors and yellow clock-spring connector)

- If all connectors are not fully seated, re-seat connectors and repeat beginning of step 3 and skip 3A.
  - **B)** — Disconnect and reconnect the airbag, then repeat lock to lock steering wheel rotation test.

- If resistance spikes go away (resistance is stable), replace airbag and steering wheel harness.
