Service Bulletin

Bulletin No.: 23-NA-115

Subject: Ticking, Tapping or Snapping Noise from Engine - 5.5L RPO LT6 Realign Camshaft Caps as Required

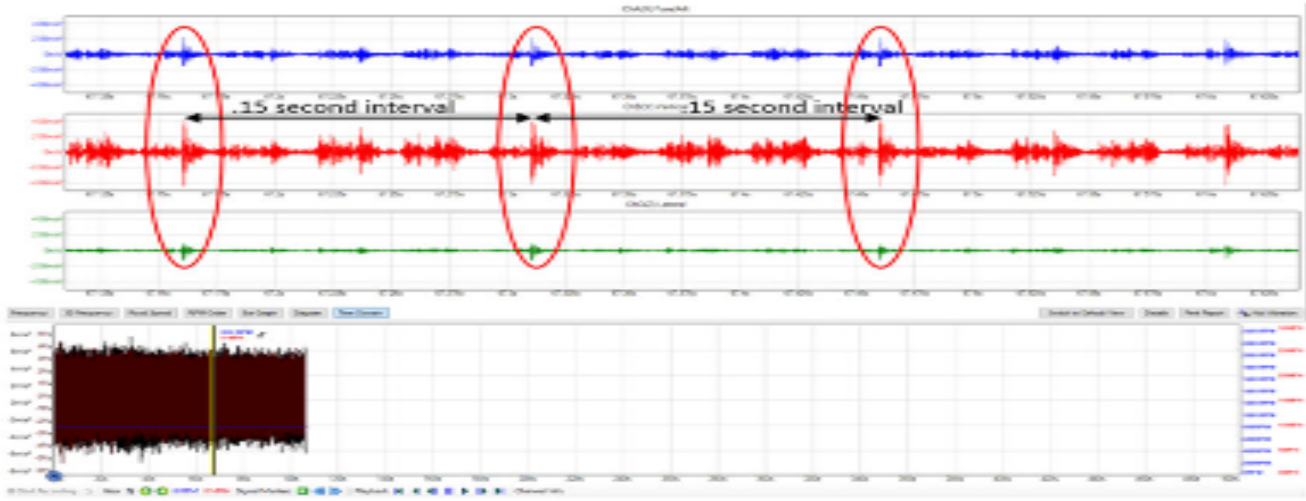
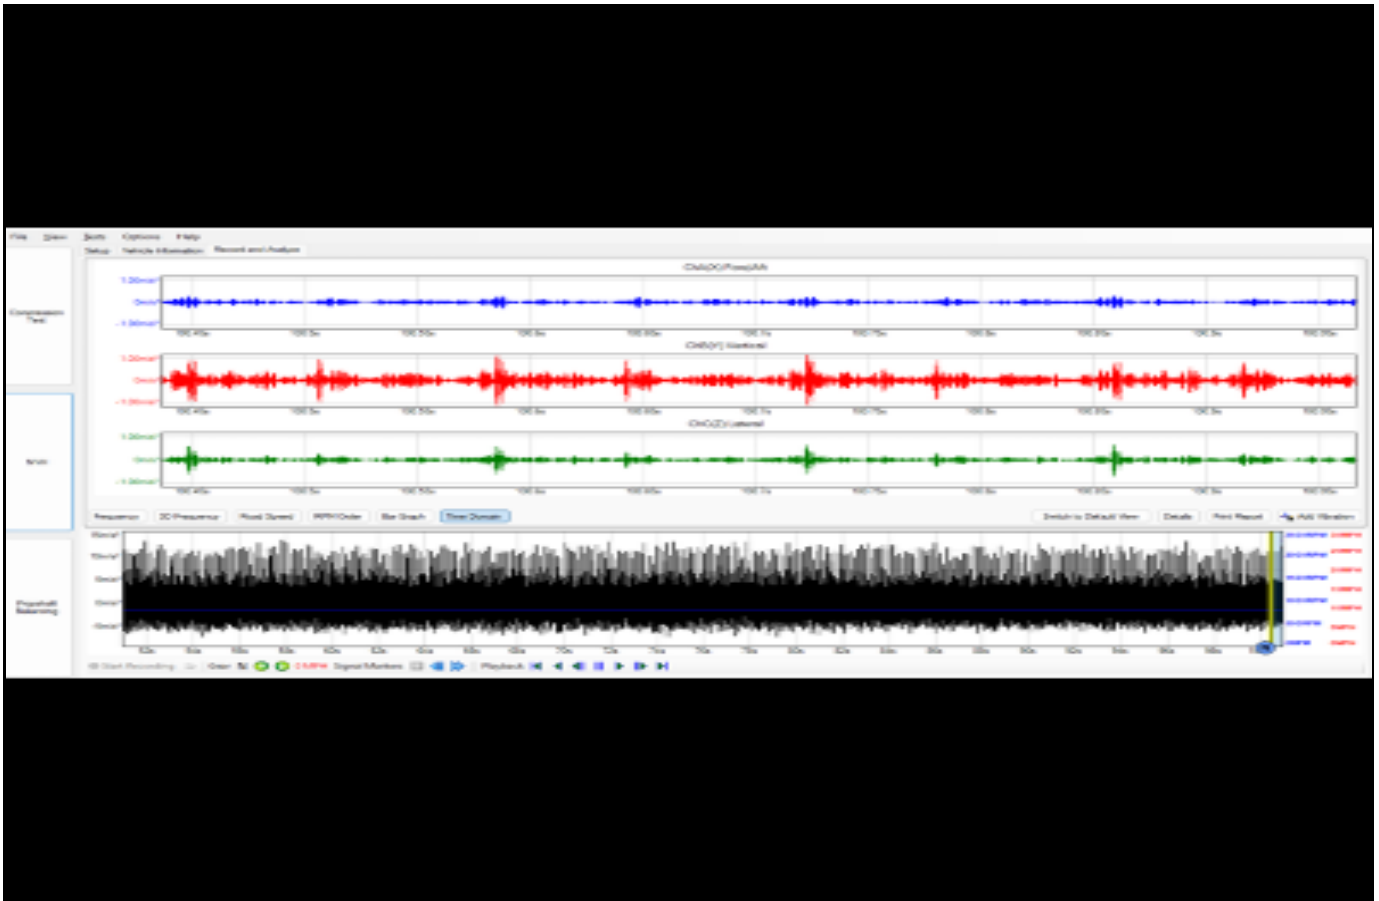
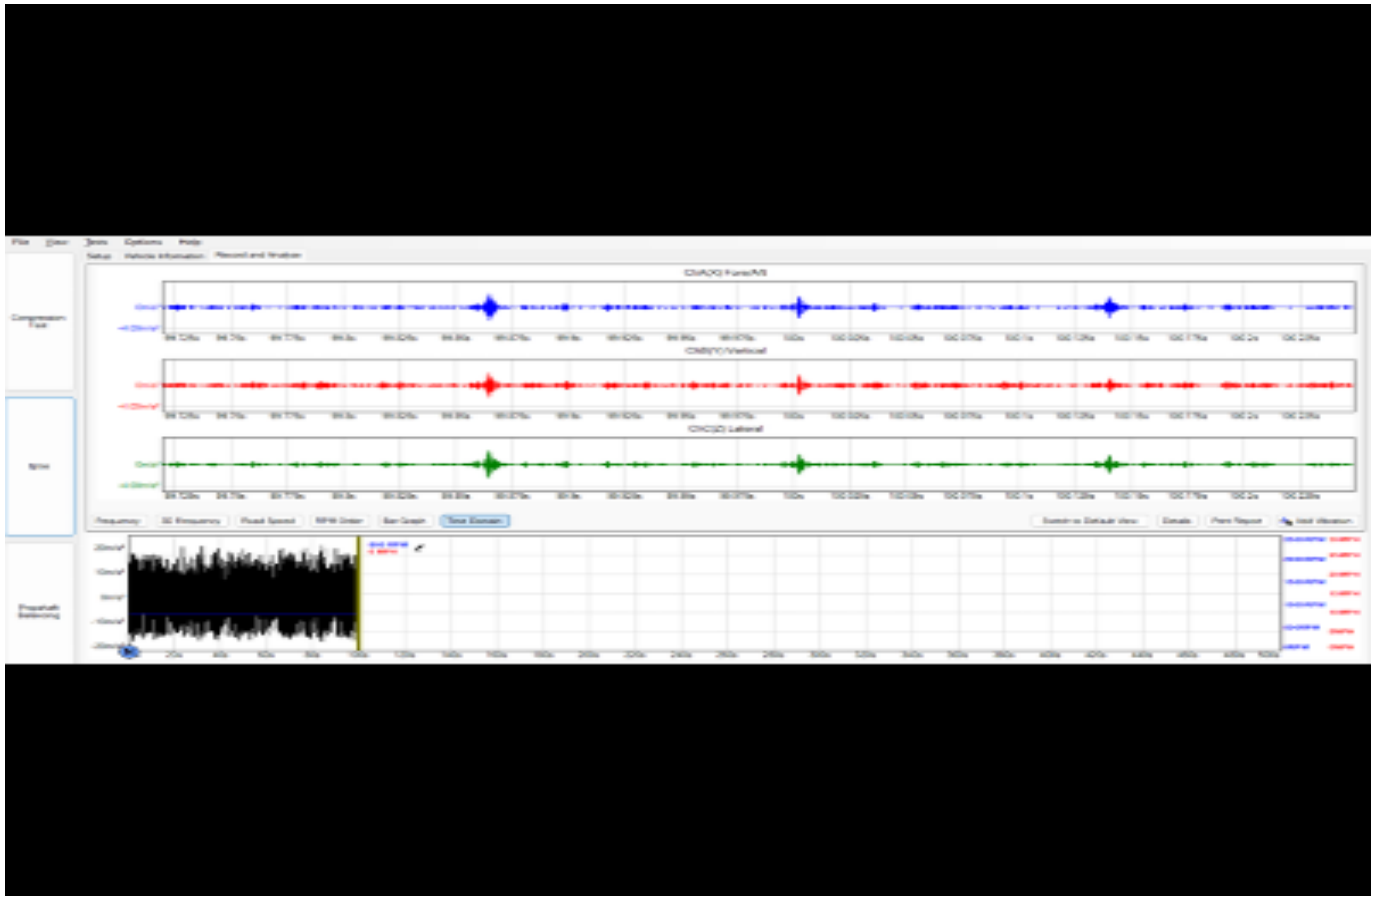
Examples of Tick:

- Right click in the time domain display and change the display mode to single.
- If scales on the left end for each channel are not ranging from -4 m/s² to 4 m/s², right click in the time domain display and select “reset scale.”
- Pull the yellow window cursors on the bottom in as close together as they will go.
- Look at the channel lines in the time domain window for ticks with a .15s gap between them.
 - ⇒ Compare to the examples below for an engine with a tick and an engine without a tick:

Once it is determined which bank the noise is coming from, it will be necessary to follow the service procedure below to adjust the camshaft cap torque.
