# Technical Bulletin

Model(s)	Year	Eng. Code	Trans. Code	VIN Range From	VIN Range To
Phaeton	2004 –2006	All	All	All	All

57 14 07 December 18, 2014 2039003

### Corrosion on Front Doors (Multiple Locations)

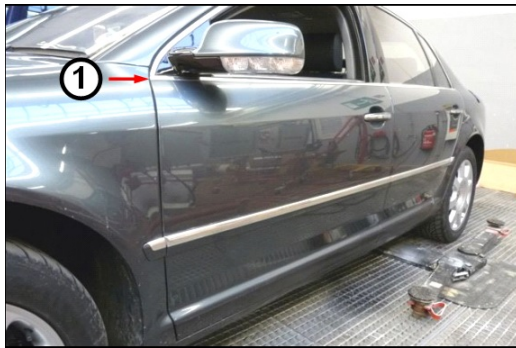
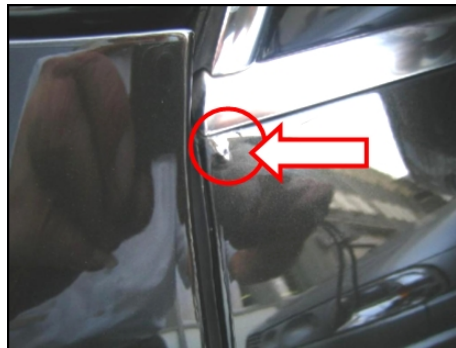
Figure 1.1

Outer door areas (Figure 1-4):

Figure 1 – Upper window channel strip

Alignments in production can lead to hairline cracks in the top coat and paint damage (edges on holes) on the already painted door. Humidity then penetrates paint and causes blistering and/or white corrosion.

- Inspect the inner edge area of the doors for cracks, particularly the fine seam sealing.
- Completely remove the corrosion in the damaged area.
- Apply a VOC compliant epoxy primer as an anti-corrosion treatment and primer to both sides of the door (locally sourced).
- Seal the edges/metal sheathings with adhesive (part number: AKD 476 KD505) before painting.
- Repaint door according to Volkswagen guidelines

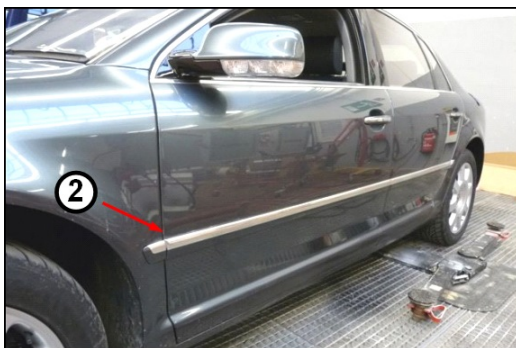
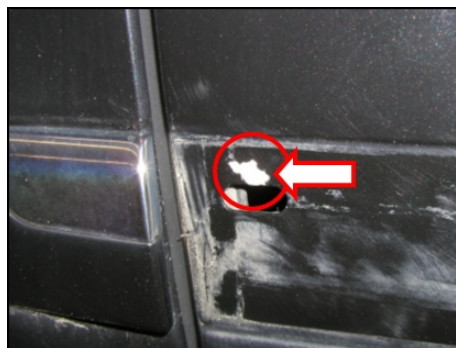
Figure 2.1

Figure 2 – Central protective strip

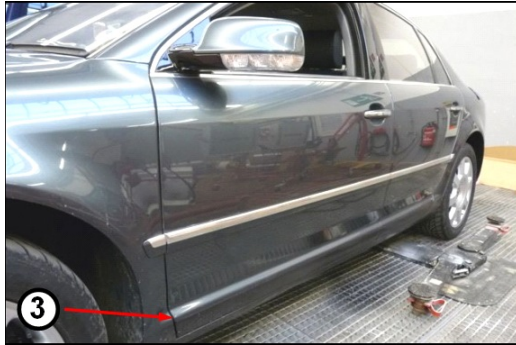
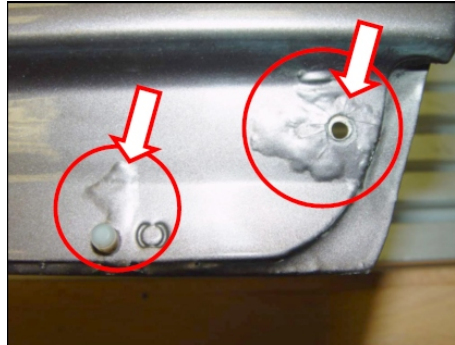
Figure 3.1

Figure 3 – Lower protective strip

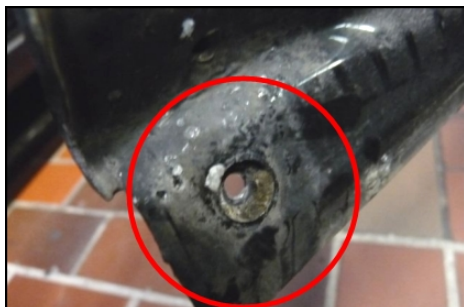
Holes and edges in the flange area.

Figure 6 (front door, lower left)
