# **Technical product information**

Торіс	Poor Engine Running Complaints (Misfires) Petrol Engines Only
Market area	Australia E04 Bentley rest Asia and Australia (6E04), China 796 VW Import Comp. Ltd (Vico), Beijing (6796), Germany E02 Bentley rest Europe (6E02), Japan E03 Bentley Japan (6E03), Korea, (South) E08 Bentley South Korea (6E08), United Arab Emirates E06 Bentley Middle East and Africa (6E06), United Kingdom E01 Bentley UK (6E01), United States E05 Bentley USA and rest America (6E05)
Brand	Bentley
Transaction No.	2051187/9
Level	EH
Status	Approval
Release date

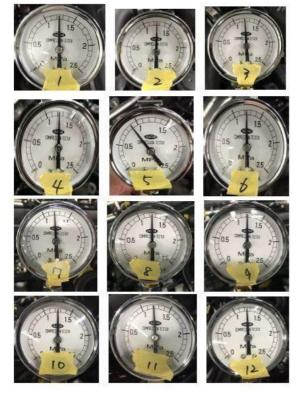
Figure 2

After completing sections 1, 2 and 3 if the root cause of the poor engine running / misfire has not been identified continue to raise a DISS query. Images accompanying a DISS query must be of a quality shown in Figures 2 and 3
