Technical product information

Topic	Charging starts and stops when using a public charging unit
Market area	Australia E04 Bentley rest Asia and Australia (6E04),China 796 VW Import Comp. Ltd (Vico), Beijing (6796),Germany E02 Bentley rest Europe (6E02),Japan E03 Bentley Japan (6E03),United Arab Emirates E06 Bentley Middle East and Africa (6E06),United Kingdom E01 Bentley UK (6E01),United States E05 Bentley USA and rest America (6E05)
Brand	Bentley
Transaction No.	2066502/2
Level	EH
Status	Approval
Release date

Bentayga Hybrid

New Flying Spur Hybrid

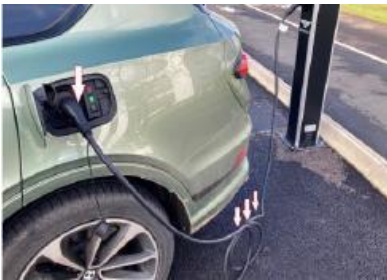
Referring to Figure 1 - Whilst charging the high voltage battery at a public charging unit and the vehicle is unlocked the charge socket locking pin retracts. The unsupported weight of the cable results in the cable relaxing within the charge socket, the charging issue is evident when the vehicle is locked, this is due to the locating pin being unable to lock into place resulting in the charging process being interrupted

5) Advise the customer that when using Public charging equipment, the charge cable should be supported until pin lock has been activated
