Technical Bulletin

72 14 01 November 17, 2014 2038960

Front Seat Creaking Noise

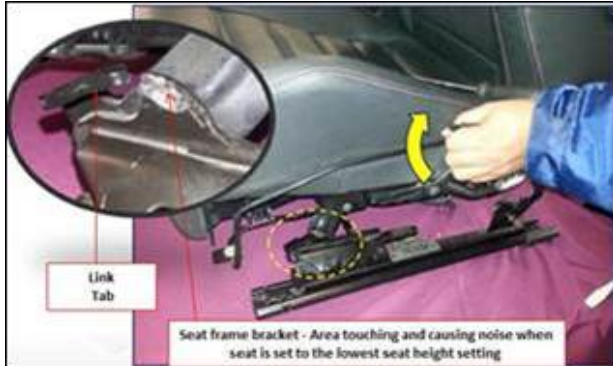
- 5. Check if the link tab is touching the seat frame track bracket.
 - a. If contact is found continue to step 6.
 - b. If contact is not found continue diagnosis. This bulletin does not apply.
