Technical Service Bulletin

15 Oil leak from the cylinder head - 2.9 and 3.0 TFSI only

15 23 44 2053278/9 July 14, 2023. Supersedes Technical Service Bulletin Group 15 number 21-39 dated June 25, 2021 for reasons listed below.

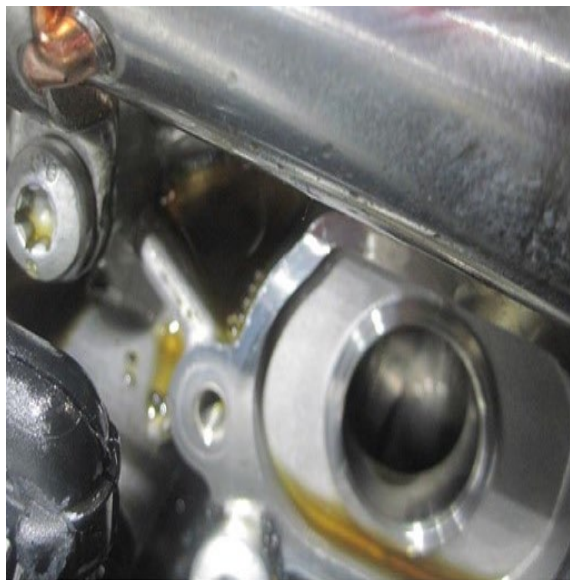
A. If there is a substantial quantity of oil below the Audi valvelift system actuator (illustration), the cause of the leak is the O ring of the Audi valvelift system actuator.

Figure 2. Oil in the Audi valve lift system.

Replace the Audi valvelift system actuator with an O ring, clean the engine compartment, and if necessary replace the noise insulation (if it is soaked in oil) (Figure 2).

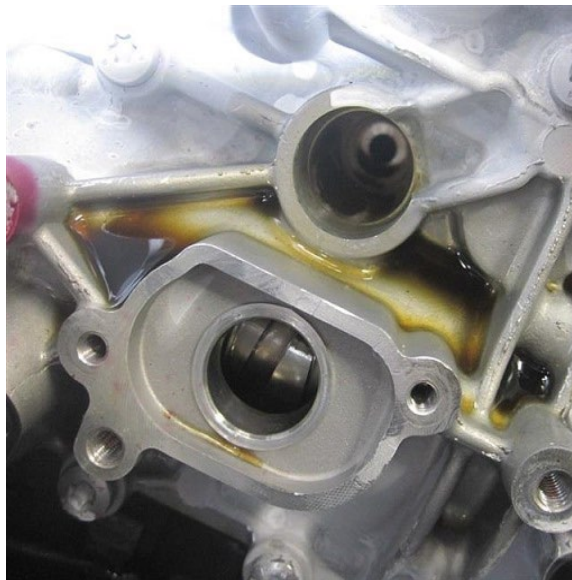
4. Remove the lower noise insulation.
5. Locate the affected cylinder. Oil should have gathered in the area of the injector (Figure 3) and the noise insulation should also be soaked in oil.

Figure 3. Locating the affected cylinder.

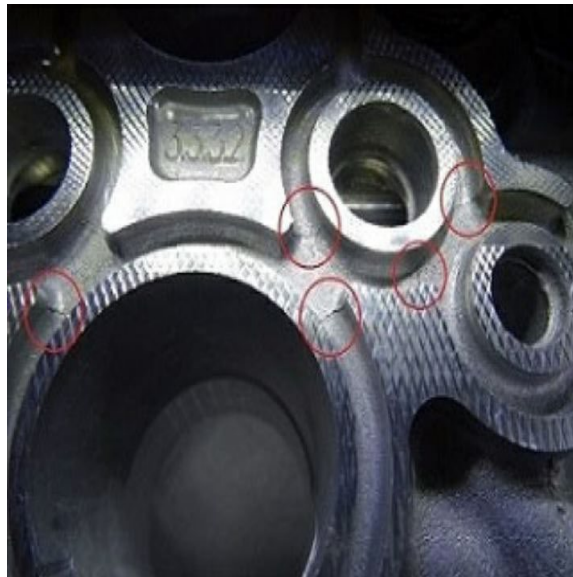
Metal shavings produced during manufacture in sealing groove between cylinder head cover and the cylinder head.

7. Inspect the gasket groove in the cylinder head cover and remove any casting residues with a suitable tool (Figure 5). The residues can be removed with a small flat screwdriver (Figure 6).

Figure 5. Before the repair.

Make sure not to damage the seal groove!

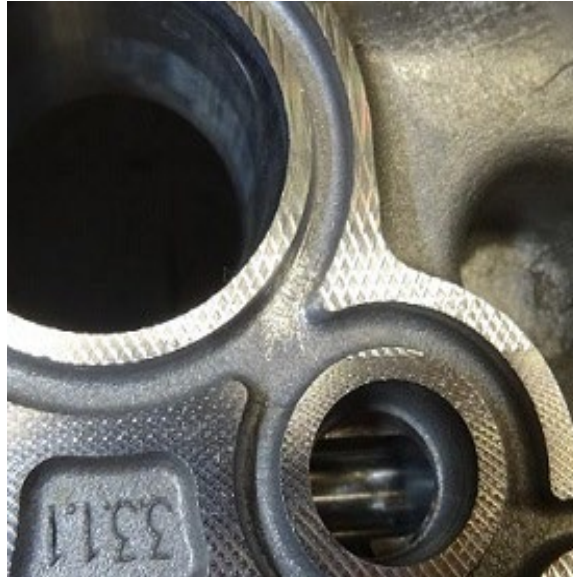
Figure 6. After the repair.

8. Install a new seal, re-assemble the camshaft cover, clean the engine compartment, and if necessary replace the noise insulation (if it is full of oil).
