# Technical Service Bulletin

## 48 Noises from steering and/or intermediate steering shaft

48 23 51 2070913/1 July 18, 2023.

Model(s)	Year	VIN Range	Vehicle-Specific Equipment
Q7, SQ7, Q8, SQ8, and RS Q8	2020 – 2024	All	Not Applicable

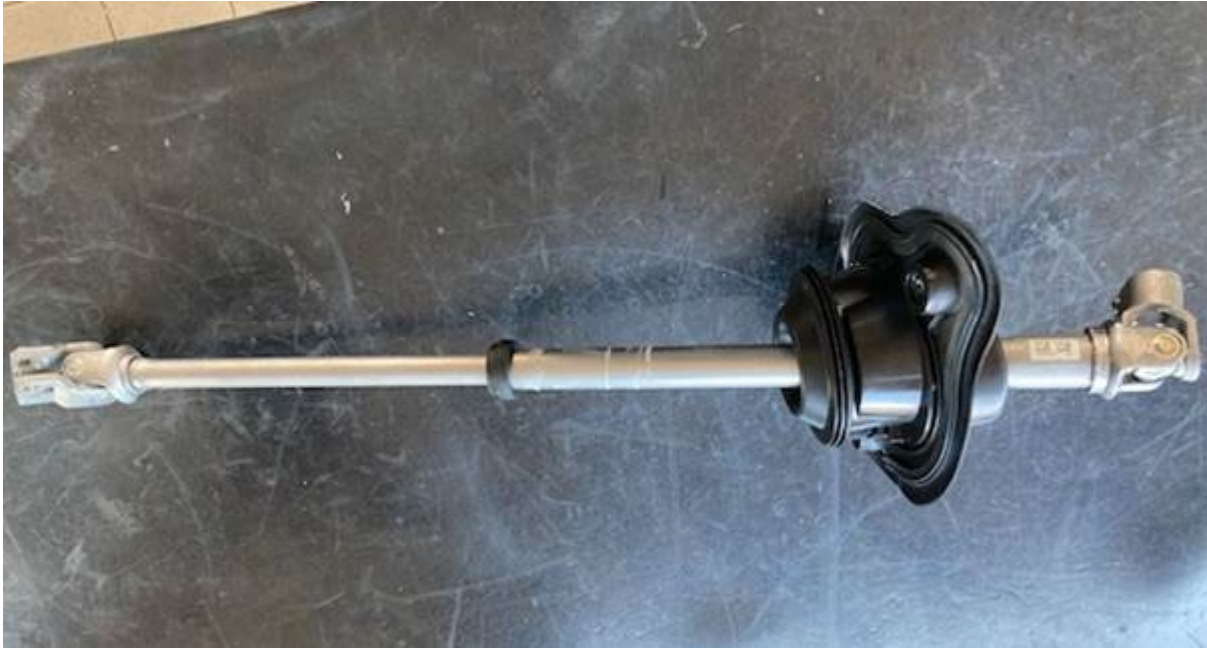
**Figure 1:** Intermediate steering shaft.

Remove the intermediate steering shaft and place it on the workbench (Figure 1).

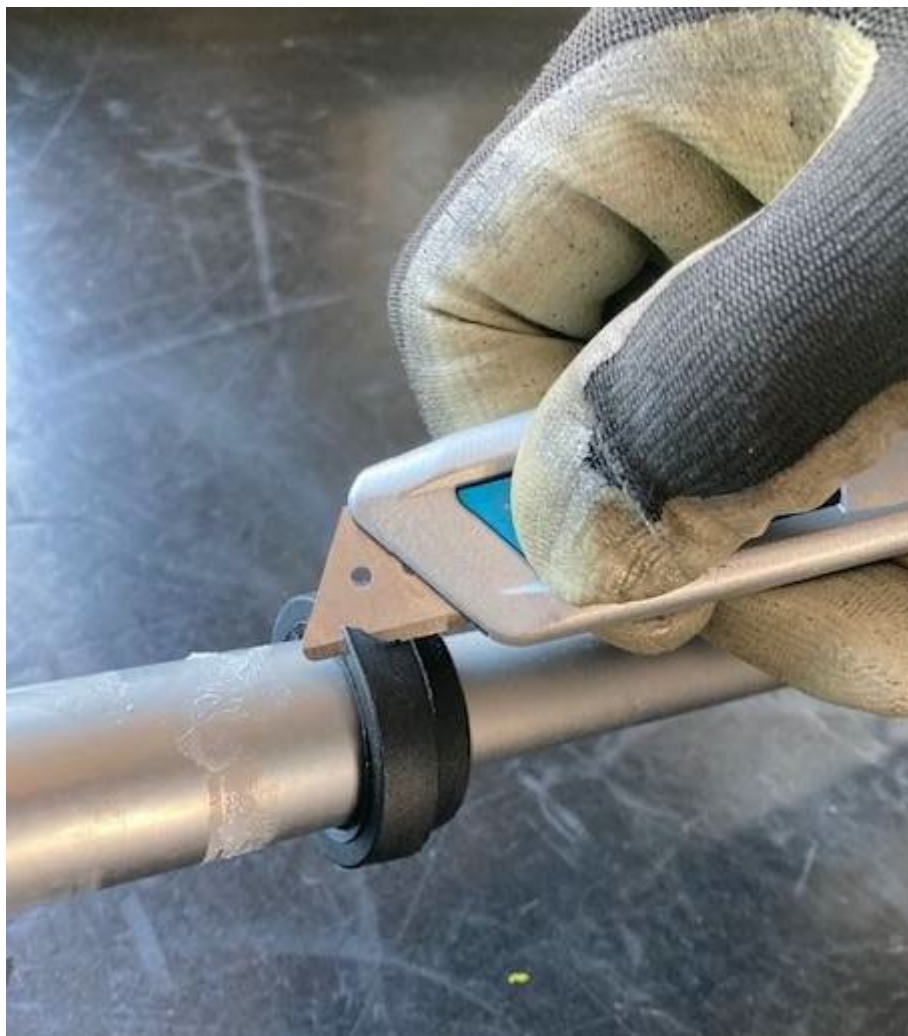
Rubber ring on the intermediate steering shaft rubs against the sealing boot.

*Figure 2: Rubber ring at the intermediate steering shaft.*

Then use a knife to cut off the rubber ring on the intermediate steering shaft on the sleeve side at a 45° angle (Figure 2).

**Note:** Please do not slide the rubber ring on the shaft. The sealing boot may be moved on the shaft.

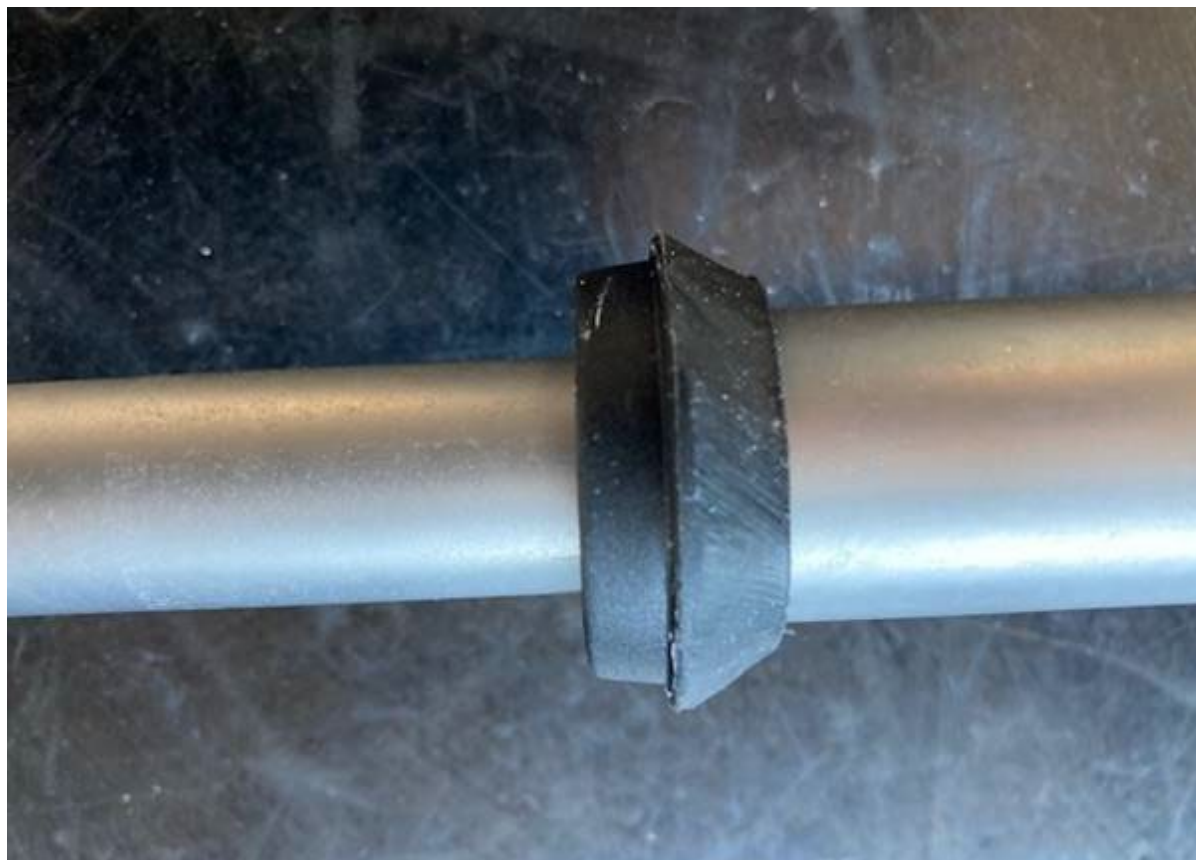
**Figure 3:** Modified intermediate shaft.

Then reinstall the modified intermediate steering shaft in the vehicle (Figure 3).
