# Technical Service Bulletin

## 85 Broken louver on the instrument panel vent

85 23 26 2071007/1 July 21, 2023.

Model(s)	Year	VIN Range	Vehicle-Specific Equipment
A3, S3, RS 3	2022 – 2024	All	Not Applicable

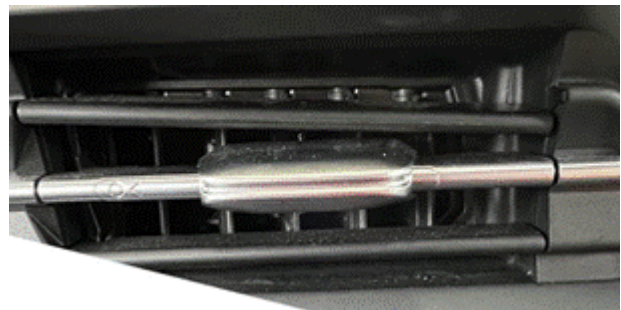
The technician confirms the customer's claim. A damaged instrument panel vent air outlet louver pivot is discovered as the root cause of the difficulty in adjusting the air outlet.

*Figure 1: Instrument panel vent with damaged louver.*

Should the vehicle present with the failure profile described in this TSB, replacement of the instrument panel vent air outlet under warranty is not permitted. This is damage due to outside influence that exceeds normal use.

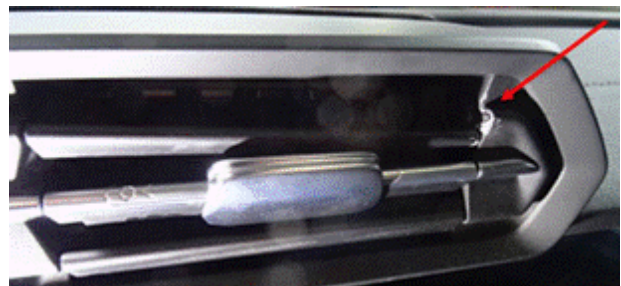
Extensive analysis under extreme magnification on damaged parts returned to the WPRC show a fracture pattern consistent with the exertion of excessive force on the adjustment louver as the cause for the louver pivot to shear off from the air outlet. Excessive force is exerted due to the installation of accessory components attached to the air outlet, an external strike to the louver, an attempt at an extreme adjustment position, etc. The forces that cause the damage exceed the force necessary for normal use.

Figure 2 shows a fractured and sheared louver pivot due to excessive force outside of normal use.

*Figure 2: Instrument panel vent with damaged lower pivot pin.*
