Technical product information

Topic	Water ingress into the front cabin footwell/bulkhead - Glass misting on the inside - Front carpets/mats wet
Market area	Australia E04 Bentley rest Asia and Australia (6E04),China 796 VW Import Comp. Ltd (Vico), Beijing (6796),Germany E02 Bentley rest Europe (6E02),Japan E03 Bentley Japan (6E03),Korea, (South) E08 Bentley South Korea (6E08),United Arab Emirates E06 Bentley Middle East and Africa (6E06),United Kingdom E01 Bentley UK (6E01),United States E05 Bentley USA and rest America (6E05)
Brand	Bentley
Transaction No.	2070638/1
Level	EH
Status	Approval
Release date

New Continental GT/C and New Flying Spur

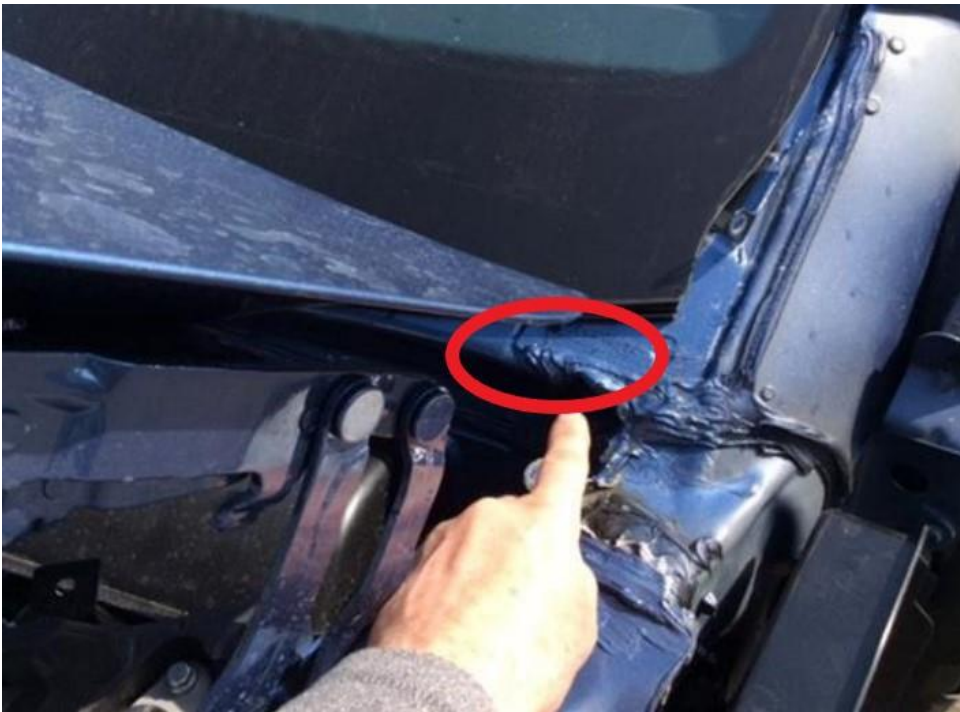
- After conducting TPI 2062622/- water ingress was found at the location shown in Figure1 (Left hand A - Pillar seam)

Figure 1 - Shows the front left hand wing removed please note this is not required for this procedure unless advised via a new or existing DISS query

Hint: The example shows a leak on the left hand side although a leak could be evident on the right hand side at the same location

- Check the condition of the seam sealant at the location shown in Figures 1 and 2
- Check to confirm that sealant has been applied to the left hand A - pillar seam
- Check to confirm that sealant has been applied to the right hand A - pillar seam

A different location the operative should clean/prepare the areas concerned and apply sealant (See parts information) to the applicable location(s)

- Once sealant has been applied conduct a local paint repair in the location in which sealant was missing

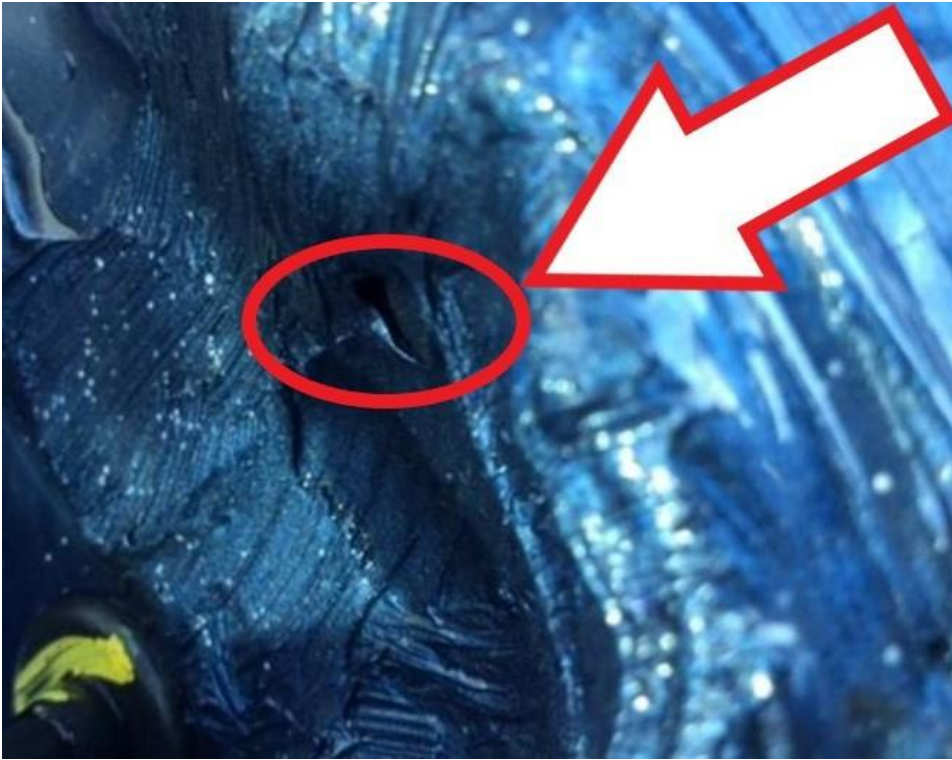
Figure 2

- The cause of the ingress can be caused by missing sealant on the A - post pillar seam
