| REFERENCE: | TSB: 09-006-23 REV. B GROUP 09 - Engine | Date: | May 10, 2023 | REVISION: | 09-006-23 REV. A |
| VEHICLES AFFECTED: | <p>2022 - 2023 (B1) Jeep Renegade 2022 - 2023 (H1) Jeep Commander 2022 - 2023 (M1) Jeep Compass This bulletin applies to vehicles equipped with a 1.3L I4 Turbo Mair DI Eng w/ESS E100 (Sales Code EYJ):</p> <ul style="list-style-type: none"> • M1 built on and after April 28, 2021 (MDH 0428XX) and built on and before **April 22, 2023 (MDH 0422XX)**. • H1 built on and after December 26, 2021 (MDH 1226XX) and built on and before **April 27, 2023 (MDH 0427XX)**. • B1 built on and after January 14, 2022 (MDH 0114XX) and built on and before **April 17, 2023 (MDH 0417XX)**. <p>This bulletin applies to vehicles equipped with a 1.3L I4 Turbo Mair DI Engine w/ESS (Sales Code EYF):</p> <ul style="list-style-type: none"> • M1 built on and after January 29, 2022 (MDH 0129XX) and built on and before **April 19, 2023 (MDH 0419XX)**. • H1 built on and after March 25, 2022 (MDH 0325XX) and built on and before **March 18, 2023 (MDH 0318XX)**. <p>This bulletin applies to B1 vehicles built on and after May 17, 2022 (MDH 0517XX) and built on and before **March 27, 2023 (MD

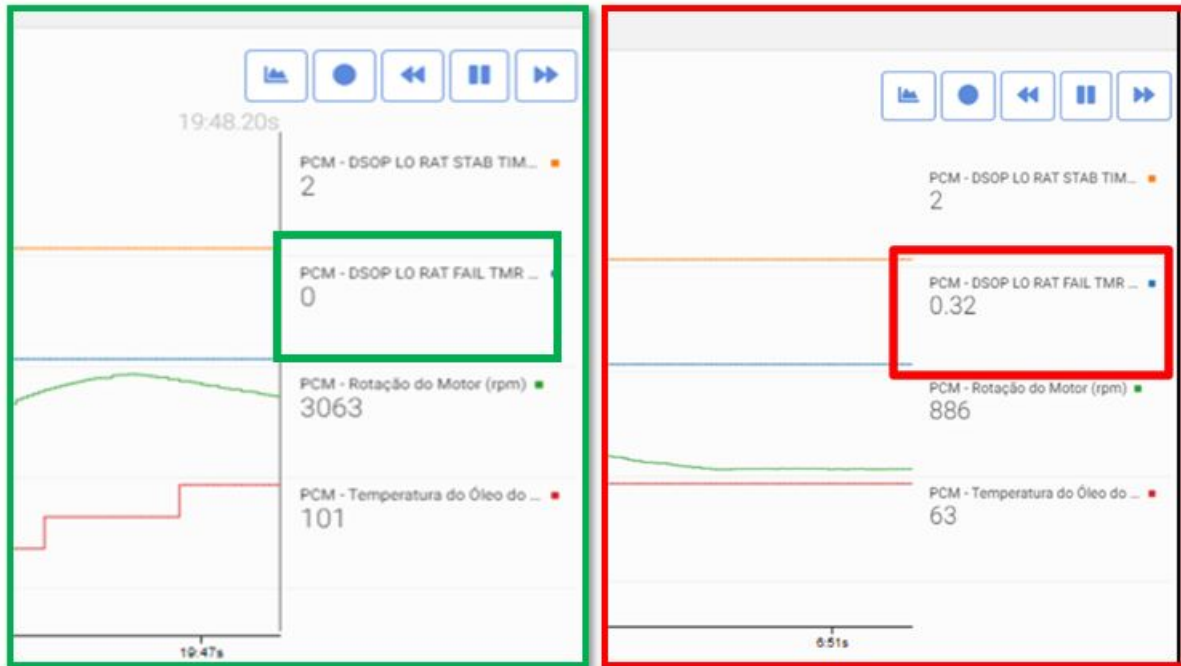
Fig. 1

1. Using wiTECH check if DTC P06DD is set in the Powertrain Control Module (PCM).
2. Was DTC P06DD found in the PCM?
 - YES>>> Replace the timing chain cover. Proceed to [Step 6](#).
 - NO>>> Proceed to [Step 3](#).
3. Start the engine at let it run at idle until the engine oil temperature reaches more than 85° C (185° F).
4. Create a graph of “DSOP LO RAT FAIL TMR” and review the value. **If it shows anything but “0”, the timing cover needs to be replaced (Fig. 1) .**

NOTE: The “DSOP LO RAT FAIL TMR” value can change in less than 20 seconds, then the oil pump (timing chain) is faulty and will need to be replaced.

Graph Showing Correct And Not Correct Values

5. Did the “DSOP LO RAT FAIL TMR” value read anything but “0”?
 - YES>>> Create a screen shot of the graph showing values other than “0” and attach it to the work order. Proceed to [Step 6](#).
 - NO>>> If the value always shows “0” and DTC P06DD was not found, this bulletin has been completed. Use Inspection LOP (09-65-01-73) to close the active RSU.
6. Replace the timing chain cover. Refer to the detailed service procedures available in DealerCONNECT/ Service Library under: 09 - Engine, 1.3L I4 16V Multi Air Turbo / Valve Timing / Cover(s), Engine Timing / Removal and Installation.
7. Using wiTECH clear any DTCs that may have been set.
