Service Category	Engine/Hybrid System		
Section	Engine Mechanical	Market USA	Toyota Supports

YEAR(S)	MODEL(S)	ADDITIONAL INFORMATION
2023	Camry

Some 2023 model year Camry vehicles equipped with an A25A-FKS engine may exhibit a condition in which a popping noise is present when the engine is running. Follow the Repair Procedure in this bulletin to address this condition.

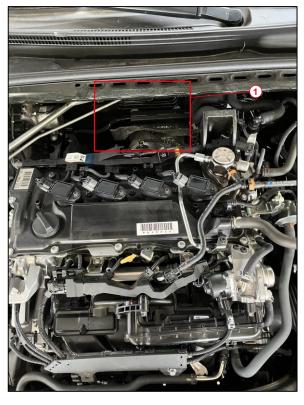
Figure 1. Engine Bay

Focus on the middle of the head casting, just above the exhaust manifold.

The water-jacket plug is located on the middle of the head casting, just above the exhaust manifold.

Area of Focus (for Phone or Borescope)
