Technical Service Bulletin

GROUP	NUMBER
CAMPAIGN	23-01-060H
DATE	MODEL(S)
JULY 2023	IONIQ 5 (NE1) IONIQ 6 (CE1)

SUBJECT: DTC P1A9096 CHECK FOR ICCU & FUSE REPLACEMENT AND ICCU SOFTWARE UPDATE (SERVICE CAMPAIGN 997)

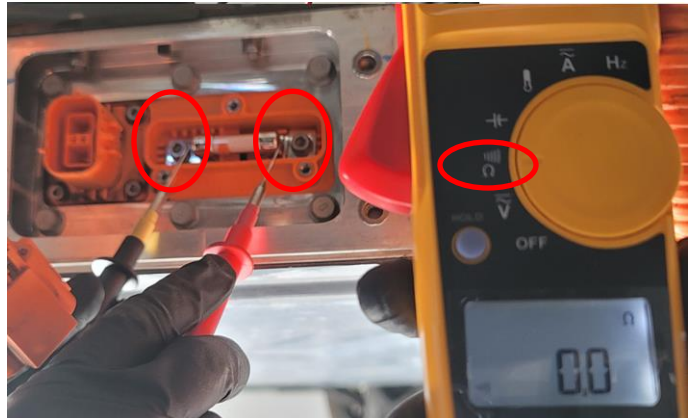
E6. Using a commonly available multimeter. Set at the ohmmeter measuring mode and inspect the fuse condition by checking the fuse's resistance value:

- **Fuse is Good:** Less than 1.0 ohm.

**DO NOT REPLACE THE FUSE.
Do not follow the remaining steps to
replace the fuse.**

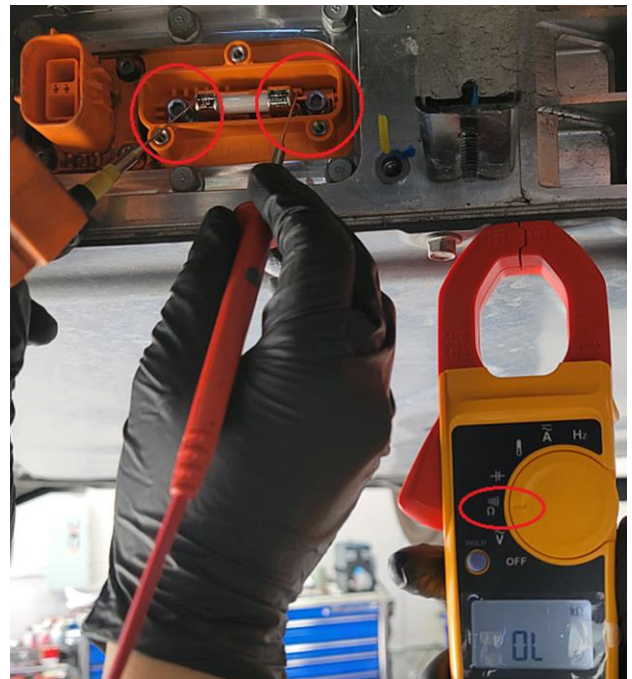
- **Fuse is Bad (Blown/Open):**
Resistance greater than 1.0 ohm or OL.

It can be difficult or with complication removing the fuse, which may include the nuts holding the fuse holder falling back into the battery.

**ONLY REPLACE THE FUSE IF
FOUND TO BE BAD
(BLOWN/OPEN).**

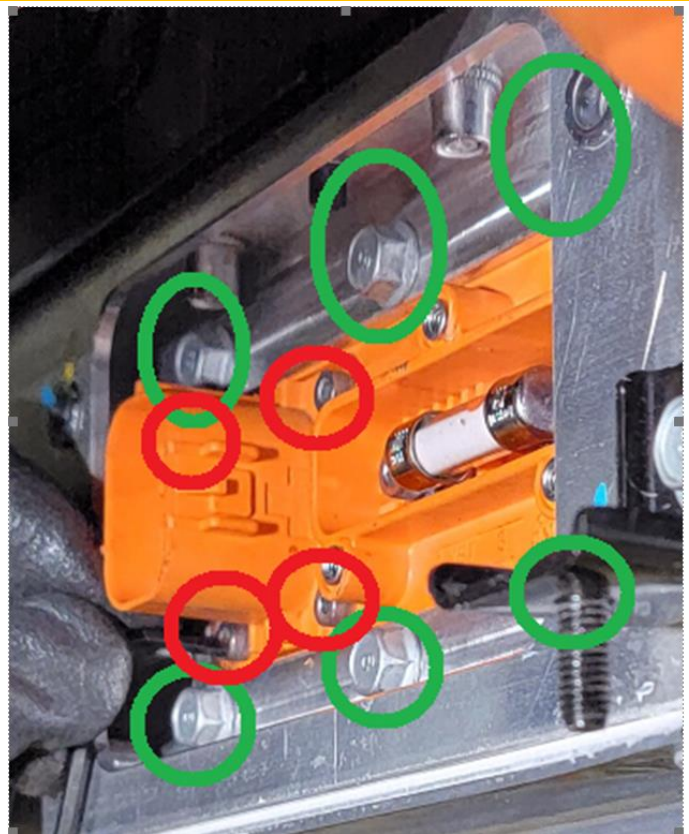
SPECIAL INSTRUCTION: Only applies when ICCU Fuse rear nut(s) falls back into the battery.

1. Remove:
 - 6 qty. 10mm bolts (Green marked),
 - 4 qty. bolts by Allen wrench (Red marked).
2. Push in bottom area. Pull out top area.
3. Reach in and grab the nut behind the plate on the bottom surface.
4. Hold the nut at the back side.
5. Install the fuse bolt at the place that the nut had dropped.
6. Install all the other bolts in reverse order of removal.
7. Install the rest of the fuse bolts.

NOTE: Contact Techline if the above procedure did not resolve a dropped nut problem.
