SERVICE BULLETIN

APPLICABILITY: 2016-19MY Legacy & Outback

NUMBER: 09-109-23

SUBJECT: DTC P2404 / Reprogramming Files

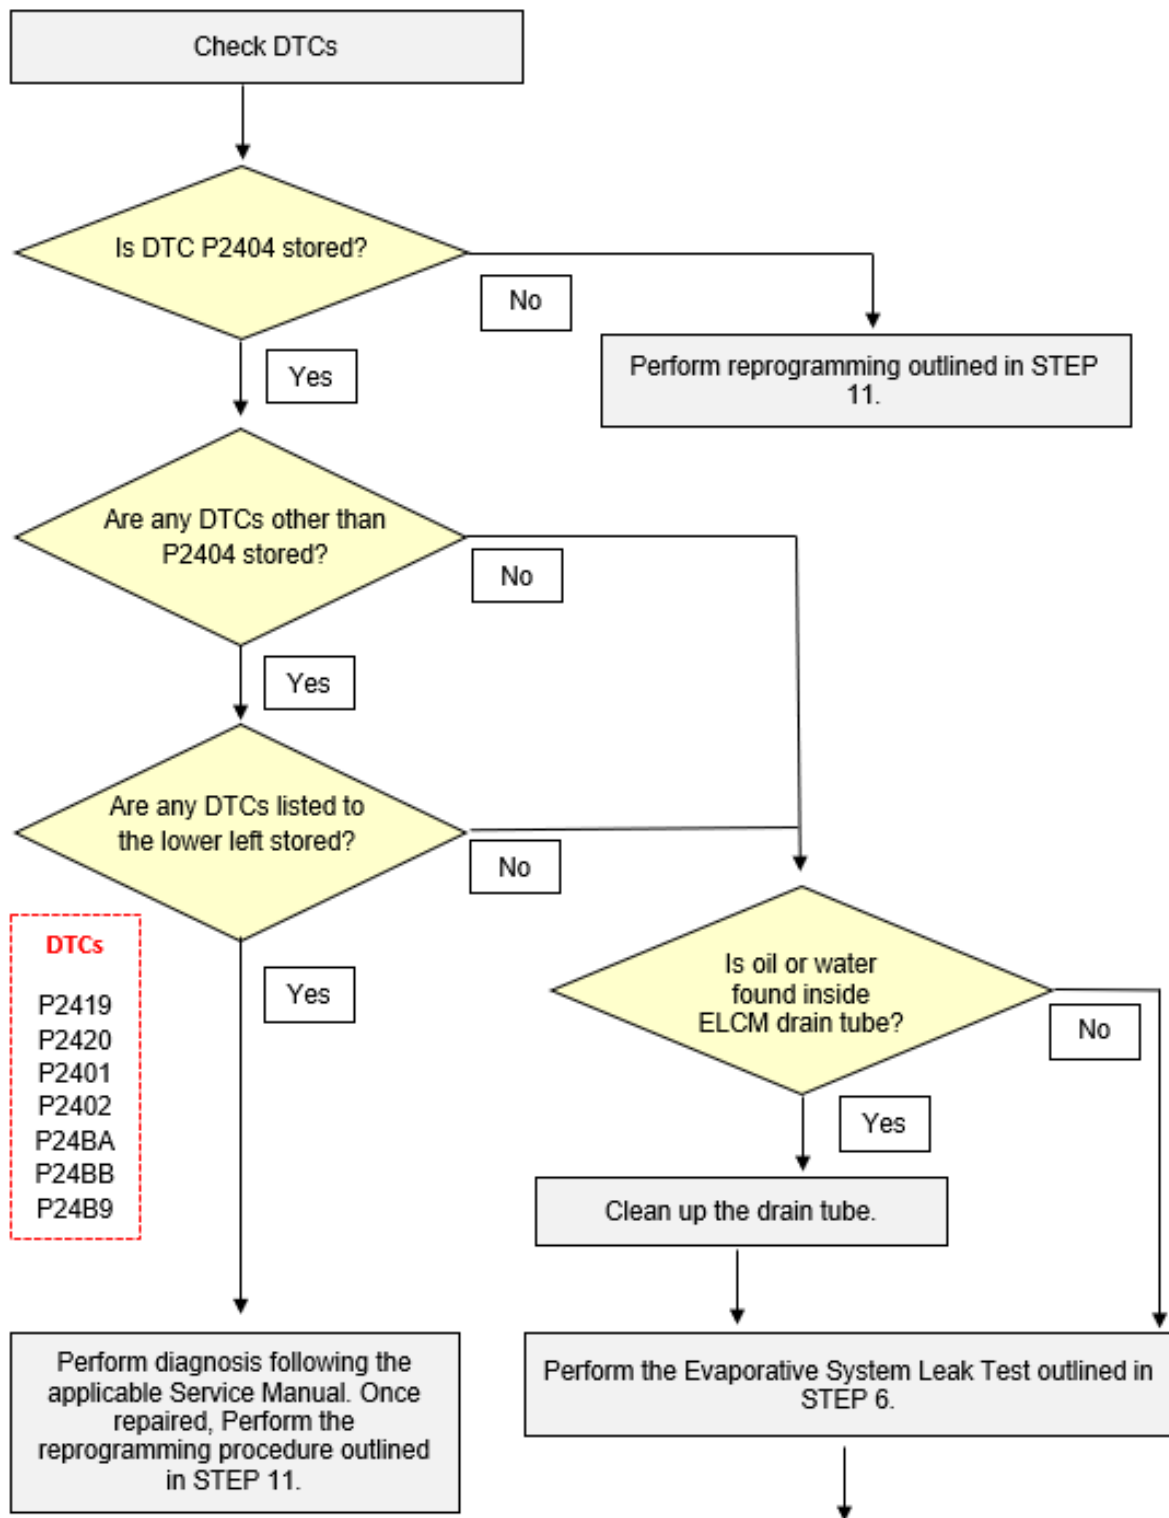
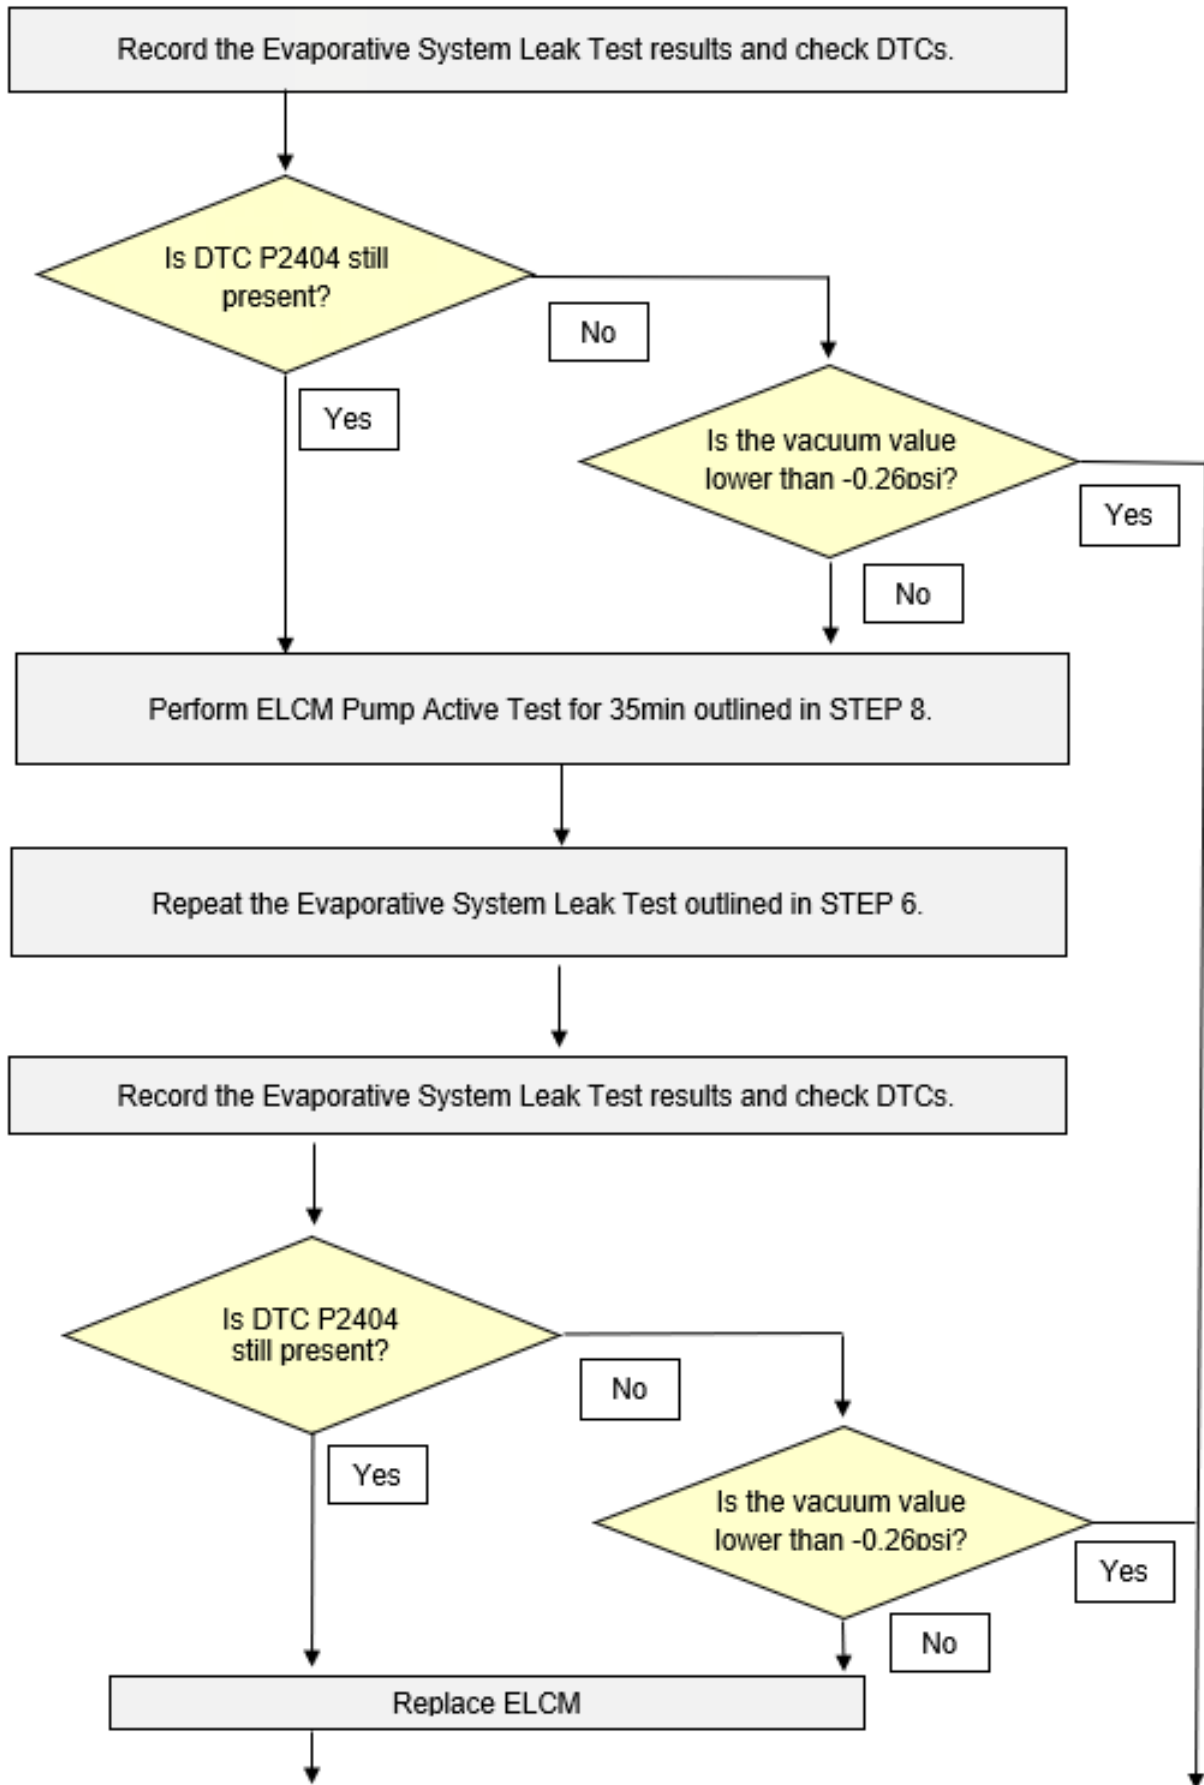
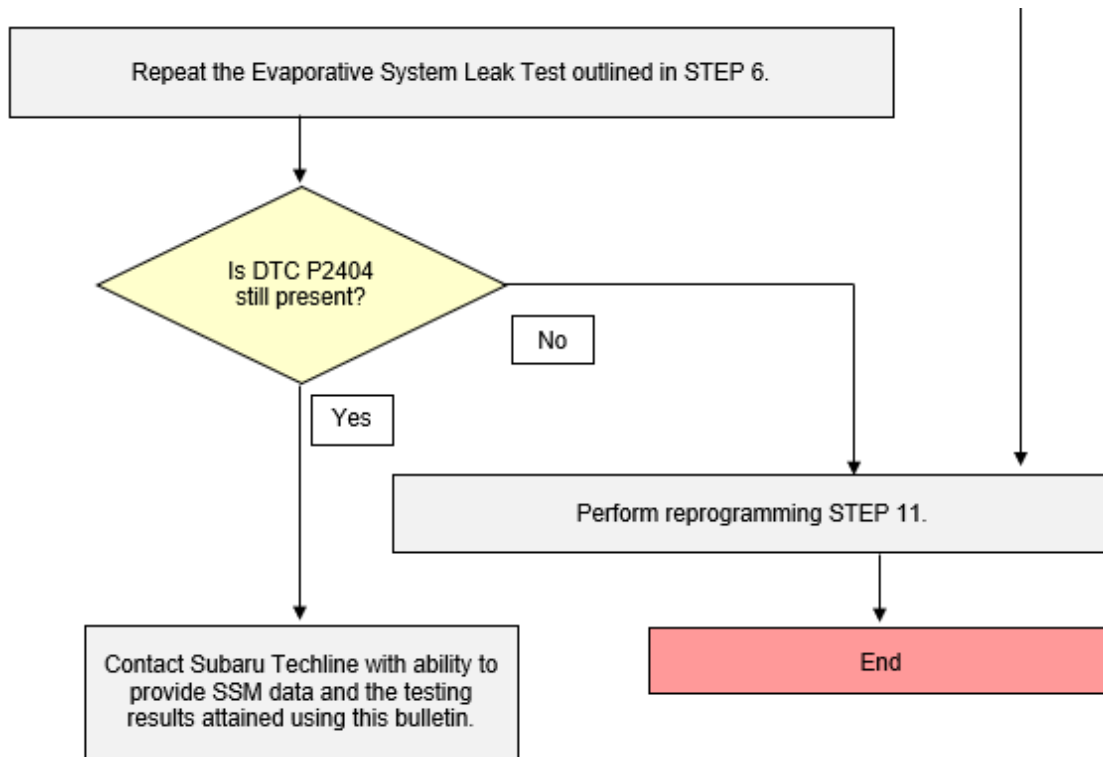
Service Procedure Flowchart:

This bulletin announces diagnostic procedures along with availability of new Engine Control Module (ECM) reprogramming files to address DTC P2404 (Evap System Leak Detection Pump Sensor Circuit Range/Performance) detection. In rare cases, condensation can accumulate within the internal pump for the Evaporative Leak Check Module (ELCM) causing improper operation. The new logic incorporates a cleaning mode for the ELCM pump to provide added protection. If P2404 is found stored in the ECM memory, follow the procedures outlined below.

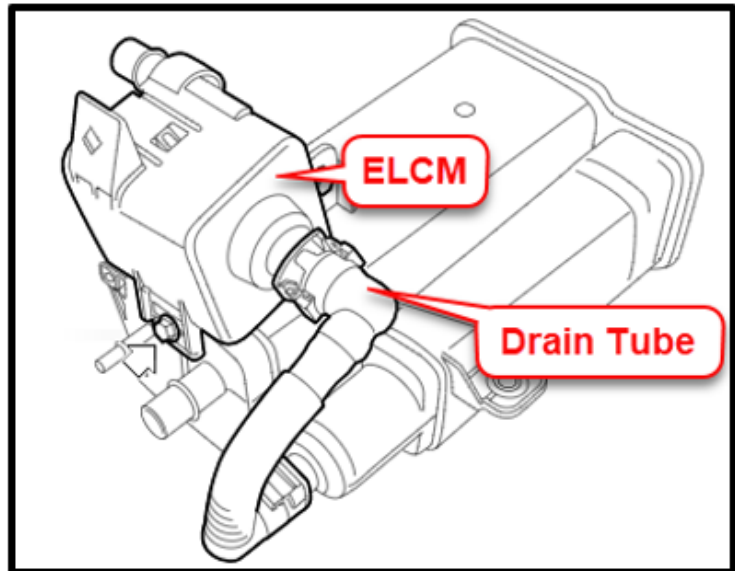
STEP 5: CAREFULLY disconnect the ELCM drain tube. Inspect for signs of water or oil.

Have signs of water or oil been detected withing the ELCM drain tube?

YES – Clean and dry the drain tube using a non-alcohol base cleaner. Proceed to STEP 6.

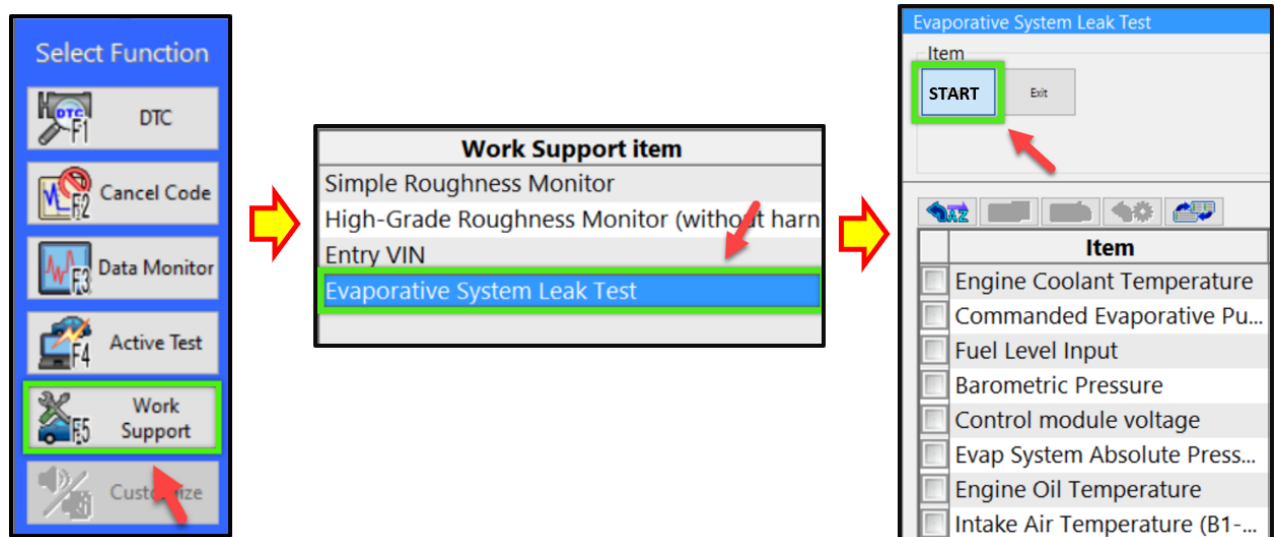
STEP 6: Connect the vehicle to a recommended power supply. See **APPENDIX A** for addition information regarding power supply. Using SSM, perform the Evaporative System Leak Test. Collect and save all data.

Once the evaporative system leak test is complete, check the DTCs and examine the vacuum value results. Record the value shown in the row labeled MID: \$3C, TID: \$C4, and Scaling ID: \$FE. This value should be lower than -0.26 PSI.

Value Must Be Lower Than -0.26 PSI

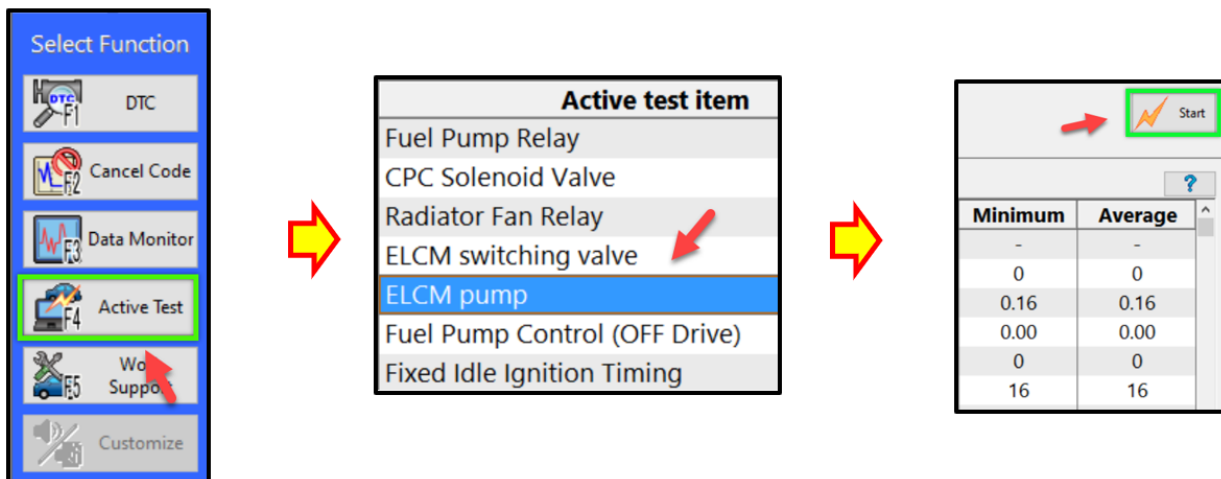
STEP 8: Using SSM, perform the ELCM Pump Active Test for a period of 35 minutes or more. See **APPENDIX A** for addition information regarding power supply.

Once the ELCM Pump Active Test has been performed for a period of 35 minutes or more, repeat the Evaporative System Leak Test outlined in STEP 6. Check the DTCs and the vacuum value results.
