Red battery warning message in IC

Topic number	LI54.10-P-076742
Version	1
Function group	54.10 - Battery, power supply, voltage converter
Date	7/25/23
Validity	All GT (190).
Reason for change

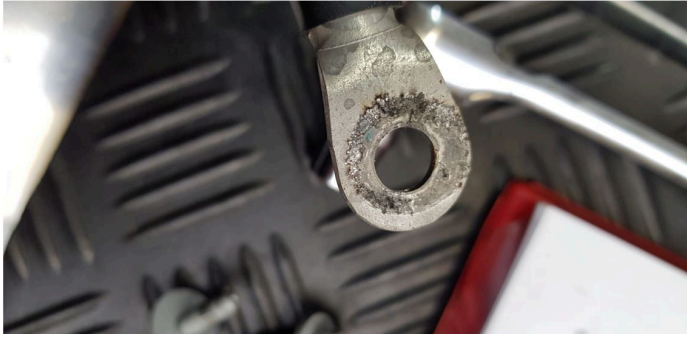
Attachments	
File	Description
Not_ok_1.JPG	Ground connection not permissible.

- Check ground points per the pictures/guide in the attachments
- Test the state of charge of the battery. Replace if necessary
- Check fuse box f32/2 for water, oxidation or damage
- Check alternator / alternator management for correct functionality via Xentry
- Update front and rear SAM

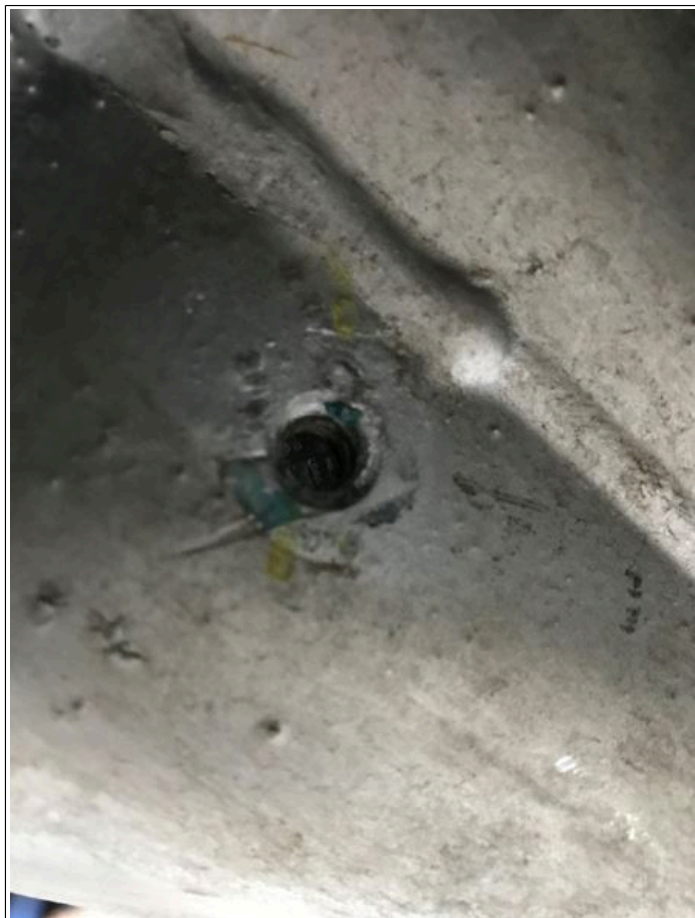
[Not_ok_3.JPG](#)

Ground connection not permissible.

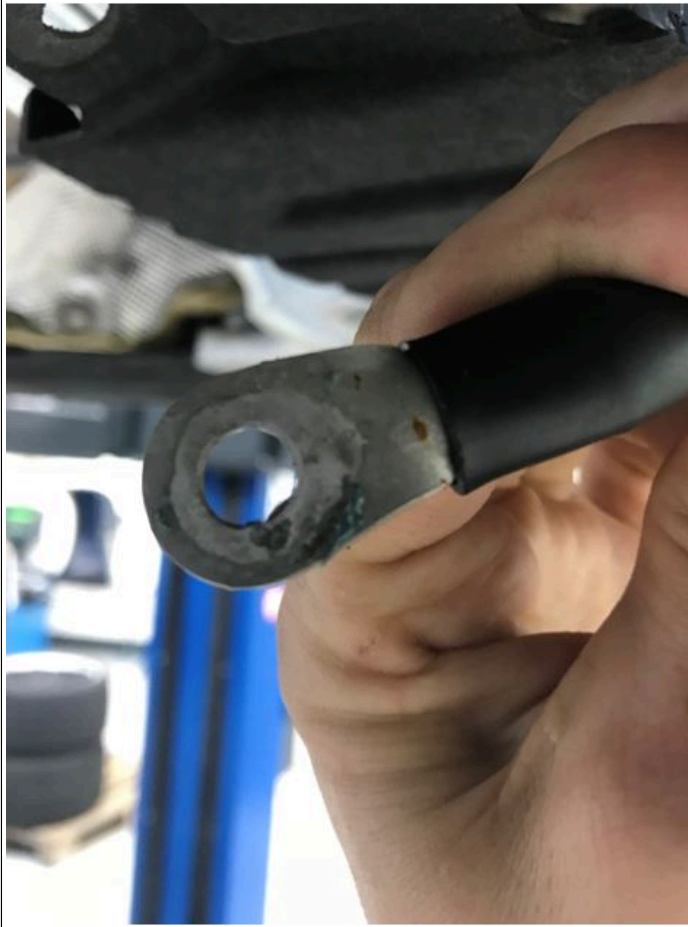
Not_ok_4.JPG

Ground connection not permissible.

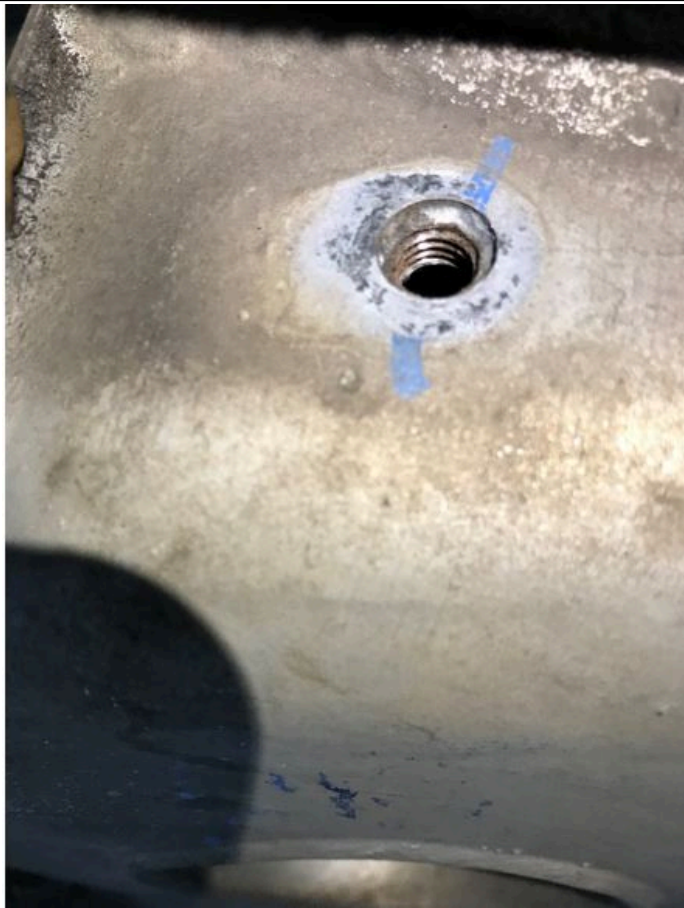
[Not_ok_5.JPG](#)

Ground connection not permissible.

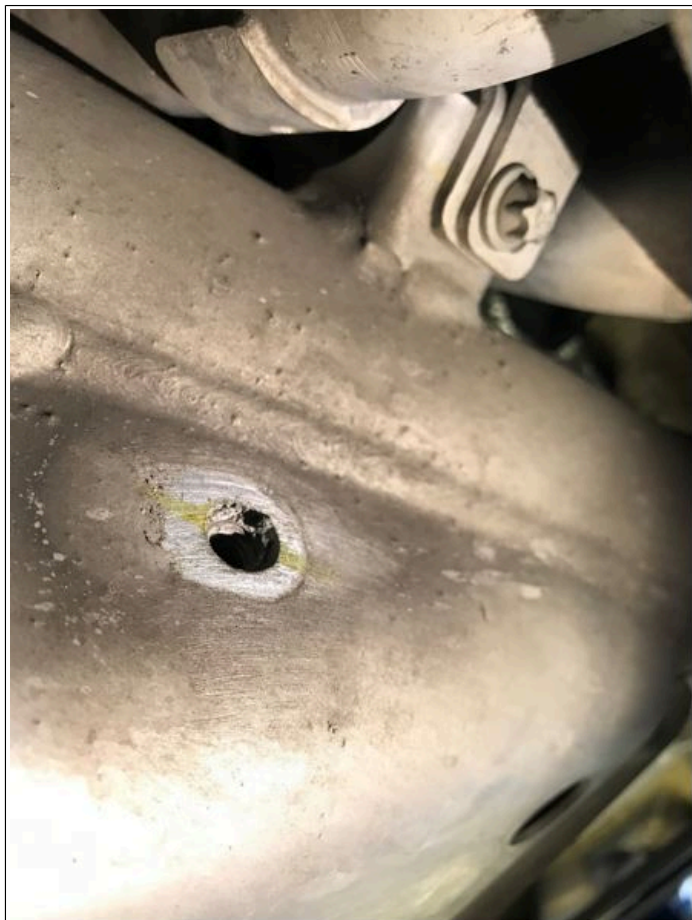
Attachments	
File	Description
OK_after_treatment.JPG	OK condition.
