# Service Bulletin

Bulletin No.: 19-NA-257

**Subject: Pickup Box Out of Alignment**

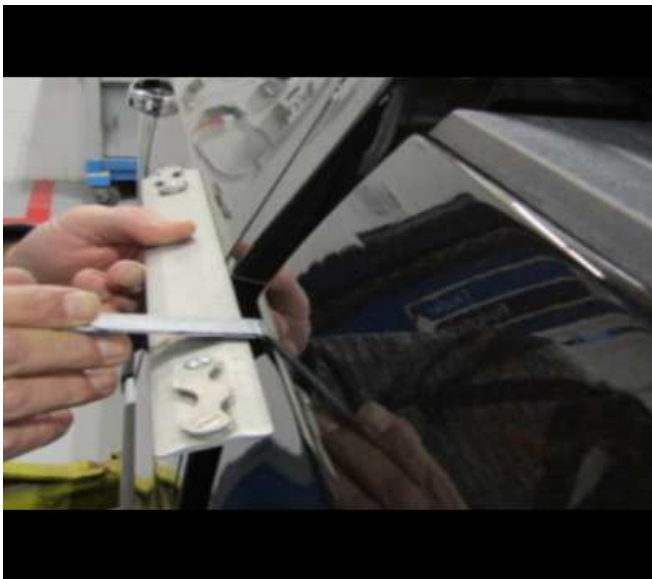
5442975

**Note:** Measure the cab to box distance on both sides of the vehicle.

- Using a straight edge on the side of the cab corner at the upper body line, measure the distance to the pickup box. The box should be sub-flush with cab and within 2.5 mm (0.10 in) total difference side to side.
  - If the box is sub-flush AND the distances ARE within the 2.5 mm (0.10 in) range side to side, no box alignment is necessary.
  - If the box IS NOT sub-flush AND the distances ARE NOT within the 2.5 mm (0.10 in) range side to side, continue on to the box alignment procedure.

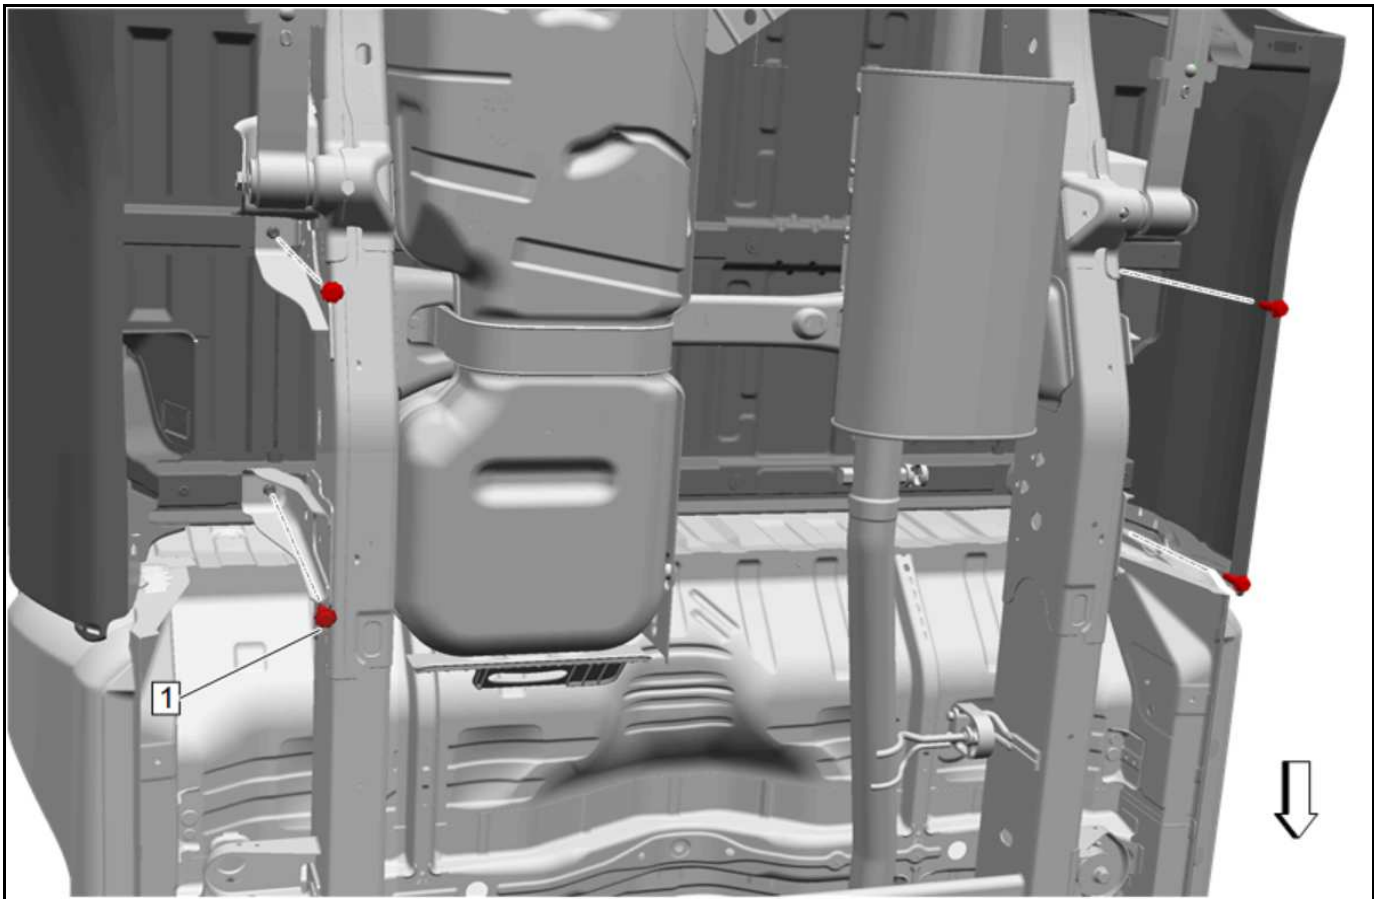
4998459

**Note:** Long pickup box shown above, has 4 front bolts, short box only has 2.

4. Remove the **front** pickup box bolts (1) and clean any sealer that may prevent movement between the bolt and frame. Reinstall the bolts and hand turn a couple of turns.

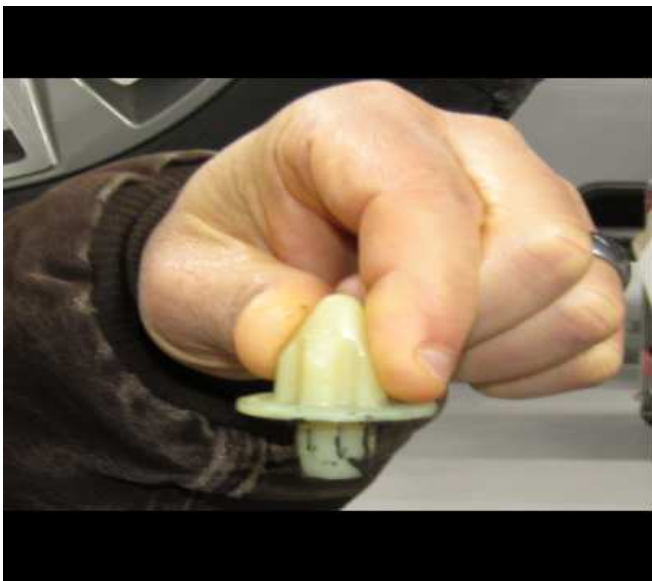
5442977

**Note:** If box alignment is limited due to locating pins in the bed preventing correct alignment, the front locating pin can be removed.

5. Remove the front bed to frame locator pin, as necessary.
6. Align the pickup box to within specifications. Box should be sub-flush with cab and within 2.5 mm (0.10 in) total difference side to side.
7. Tighten all pickup box bolts. Refer to Fastener Specifications in the Body Repair section in SI, for proper Torque specifications
8. Remove any tape/protection that was applied.
