# Service Bulletin

Bulletin No.: 21-NA-148

**Subject:** Diagnostic Aid – DTC P2797, P2798 or P0C2D for Transmission Fluid Pump Performance

Brand:	Model:	Model Year:		VIN:		Engine:	Transmission:
		from	to	from	to		
Chevrolet	Bolt EV	2021	2023	—	—	EN0	1ET25 Automatic (MMF)
	Bolt EUV	2022

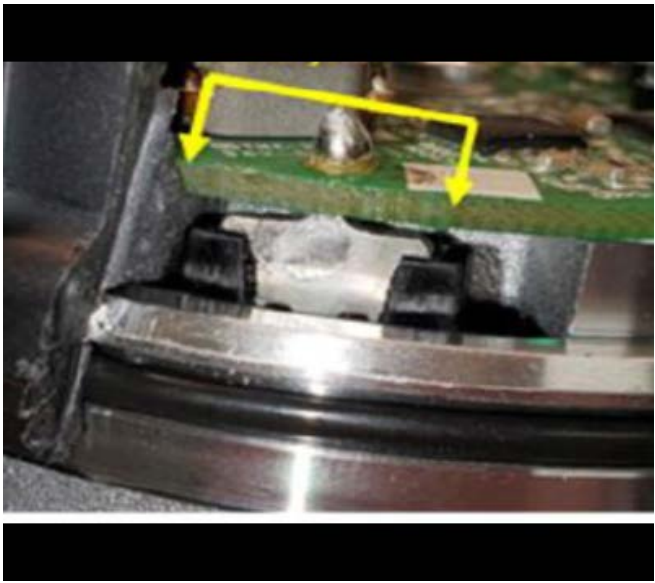
<p>5867264</p>

<p>5867265</p> <p>A part quality spill has been identified with the low voltage electric transmission fluid pump attached to the driver side of the transmission. A soldering process was out of specification like the illustration above.</p> <p><b>Note:</b> The pump motor is not internally serviceable and the pictures provided are only for helping to visually show the issue.</p>
<p>Correction</p>	<p>Replace the transmission fluid pump.</p> <p><b>Important:</b> The pump motor is not internally serviceable.</p>

If you encounter a vehicle with the above concern, replace the transmission fluid pump. Refer to *Transmission Fluid Pump Replacement* in SI.
