# Service Campaign Bulletin

Campaign No. 2023070010, July 2023

SUBJECT: **Model GLE (167 platform)**  
**Model Year 2022**

## **Inspect Right Longitudinal Member**

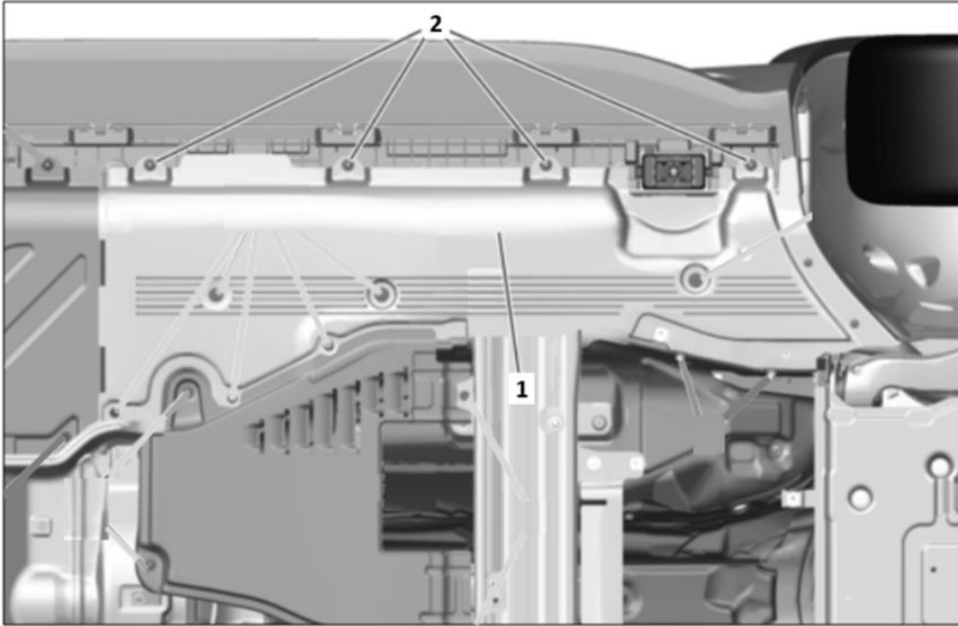
Figure 1

1. Remove the right front underfloor paneling (**1, Figure 1**).

- a. **No** surface damage on outer longitudinal member:  
Fasten right front underfloor paneling (**1, Figure 1**) and **end measure**.
- b. Surface damage present on outer longitudinal member: **Perform work procedure**.

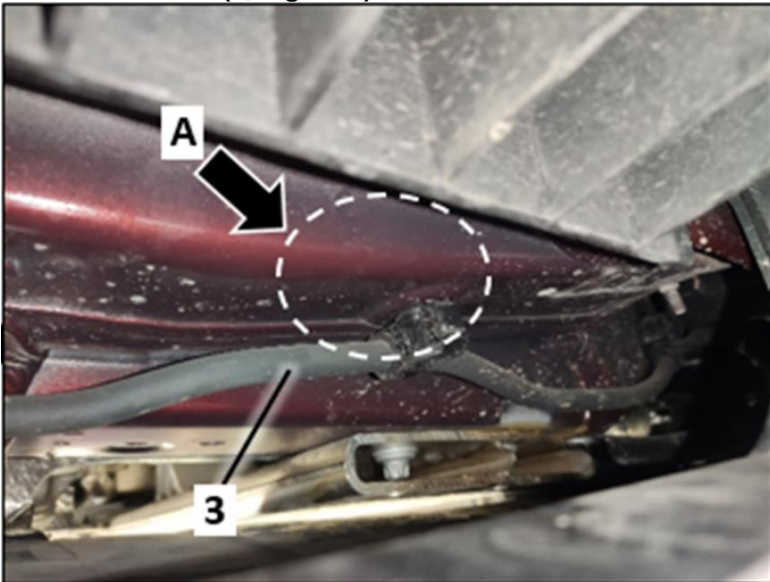
Figure 2

Mercedes-Benz AG (“MBAG”), the manufacturer of Mercedes-Benz vehicles, has determined that on certain Model Year (“MY”) 2022 GLE (167 platform) vehicles, surface damage may have occurred to the longitudinal member, causing subsequent corrosion. An authorized Mercedes-Benz dealer will inspect for surface damage on the outer right front longitudinal member and re-work, if necessary.

2. Check longitudinal member in the marked area (**arrow A, Figure 2**) for surface damage.

**i** Press line (**3, Figure 2**) installed in area to one side, unclip if necessary.

1. Clean longitudinal member in processed area and rework with seam sealant.
