SQUEAK/RATTLE TYPE SOUND FROM WARNING TRIANGLE LOCATION IN LOADSPACE AREA

Range Rover

- 23MY RR Sport

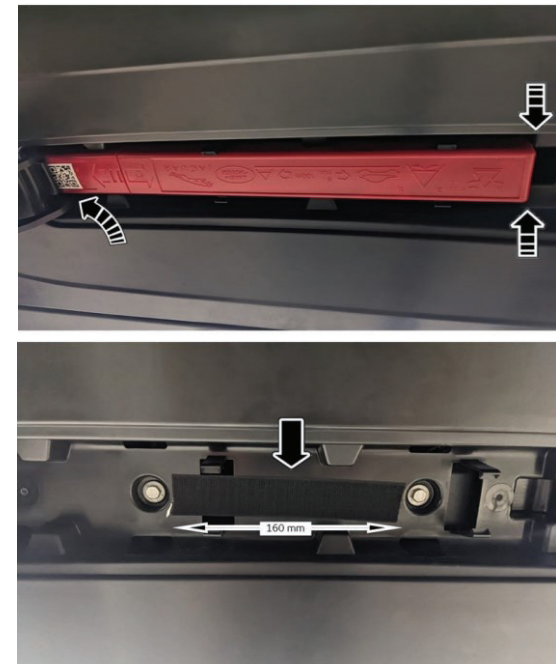
- That there is a squeak or rattle in the rear loadspace area of the vehicle.

- The roadside warning triangle kit may be moving around in the mounting tabs.

- To address this concern, a Velcro strip has been added to prevent the triangle kit movement in production from PA107083.
- **SSM 75858** has been published to provide repair guidance by adding a Velcro strip that is locally sourced.
