Technical Service Bulletin

97 Diagnostic tester does not communicate with vehicle via OBD socket - contacts widened

97 23 98 2070383/2 July 26, 2023. Supersedes Technical Service Bulletin Group 97 number 23-94 dated May 19, 2023 for reasons listed below.

Model(s)	Year	VIN Range	Vehicle-Specific Equipment
A4, A4 allroad, S4, A5, A5 Cabriolet, A5 Sportback, S5, S5 Cabriolet, S5 Sportback, RS 5, and RS 5 Sportback	2023	Produced between January 6, 2022 – June 21, 2023	Not Applicable

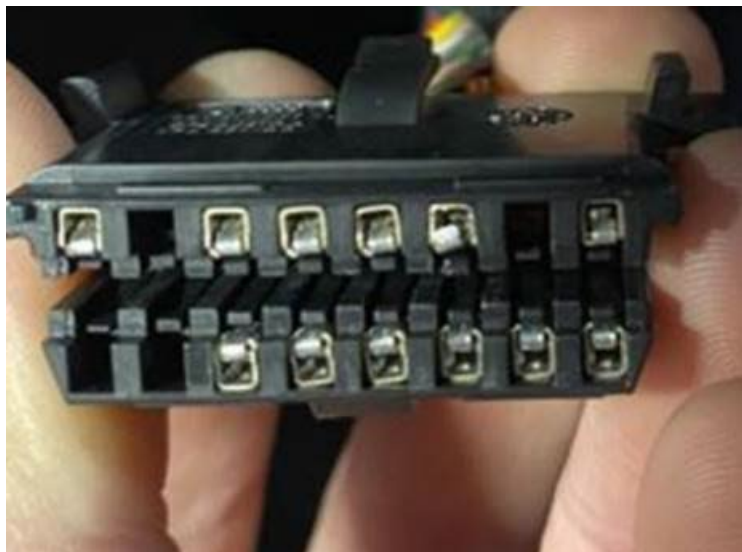
Pins within the OBD port U31 (Figure 1) may have been damaged in production.

Figure 1: OBD port (U31).

Check contacts on diagnostic connection for damage.

If damaged contacts are found, document the pin number(s) damaged and attach photos as seen in figures 1 and 2 to DOC-IT.

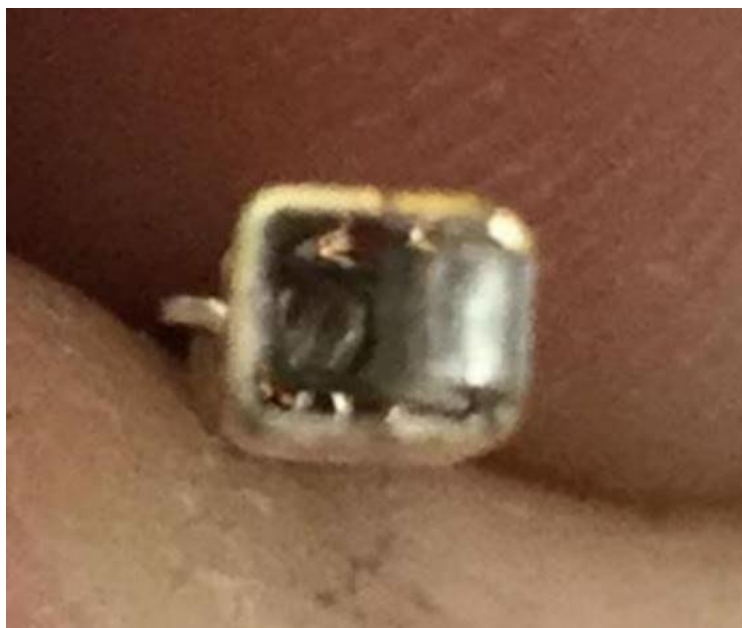
Contacts on the diagnostic connection (OBD socket) may have been damaged in the production process.

Figure 2: Damaged pin.

Repair the wires as needed using VAS 1978 B.
