Service Bulletin

Bulletin No.: 23-NA-130

Subject: Driver Side Mirror Distorted

Brand:	Model:	Model Year:		VIN:		Engine:	Transmission:
		from	to	from	to		
Chevrolet	Blazer	2019	2023

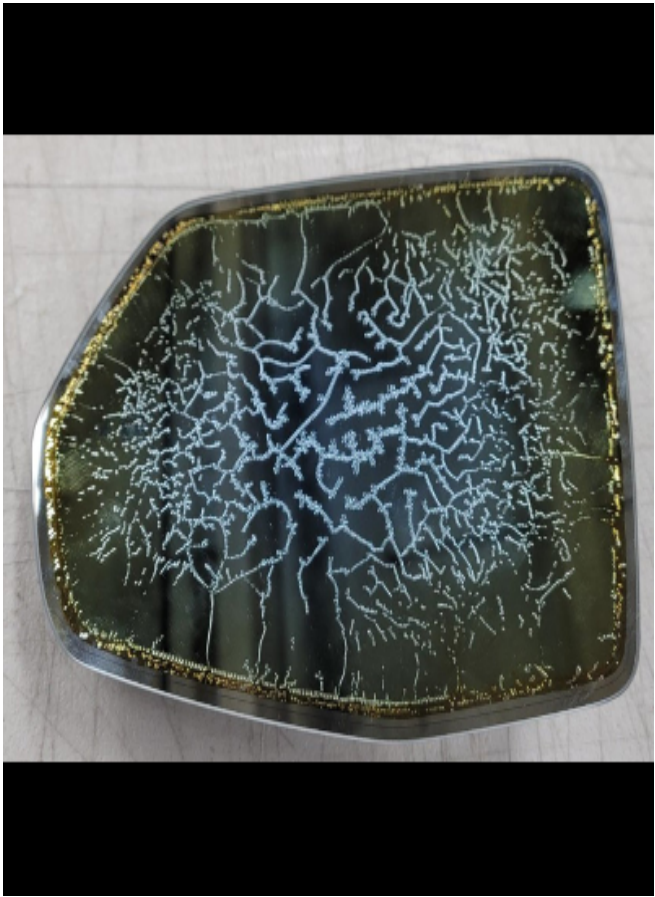
6388604

Involved Region or Country	North America
Additional Options (RPOs)	
Condition	<p>Some customers may comment on the driver side view mirror being distorted with squiggly lines going through it.</p>

Cause	The cause of the condition may be too much current going to the mirror defogger circuit.

Correction	Before replacing the mirror, check connector X500 for corrosion. If corrosion is found, then repair as needed prior to replacing the mirror. Identify water intrusion pathway and repair to prevent future water intrusion into connector. Refer to <i>Repairing Connector Terminals in SI</i> .
------------	--
