## SERVICE BULLETIN 23-01

**RE:** Immediate and recurring inspection; torque setting and replacement of damaged cap bolts in aftermarket SPL front lower control arms, FLCA SKU's: FLCA F8X, FLCAR F8X, FLCA E9X, FLCAR E9X, FLCA F3X, FLCAR F3X, FLCA G29, FLCA G8X, FLCA G8X IX, FLCA GT350, FLCA ATS, FLCA CAM6, FLCA S550

**Effective Date:** JULY 16TH, 2023 with cap bolt inspection, torque confirmation of 180/ft. Lbs or replacement before further use.

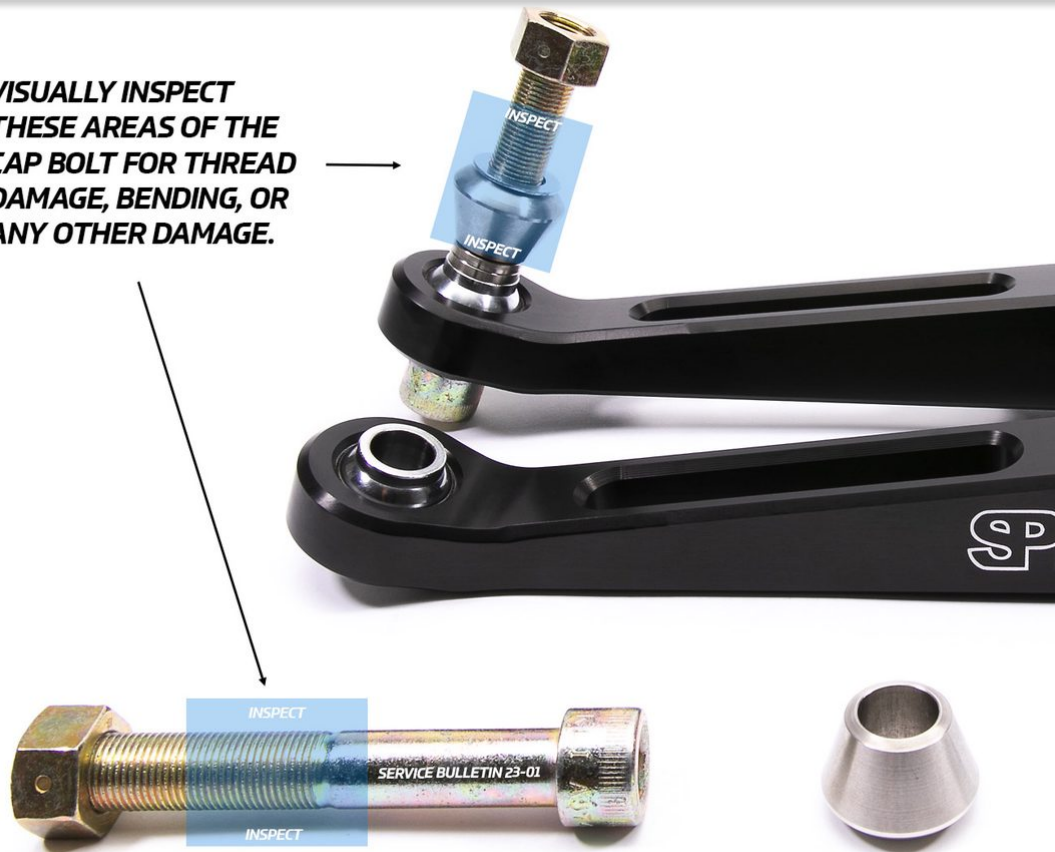
**Description of Issue:** SPL has received inquiries regarding bending and failures of cap bolts used in SPL front lower control arms. Information supplied to SPL indicates inadequate or un-retained torque of retaining nut/bolt to lower control arm may be contributing to bending and fatigue of grade-8 fasteners.

**VISUALLY INSPECT THESE AREAS OF THE CAP BOLT FOR THREAD DAMAGE, BENDING, OR ANY OTHER DAMAGE.**

**Immediately Remove and Replace any cap bolt with signs of bending distortion or damage! Do NOT drive the vehicle until it is properly repaired. (contact SPL for part number)**

1. Clean threads and re-torque undamaged cap bolt retaining nuts to 180 ft-lbs (dry threads). SPL strongly recommends replacement of any cap bolts where inspection indicates installed torque less than 110 ft-lbs, regardless of damage or time in use.

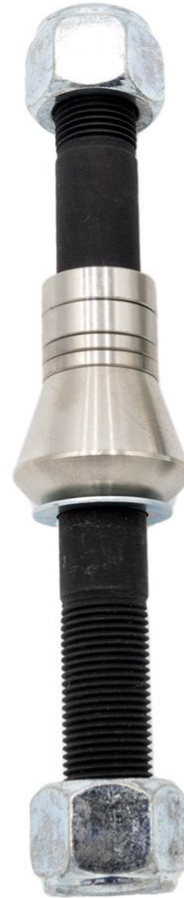
***REPLACEMENT  
STUD***

Current SPL kits ship with a stud & nut fastener that will retrofit to older kits as replacement parts (See illustrations below).

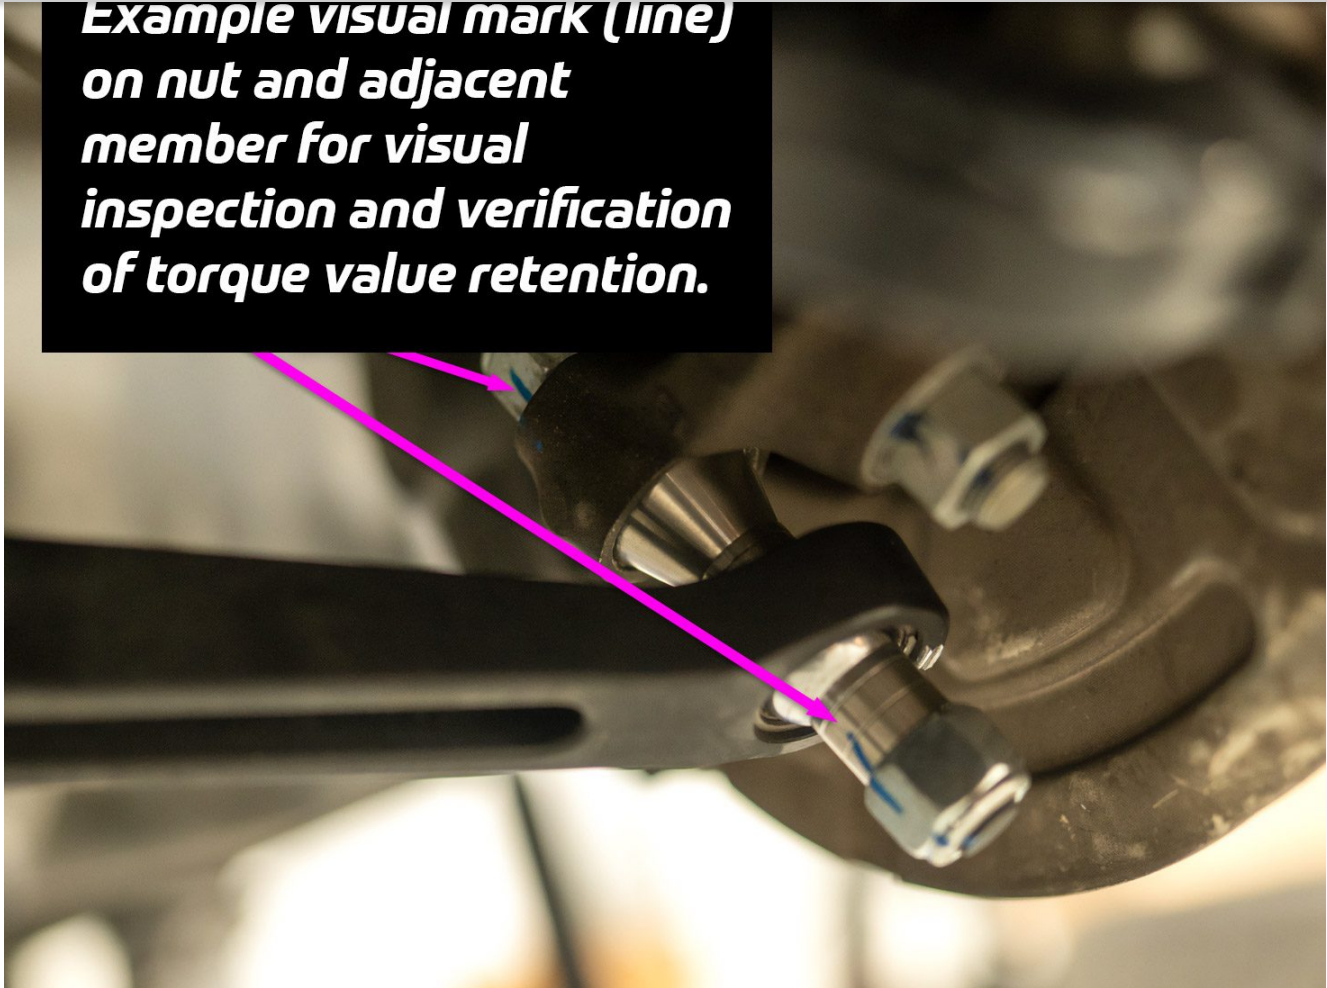
***Example visual mark (line)  
on nut and adjacent  
member for visual  
inspection and verification  
of torque value retention.***

2. Apply permanent marking (via marker or other method) line on the nut(s) and adjacent member(s) for visual indication that the torque value has been retained and no rotation has occurred. (See images below)
