SERVICE BULLETIN 23-01

RE: Immediate and recurring inspection; torque setting & replacement of damaged *cap bolts* in aftermarket Turner Motorsports front lower control arms: FLCA SKU's: TMSFLCAG2X, TMSFLCAE9X, TMSFLCAF3X, TMSFLCAF8X, TMSFLCAG8X

Effective Date: JULY 17TH, 2023 *with cap bolt inspection, torque confirmation of 180/ft. Lbs or replacement before further use.*

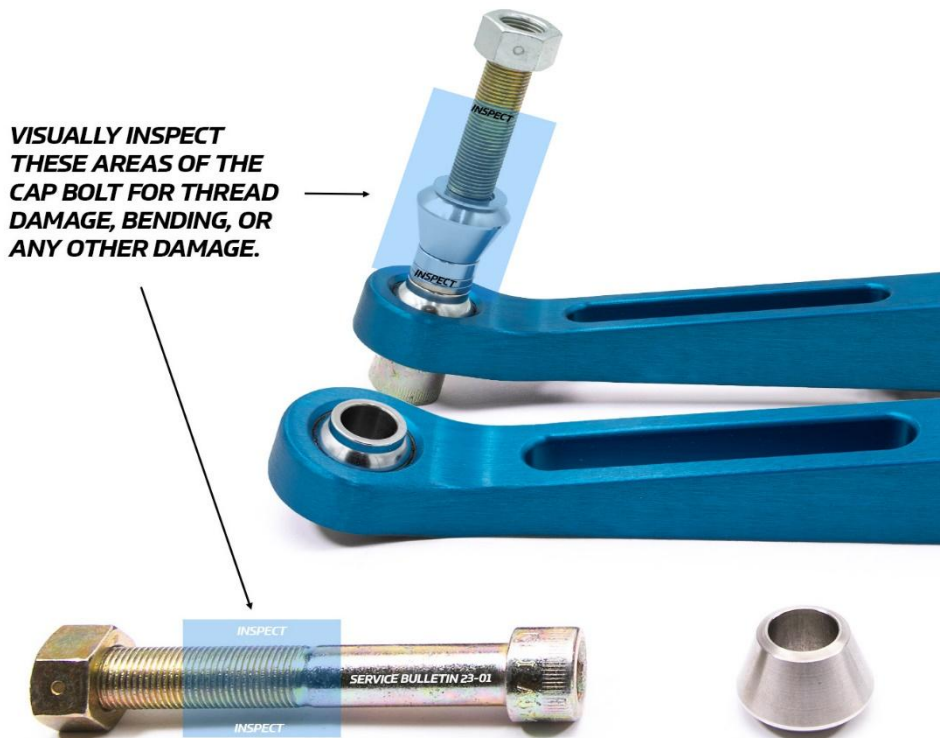
Description of Issue: Turner Motorsports has received inquiries regarding bending and failures of cap bolts used in Turner Motorsports front lower control arms. Information supplied to Turner Motorsports indicates inadequate or un-retained torque of retaining nut/bolt to lower control arm may be contributing to bending and fatigue of grade-8 fasteners.

Recommended Action: Visually inspect cap bolt and control arm attachment points for bending, impact or other wear/distortion/damage; paying particular attention to the area where cap bolt threads exit retaining nut:

Immediately Remove and Replace any cap bolt with signs of bending distortion or damage! Do NOT drive the vehicle until it is properly repaired. (contact Turner Motorsports for part number)

1. Clean threads and re-torque undamaged cap bolt retaining nuts to 180 ft-lbs (dry threads). Turner Motorsports strongly recommends replacement of any cap bolts where inspection indicates installed torque less than 110 ft-lbs, regardless of damage or time in use.

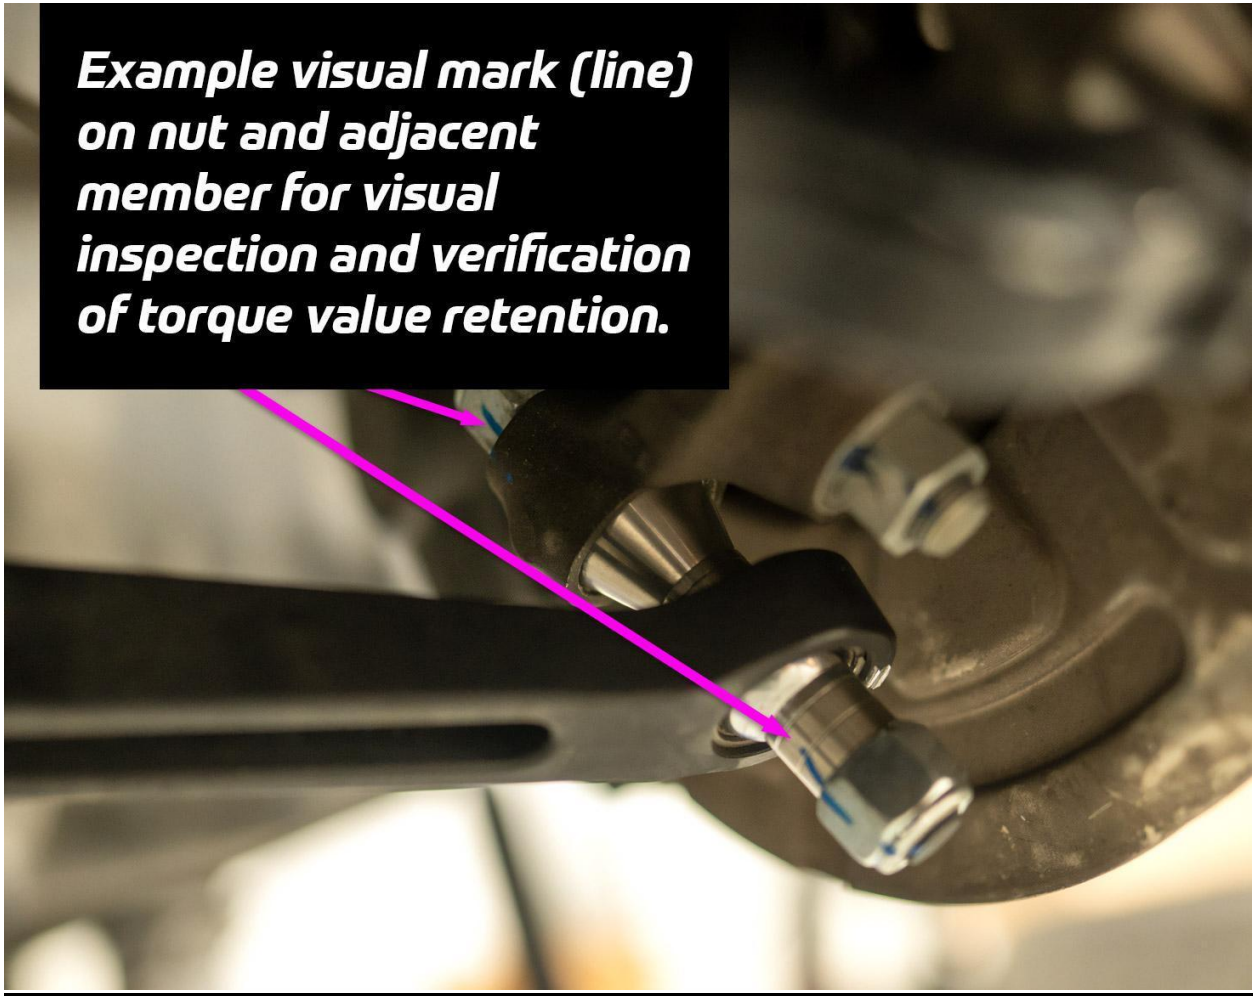
Visual Inspection Marks

***Example visual mark (line)
on nut and adjacent
member for visual
inspection and verification
of torque value retention.***

2. Apply permanent marking (via marker or other method) line on the nut(s) and adjacent member(s) for visual indication that the torque value has been retained and no rotation has occurred. (See images below)
3. Make inspection and confirmation of 180 ft-lbs torque setting part of your routine pre-use and race preparations and maintenance. **NOTICE** Consult your Turner Motorsports instructions and customerservice@turnermotorsport.com for additional set-up recommendations, warnings and product safety information.
4. The prevailing torque nuts without the nylon anti-rotation ring can only be tightened twice before they should be replaced. Nylock style nuts should be replaced after three uses. Exceeding this limit, even with proper torque values, can result in loosening.
