Complaint - Cylinder Head Cover Near the Injector Holes Leaking: Subsequent Work on Cylinder Head (180/18)

Vehicle Type: **Cayenne (9YA) / Cayenne Coupé (9YB) / Cayenne E-Hybrid (9YA) / Cayenne E-Hybrid Coupé (9YB) / Cayenne S (9YA) / Cayenne S Coupé (9YB)**

Concerns: **Cylinder head cover**

Cause: **Complaint about injector hole leaks**

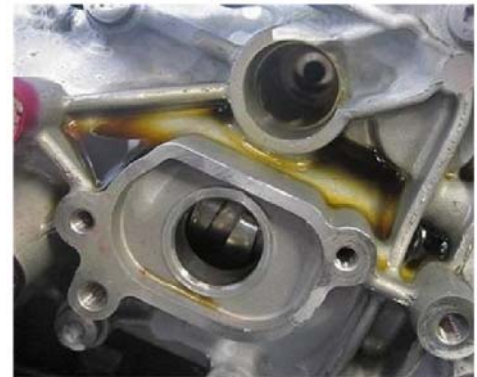
Fault type 2: Cylinder head cover leaking

2.3.1 Oil must have collected in the vicinity of the injector of the affected cylinder and the insulation on the bottom of the cylinder head cover should be fully soaked.

⇒ *Fault type 2: Cylinder head cover leaking*

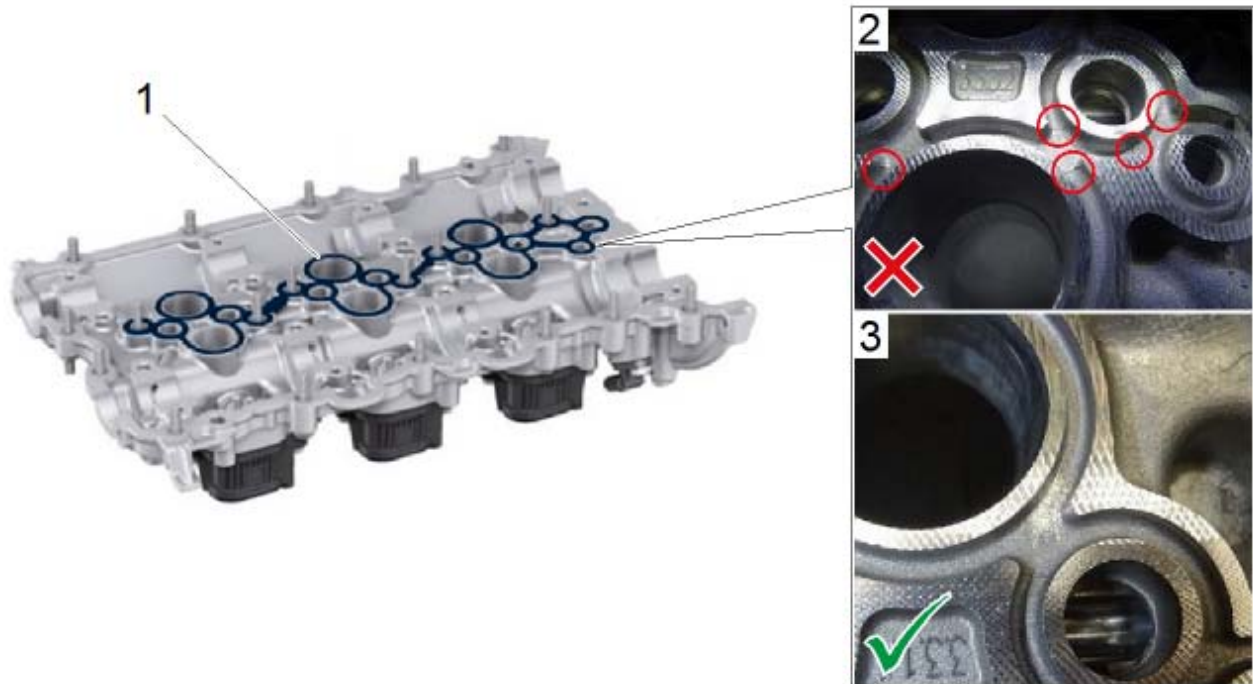
Cylinder head cover sealing groove

- Due to a batch error in the casting procedure there may be cast residue in the cylinder head cover sealing groove.
- This cast residue may be the reason for leaks in the injector holes.

2.6 Check the sealing groove (⇒ *Cylinder head cover sealing groove -1-*) of the cylinder head cover visually. Be particularly meticulous when doing this especially in the vicinity of the affected cylinder.

2.7 Carefully remove any cast residue (⇒ *Cylinder head cover sealing groove -2-*) using a small flat screwdriver, ensuring that the sealing groove is not damaged. There must be no more cast residue in the sealing groove after machining (⇒ *Cylinder head cover sealing groove -3-*).
