**Subject:**

ARTIFICIAL MOTOR SOUND NOT HEARD

**Bulletin No.:** 30-002/23

2022 MX-30 with VINS from JM1DR\*\*B\*\*\*100475 to 101083 (produced from November 1, 2021 through June 1, 2022)

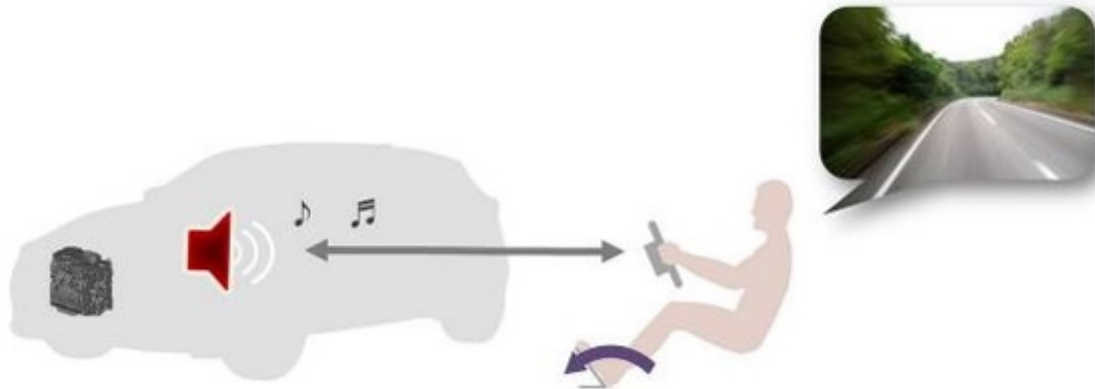
**NOTE:** The EV sound is provided for the driver to inform the vehicle's behavior, such as level and changes of motor torque, by an electronically generated sound through the audio system, instead of an engine sound.

This is caused by the Initial status of the electronic sound not being set properly. To eliminate this concern, the control software of the PCM has been modified.

1. Verify the customer concern.
2. Reprogram the PCM using the Mazda Diagnostic And Repair Software (MDARS). Refer to MDARS ECU Reprogramming Procedure.
