E3 Cayenne – Front Seats Make Excessive Noise During Longitudinal Adjustment

Models	Model Year	Model Type	VIN Range	Vehicle-Specific Equipment
Cayenne	2019 - 2024	9YA, 9YB	n/a	n/a

Revision	Release Date	Changes
0	July 25, 2023	Original document

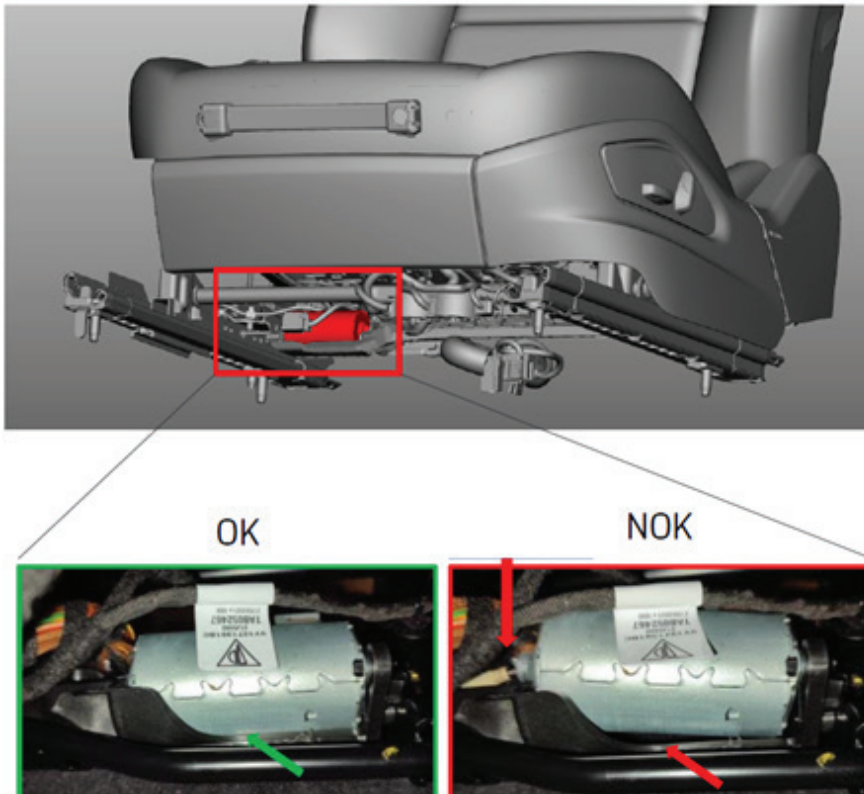
The current hypotheses suggest that the noise comes from either the longitudinal adjustment motor or the seat frame itself.

1. Take a video of the noise and attach it to the PCSS job.
2. Please ensure that the motor for longitudinal seat adjustment is properly inserted into its holder

Figure 1: OK vs. Not OK installation of longitudinal seat adjustment motor

- a. If the motor is properly installed in its holder, please continue to step 3.
- b. If the motor is not properly installed in its holder, push down on the top of the motor until it clicks into the mounting bracket.

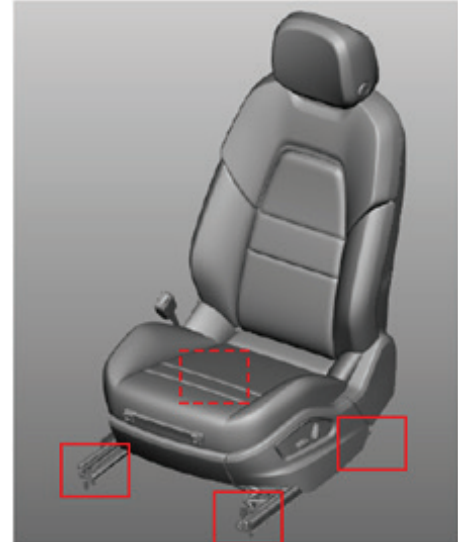
Figure 2: Seat mounting bolt locations

3. If the motor is properly inserted and the noise persists, please check that the seat frame is properly installed:
 - a. Loosen the seat mounting bolts
 - b. Ensure that the seat frame is properly positioned on the floor (e.g., the guide pins on the bottom of the seat rails are inserted into the correct holes on the floor)
 - c. Torque the seat mounting bolts to specification => 50 Nm
NOTE: If the noise is eliminated by properly torquing the seat mounting bolts, the seat mounting bolts must be replaced before handing the vehicle back to the customer.

4. If the noise further persists, please replace the seat frame as instructed in *WM 720955 – Replacing seat frame*
