TECH TALK - VOLUME 275

July - August 2023

TECHNICAL INFORMATION

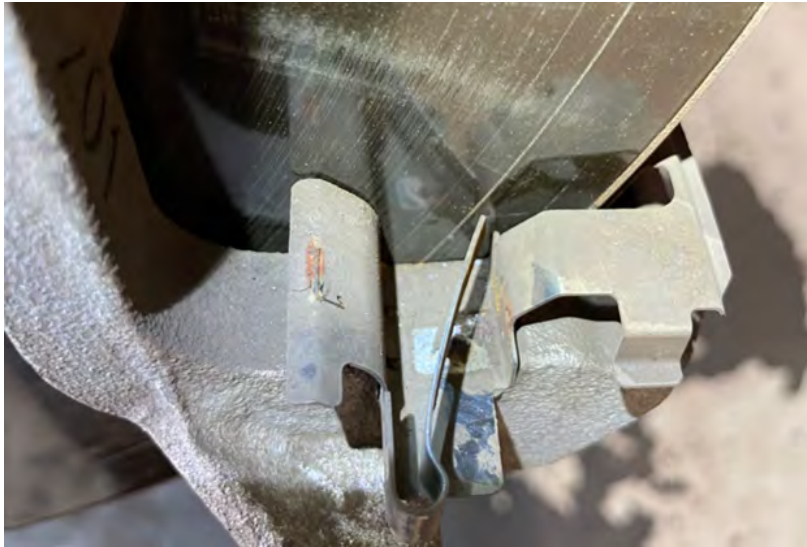
If a customer complains of noise from the front when braking, moving at parking lot speeds, turning in reverse, etc. the issue could be caused from brake hardware contacting the rotor resulting in vibration and noise. During your visual inspection, you may also notice light scratching on the rotor surface which you should be able to rectify by resurfacing. See the example in the photo below.

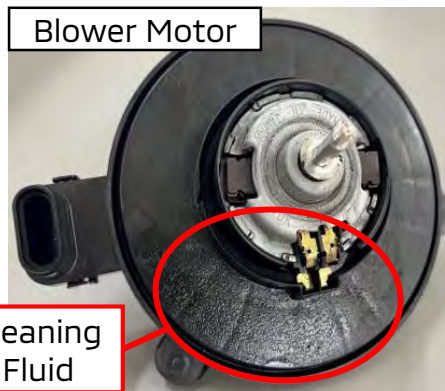
If MITSUBISHI Genuine Evaporator Cleaner (MZ100950EX) is used while the blower motor is disassembled, the cleaning fluid may enter the inside of the motor and cause abnormal noise when the air conditioner operates.

The evaporator cleaner should be used with the blower motor assembled on the vehicle and the "Air Flow Volume" set to "ON".

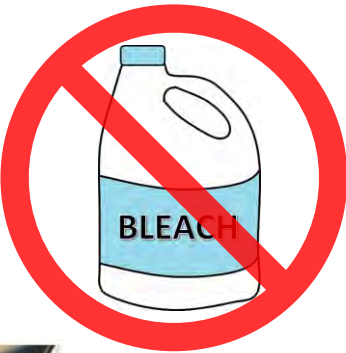
Peeling paint on the door switch panel

Avoid using household chlorine bleach(*) or alcohol of concentration of 60% or higher of cleaning of vehicles since it may cause the discoloration, erosion, and/or corrosion of vehicles parts. You should advise customers to use a neutral household detergent when cleaning their vehicle.

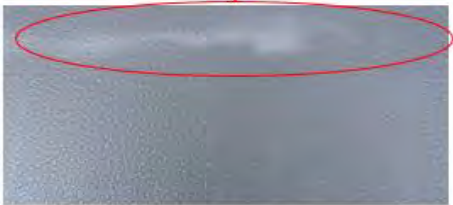
Discoloration of the instrument panel

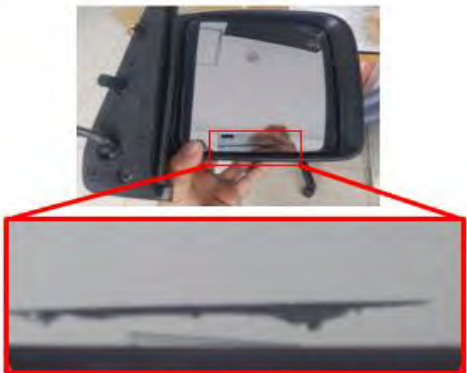
Erosion into the door mirror

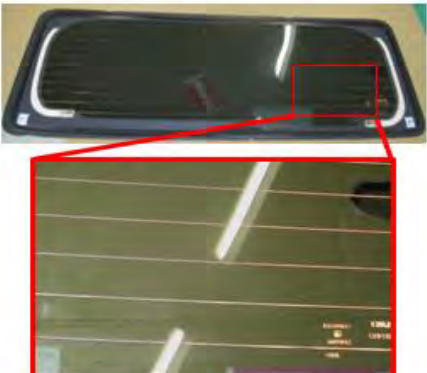
Discoloration of tailgate glass
