The Service Awareness Newsletter is an informal communication that contains information that may not be presently available in a TSB, SSM, GSB, or other electronic communication. This article includes information on warranty, technical service tips and other service information.

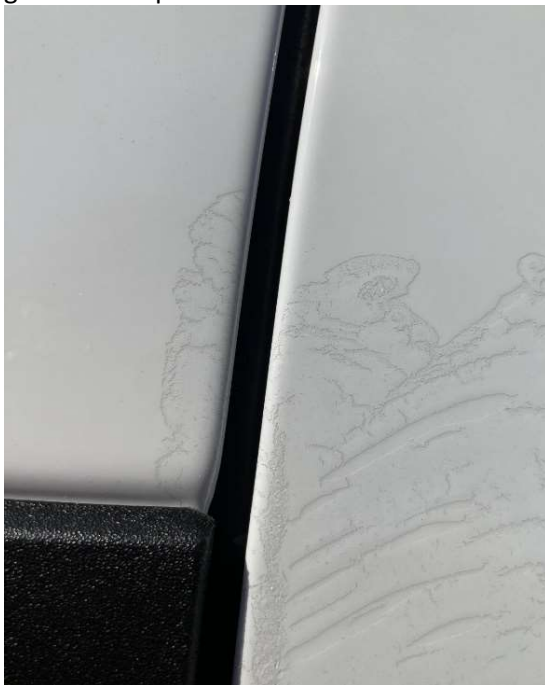
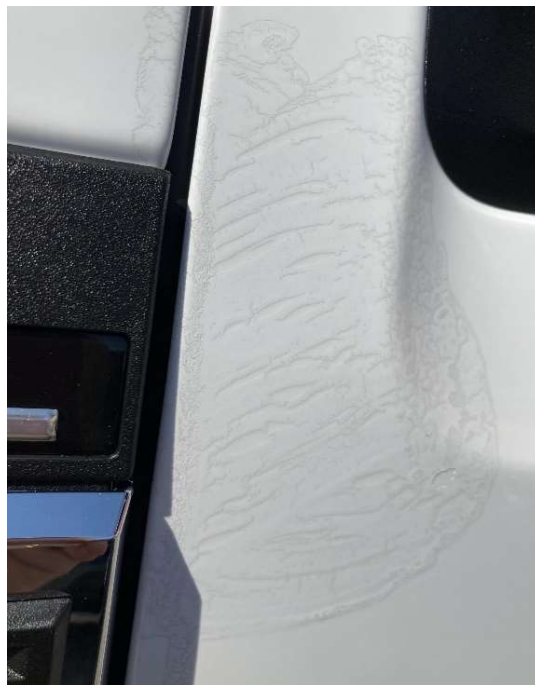
### **Liquid Chip Guard That May Appear As A Paint Quality Issue**

2017 through 2023 F-Super Duty, Expedition, and Navigator vehicles may have a liquid chip guard applied at the factory which should be washed off the vehicle during PDI. This liquid chip guard will sometimes look like clear coat peeling, runs/drips in the paint, or paint bubbles. If a concern of a clear coat peeling, paint run/drip, or paint bubbles is received for a F-Super Duty, Expedition, or Navigator that was discovered upon delivery to the dealership, make sure that the dealership has thoroughly cleaned the affected panel before making a determination. In some cases, it may be required to press a rag or towel saturated with warm water against the area for 20 to 30 minutes and the excess liquid chip guard will wipe off.
