MAS003711 RU 23-37

RAPID UPDATE

Rapid Update 645 MC20 – Knock Sensor Check

DATE: JULY 26 2023

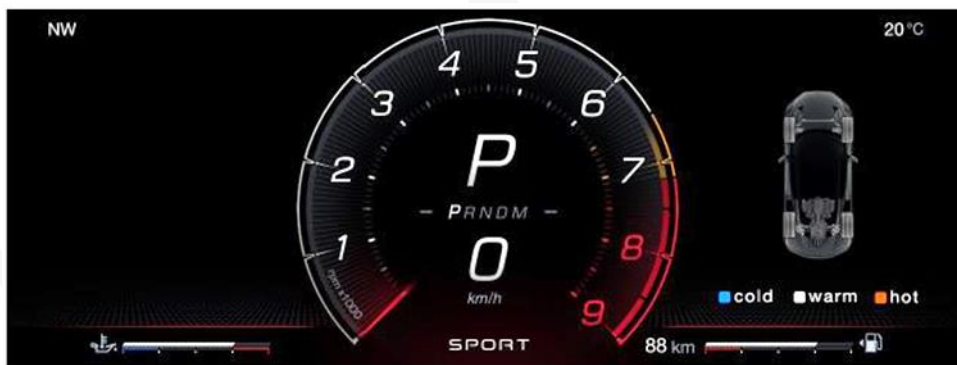
Note: Please follow the indication of the cluster to check the state of the engine.

ENGINE OFF (no)

COLD (no)

WARM (ok)

HOT (no)
