Technical Service Bulletin

35 Gearbox Malfunction Warning, DTC P0C2900, P176F00, P176E00 or P175E00 stored in the TCM

35 23 43 2050723/3 August 2, 2023. Supersedes Technical Service Bulletin Group 35 number 18-31 dated June 27, 2018, for reasons listed below.

Model(s)	Year	VIN Range	Vehicle-Specific Equipment
A3, and A3 Cabriolet	2017 – 2018	All	7 Speed S-Tronic
S3	2018

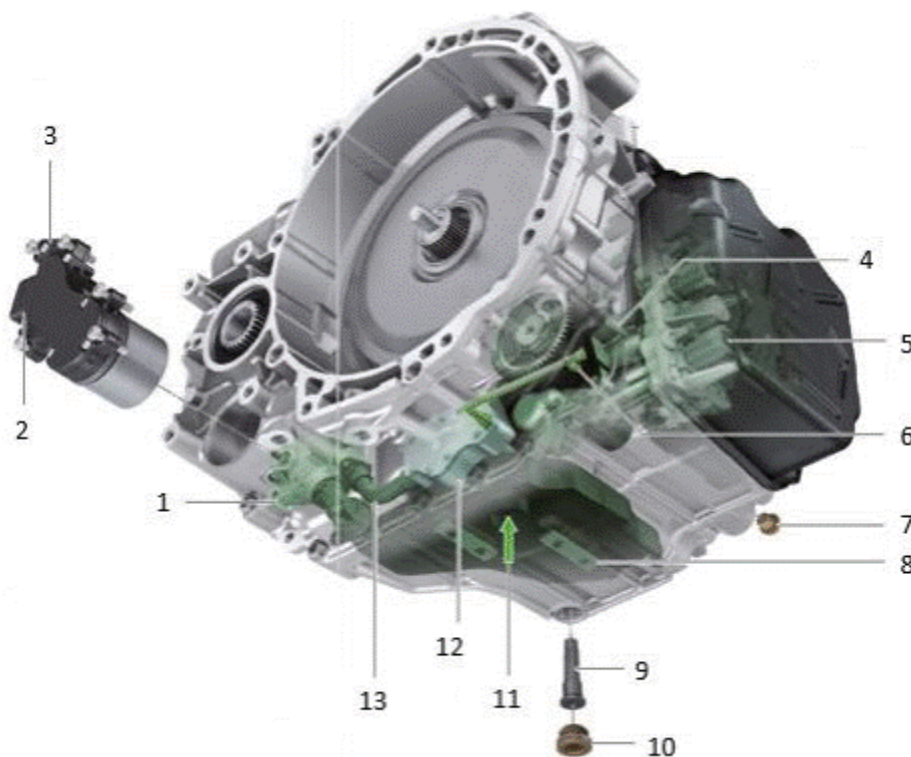
Figure 1. 0GC Gearbox Components.

Component related issue of auxiliary hydraulic pump (Figure 1).

Improved auxiliary hydraulic pump in production.
