Technical Service Bulletin

48 Electric steering column adjustment is not working, DTC B14BF01 is stored in the BCM 1

48 23 54 2062288/4 August 23, 2023. Supersedes Technical Service Bulletin Group 48 number 21-01 dated May 14, 2021 for reasons listed below.

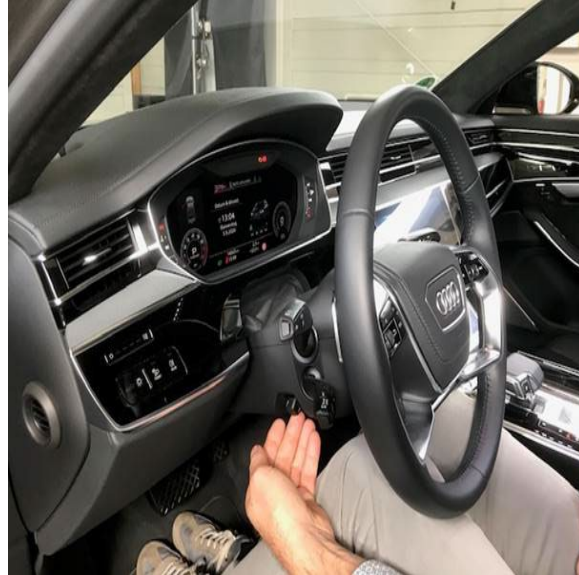
Figure 1. 40 kg force pushing steering wheel upward.

- Get into the vehicle and use your knees to push the steering wheel upward (a force of approx. 40 kg or 88 lbs is required), at the same time press the steering column adjustment switch upwards in the vertical adjustment direction (Figure 1).
- This will restore the function of the electric steering column adjustment.

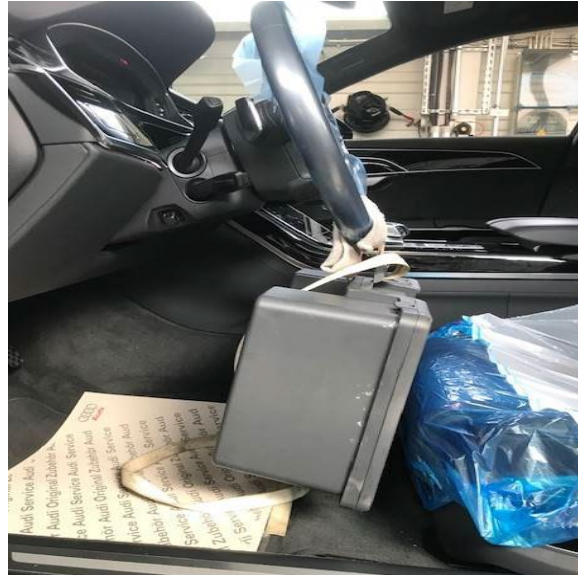
Figure 2. Weight necessary for steering adjustment.

6. Attach the tool kit to the steering wheel using a small securing strap (Figure 2). Take care not to damage the steering wheel.

We recommend placing a cleaning cloth underneath, as shown in Figure 2.

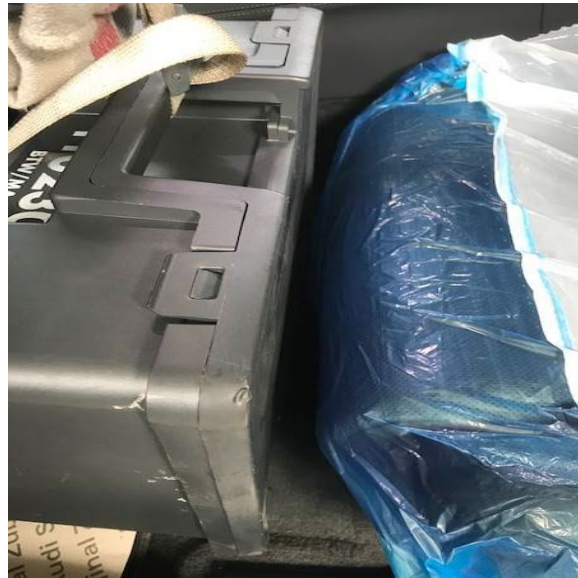
Figure 3. Plastic foil protection for the seat.

7. Apply plastic foil to make sure the tool kit cannot scrape against the seat (Figure 3).
