Technical Service Bulletin

87 Air conditioning does not cool - P053000, P251500 stored in C5

87 23 50 2068460/4 August 10, 2023. Supersedes Technical Service Bulletin Group 87 number 23-40 dated April 10, 2023, for reasons listed below.

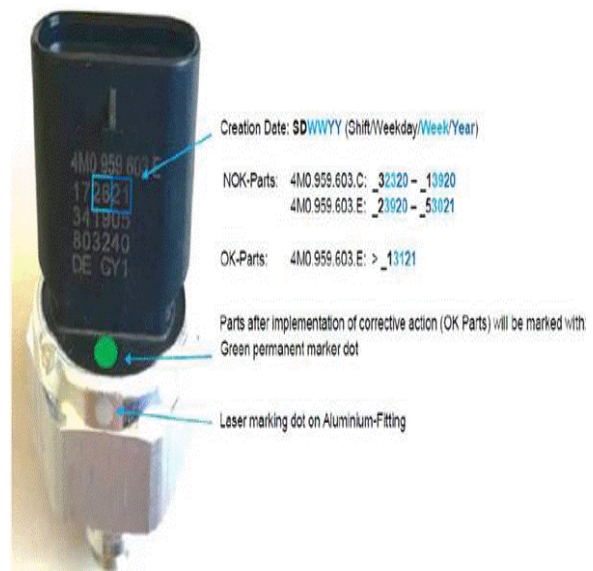
2. Inspect the markings on the sensor to determine if the sensor has been previously replaced with an improved sensor produced after Calendar Week 31, 2021. Figure 1 shows the locations of the markings and their interpretation. In this example, while the sensor is an 'E' index sensor, contains a green dot on the connector housing and a laser marking on the aluminum housing the build date of the sensor is *before* Calendar Week 31, 2021, and would require replacement.

Figure 1. Pressure and temperature sensor markings and build date.

The presence of the green dot on the sensor is not the sole, conclusive evidence of the sensor being of the improved type. The green dot was applied in production as an immediate identification of an improved sensor but the green dot was not applied indefinitely. Always check the sensor date as this is the confirmation of the sensor status.

- A sensor with index 'E', produced after Calendar Week 31, 2021, has a laser marking on the aluminum housing and may or may not contain a green dot on the connector housing is of the improved type and need not be replaced.

1. Should the vehicle present with the symptom profile described in this TSB inspect and/or replace all of the pressure sensors in the refrigerant circuit that are of the base part number 4M0959603 and have a build date before Calendar Week 31, 2021. Each model for which this TSB appears will have between 1 and 3 of this type of sensor installed at various positions in the refrigerant circuit, either on the low or high pressure sides of the circuit (G395 / G827).
