# Technical Service Bulletin

## 87 Air conditioning does not cool; B10AE21

87 23 52 2063575/3 August 18, 2023. Supersedes Technical Service Bulletin Group 87 number 22-28 dated July 12, 2022, for reasons listed below.

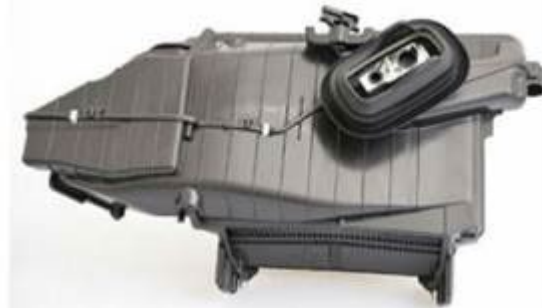
The refrigerant circuit head pressures are checked, found to be insufficient and after recovering the refrigerant volume the diagnostic finding is determined that the refrigerant volume in the circuit is very low or empty. DTC B10AE21 (High-pressure sensor Lower limit not reached) may be stored in the Heating/Air Conditioning Electronics control module, E87 (address word 0008). Leak identification dye is added to the refrigerant circuit along with a full charge of the refrigerant and the vehicle is test driven. Correct cabin cooling is restored. A visual inspection of the refrigerant circuit is conducted and no obvious leak can be seen under UV lighting. When using an electronic refrigerant leak detector at the central vents and condensate drain it alerts that the evaporator core may be the source of the leak.

**Figure 1.** HVAC evaporator and housing.

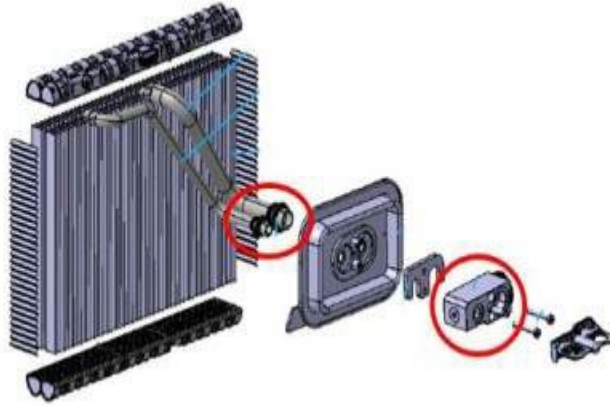
If, after checking for refrigerant leaks at each component and connection in the refrigerant circuit and systematically excluded as a cause, your diagnostic conclusion is that the evaporator core is the only refrigerant leak in the entire circuit apply a high level of scrutiny to the connection junction at the evaporator core /expansion valve/refrigerant lines for a possibly overlooked leak in these areas (figures 2 - 3).

**Figure 2.** Refrigerant connections in need of closer observation.

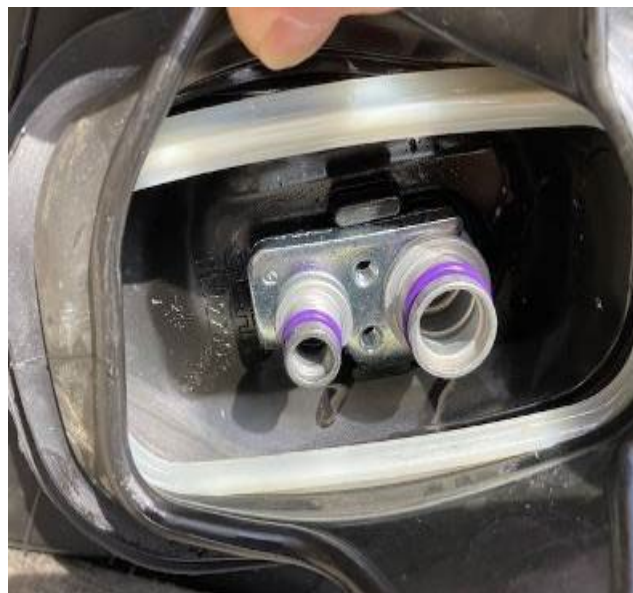
**Figure 3.** Refrigerant connections to the expansion valve.

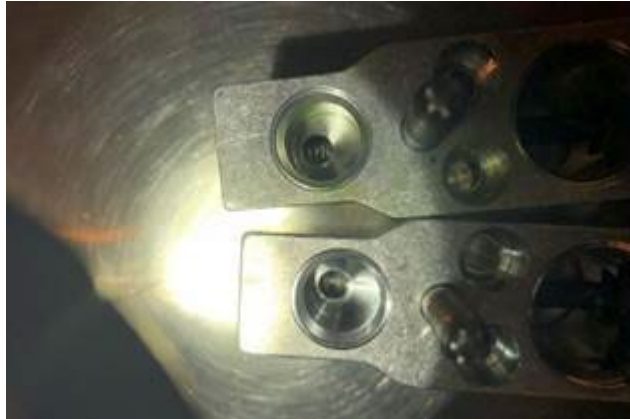
**Figure 4.** Leak at expansion valve connection evidenced by residue from the contrast agent.

If a refrigerant leak is detected from the evaporator core/expansion and valve/refrigerant line junction, take a short video showing the diagnostic confirmation of a leak in this area and post it to Doc-IT. Then, replace the expansion valve and all four O-rings without replacing the evaporator (figure 4). Re-test to ensure that the refrigerant leak is solved without the replacement of the evaporator core. Photograph any damage to the expansion valve ports, damaged o-rings, or refrigerant line connections and post these to Doc-IT as well.

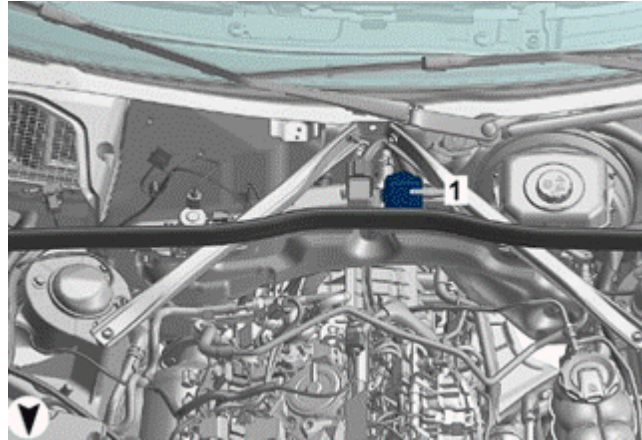
*Figure 5. Relay and fuse carrier 3 –SR3-*

Should the evaporator for the Q5 be confirmed leaking by way of this diagnostic procedure and replacement of the evaporator is performed it is necessary to loosen and refasten the Relay and Fuse Carrier 3 -SR3- (shown in figure 5, position 1) in the course of the repair. During reassembly of the vehicle it is critically important that this relay and fuse carrier in particular be reinstalled in its correct original position. Failure to reinstall the Relay and Fuse Carrier 3 precisely will result in water intrusion and subsequent component damage.
