Technical Service Bulletin

87 HVAC blower setting adjustment not possible

87 23 54 2071139/2 August 25, 2023. Supersedes Technical Service Bulletin Group 87 number 23-48 dated August 8, 2023 for reasons listed below.

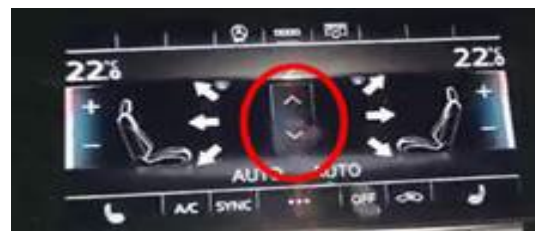
Figure 1. Normal HVAC control panel appearance.

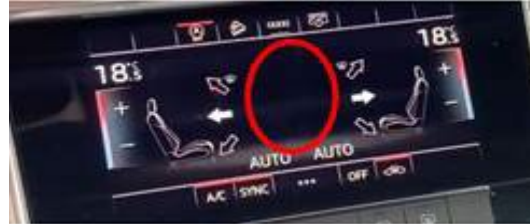
On rare occasions the fan control strip in the lower HVAC screen used for increasing or decreasing the fan speed does not appear (Figures 1-2).

This symptom is difficult to reproduce. When the symptom occurs the center strip for the fan control is blank. The fan speed cannot be controlled.

Figure 2. Appearance of HVAC control with the fan speed strip blank.

Please explain to the customer that, should this symptom occur, a restart of the MMI system will restore the fan control to the screen. Demonstrate to the customer the process by pressing and holding the on/off button for at least 10 seconds. The restart should take less than a minute.

Do not replace any parts should the vehicle exhibit this symptom. Parts replacement will not solve this issue. Any parts replaced for this condition under warranty will be debited.
