Technical Service Bulletin

91 No diagnostics communication to the telematics control module; DTC U142100

91 23 19 2056076/19 August 8, 2023. Supersedes Technical Service Bulletin Group 91 number 23-08 dated June 29, 2023, for reasons listed below.

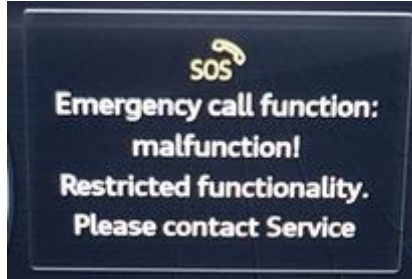
- An SOS Warning might be displayed in the instrument cluster (Figure 1).

Figure 1. Emergency call malfunction warning.

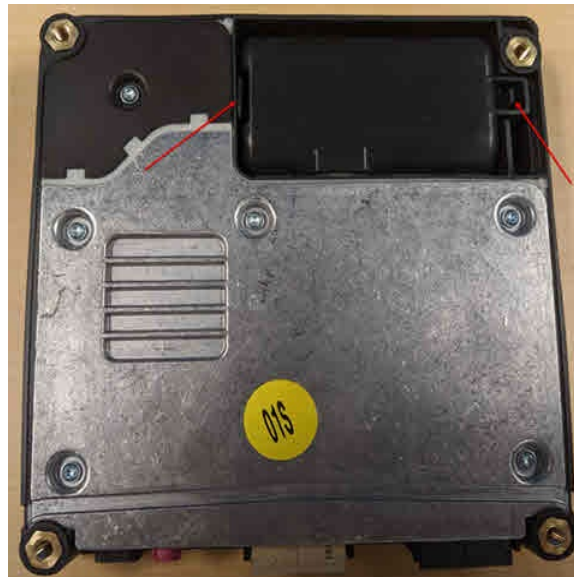
A software bug can cause the control module to freeze during a cold start.

Figure 2. Backup battery compartment location.

1. Remove and unplug the telematics control module, -J949- (address word 0075) according to the Elsa Repair Manual.
2. Open the battery compartment of the telematics control module, -J949- (address word 0075), and disconnect the backup battery (Figures 2 - 3).

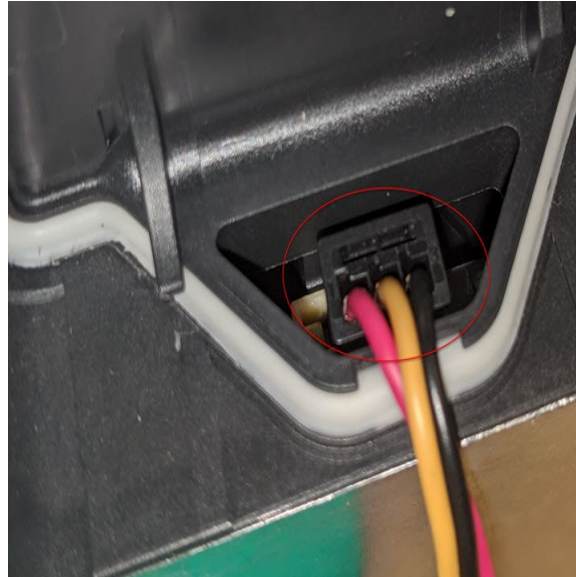
Figure 3. Backup battery connector (no release mechanism).

4. Leave the battery and Gateway fuse disconnected for approximately 20 minutes, then reinstall the fuse.
5. Reinstall the backup battery back into the telematics control module, -J949- (address word 0075).
6. Reinstall the telematics control module, -J949- (address word 0075) back into the vehicle.
7. If ODIS **still cannot** connect to the telematics control module, -J949- (address word 0075), then follow the ODIS test plan and replace the telematics control module with part number **992 035 286 C**.
