## Technical product information

<b>Topic</b>	Grease evident at the front lower ball joint bellows
<b>Market area</b>	Australia E04 Bentley rest Asia and Australia (6E04),China 796 VW Import Comp. Ltd (Vico), Beijing (6796),Germany E02 Bentley rest Europe (6E02),Japan E03 Bentley Japan (6E03),Korea, (South) E08 Bentley South Korea (6E08),United Arab Emirates E06 Bentley Middle East and Africa (6E06),United Kingdom E01 Bentley UK (6E01),United States E05 Bentley USA and rest America (6E05)
<b>Brand</b>	Bentley
<b>Transaction No.</b>	2068455/2
<b>Level</b>	EH
<b>Status</b>	Approval
<b>Release date</b>

### New Continental GT/C and New Flying Spur

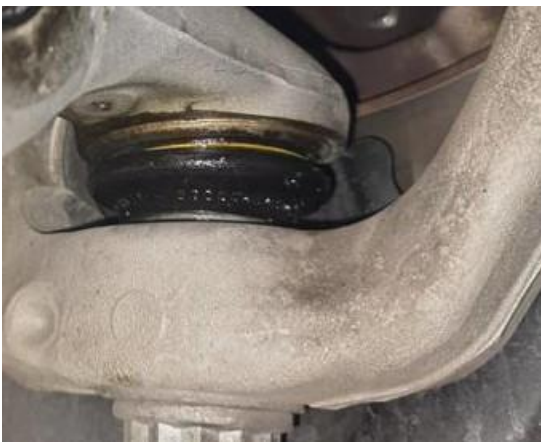
Figure 1

Grease may leak during the initial assembly of the front lower levers. This due to a maximum deflection of the conical spigot before the lower lever is assembled into the wheel carrier. Over the service life, additional foreign bodies can collect in the corresponding area and stick to the excess grease, which can then be distributed over a larger area

The level of grease on or around the lower ball joint boot/wheel bearing housing (Figures 1,2 and 3) is deemed as a normal characteristic

### “Normal” Characteristic:

If there is no customer complaint about noises (rattling, pinching, creaking) from the area of the front axle and the lower levers have clearance, the operative must remove any excess grease and check the ball joint and bellows for damage

If the ball joint/bellows is not damaged, the lower lever does not need to be replaced

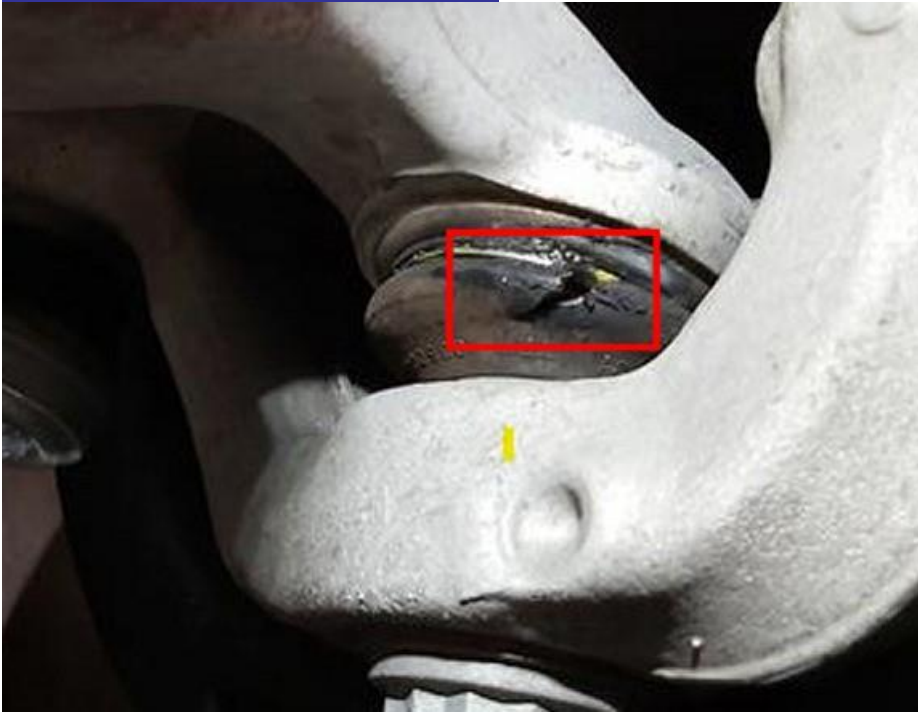
Figure 4

"Torn/split bellows" - Replacement necessary

If the ball joint is worn/damaged or the ball joint bellows is split/damaged (as shown in Figures 4 and 5) the lower front lever must be replaced – Refer to Rep.Gr 40

**IMPORTANT:** Prior to replacing the lower lever the operative **MUST** raise a Technical DISS query requesting permission to replace the front lower lever
