Noises Between Seat-back Lining And Function Carrier

Topic number	LI91.10-P-076798
Version	1
Function group	91.10 - Front seats
Date	8/14/23
Validity	Model series 206, 254, 297 Cleanpoint felt at function carrier: 01.08.2023 Cleanpoint felt at seat backrest frame: 15.05.2023
Reason for change

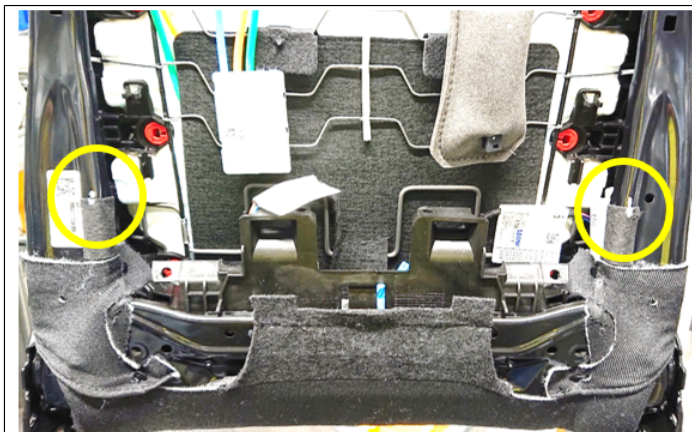
Attachments	
File	Description
Pic. 1.PNG

Noise at front seats between seat-back lining and function carrier.

Noise is caused by friction of the two component parts.

Via adhesive bonding, affix 2 pieces of felt at the lower seat backrest structure (see pic. 1).
