Flush Door Handle - Servo Opening Inoperative

Topic number	LI72.10-P-076701
Version	1
Function group	72.10 - Front door
Date	7/14/23
Validity	MODEL 223 with code 889 MODEL 294 with code 889 MODEL 295 with code 889 MODEL 296 with code 889 MODEL 297 with code 889
Reason for change

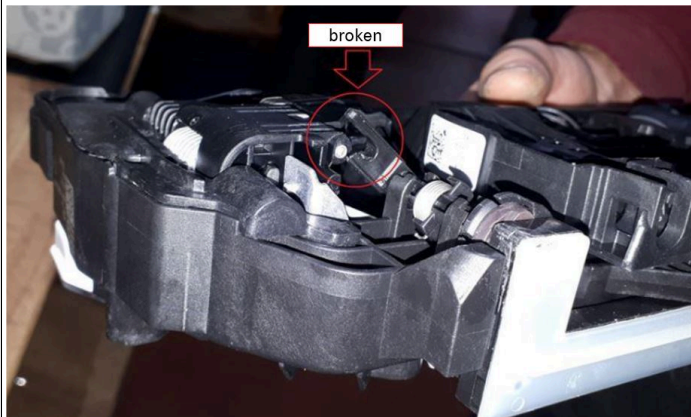
Flush door handle needs to be pulled on with increased force in order to open the door manually.

Turning angle sensor lever is broken (see picture).

File	Description
Bild.JPG	Broken Turning Angle Sensor Lever

Replace the bearing bracket of the flush door handle.
