TECHNICAL SERVICE BULLETIN

Lack Of Air Flow/HVAC Blower Motor Inoperative

23-2258
15 August 2023

Ford 2021-2023 E-Series

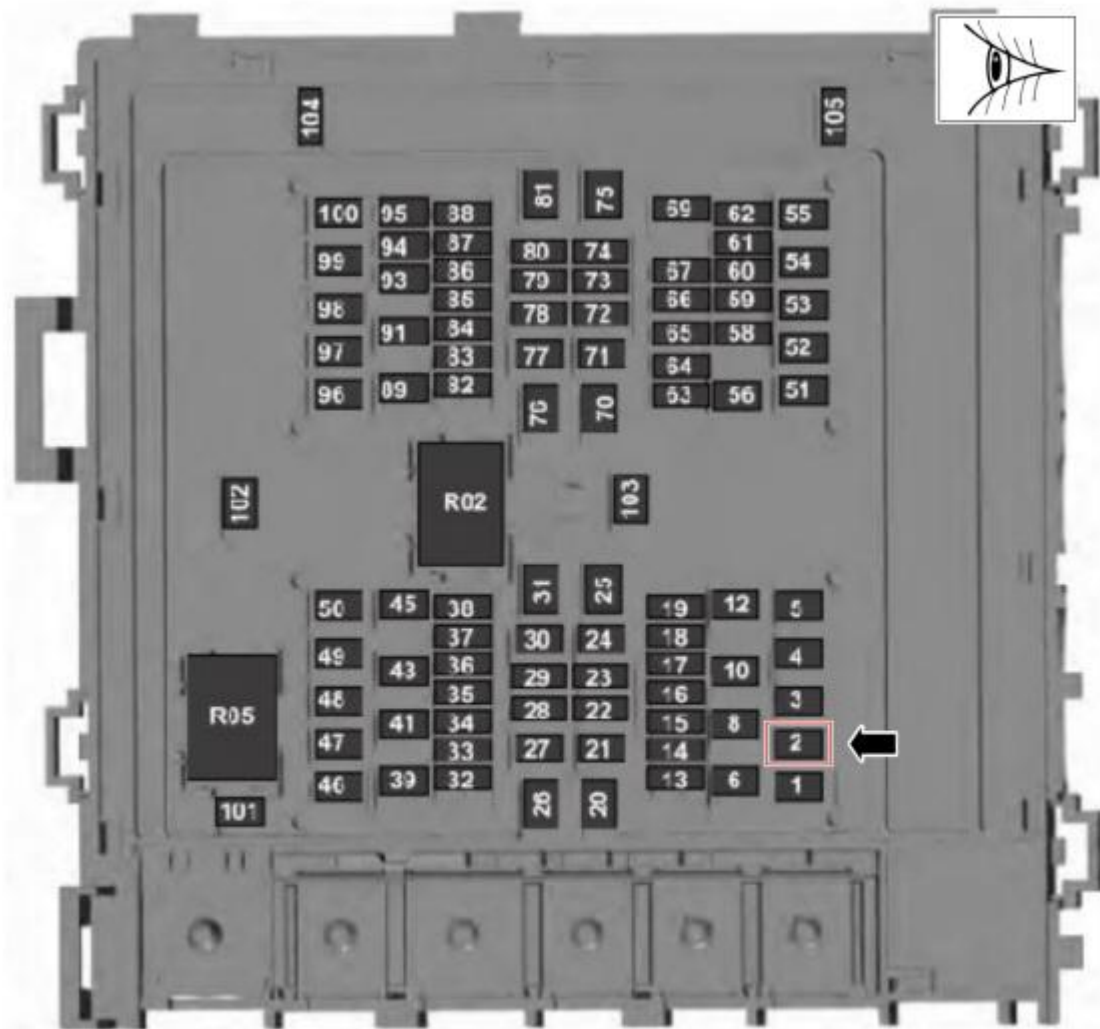
Figure 6

Issue: Some 2021-2023 E-Series vehicles may exhibit a lack of air flow due to an inoperative heating, ventilation, and air conditioning (HVAC) blower motor. This may be due to a damaged fuse F2 (50A) in the battery junction box (BJB). To correct the condition, follow the Service Procedure to replace the BJB and replace fuse F2 in the new BJB with the listed service replacement part.

7. Remove fuse F2 and replace with the listed service replacement part. (Figure 6)
